VEHICLE INSPECTION REPORT

FJ65VXY

DAF LF 250

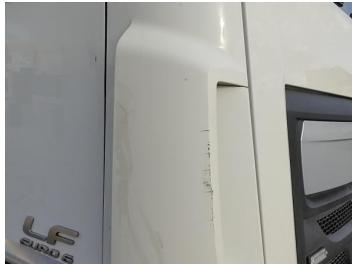
1: Wing osf Scratched Over 25mm Thru Paint

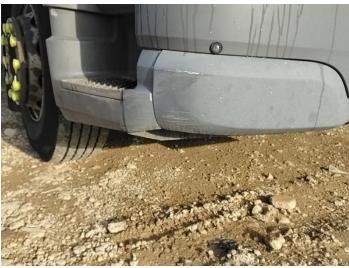
2: Bumper Front Moulding Scuffed (Unpainted) UpTo 100mm

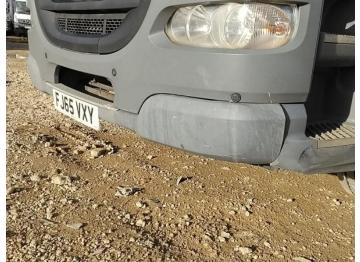
5: Bumper Front Moulding Scuffed (Unpainted) UpTo 100mm

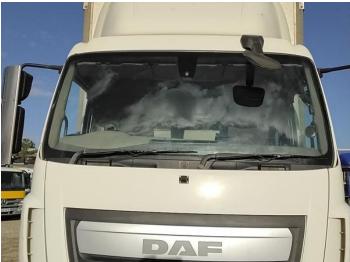
6: Screen Front Chipped Over 10mm

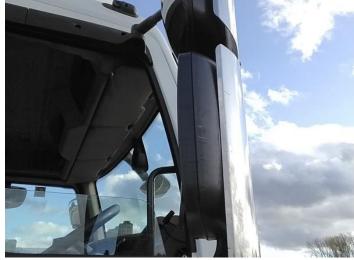
13: Door Mirror Assy osf Scuffed (Unpainted) UpTo 100mm

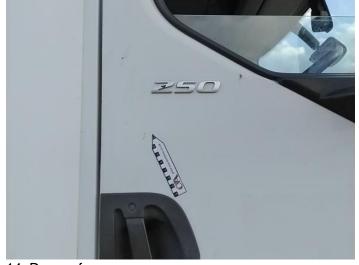
14: Door osf Scratched Over 25mm Not Thru Paint

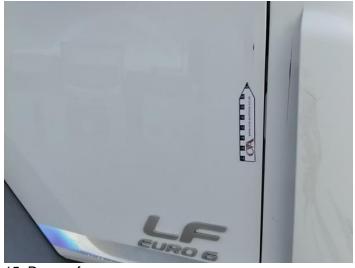
15: Door osf Scratched UpTo 25mm Thru Paint

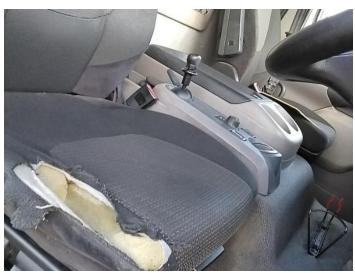
16: Seat Base Cover osf Holed Over 3mm
