VEHICLE INSPECTION REPORT

YN67YXU

Daf LF 150

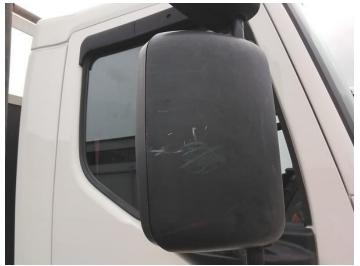
1: Door Mirror Assy osf Scuffed (Unpainted) Over 100mm

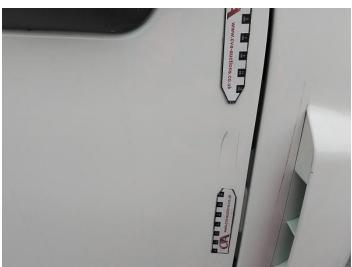
2: Door osf Dented With Paint Damage

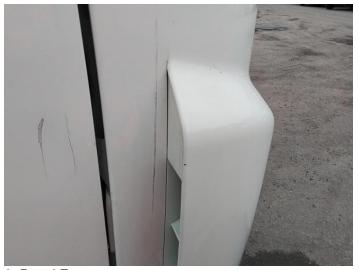
3: Panel Front Scratched Over 25mm Thru Paint

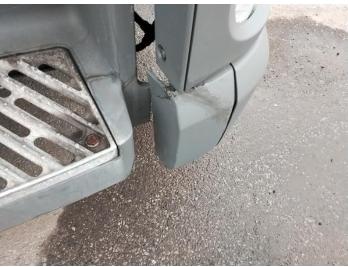
4: Bumper Front Moulding Broken Replace

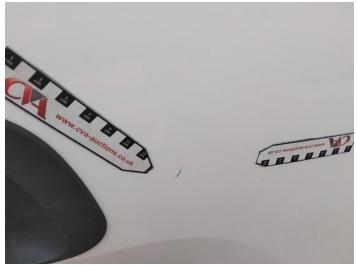
5: Door osf Scratched Over 25mm Thru Paint

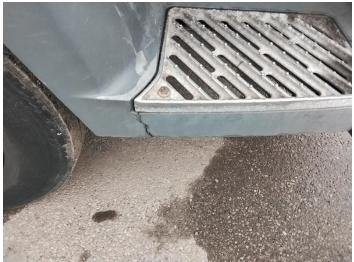
6: Bumper Front Moulding Broken Replace

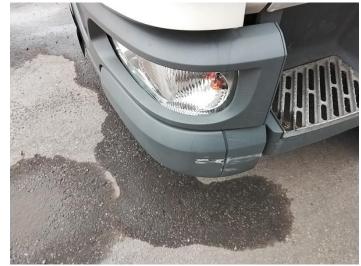
7: Bumper Front Scratched Over 100mm Thru Paint

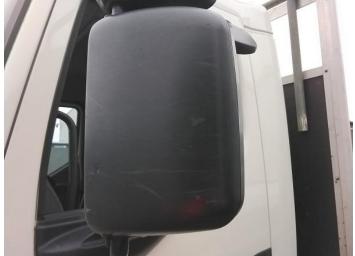
8: Door Mirror Assy nsf Scuffed (Unpainted) Over 100mm

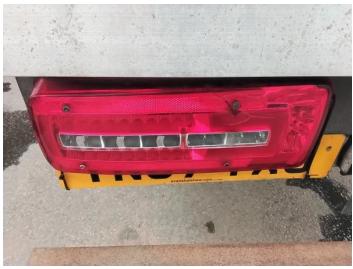
9: Lamp nsr Broken Replace

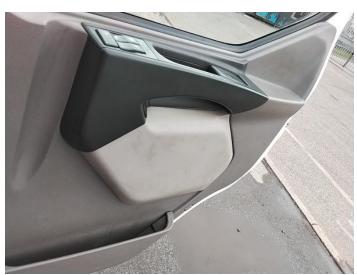
10: Door Pad osf Soiled Heavy

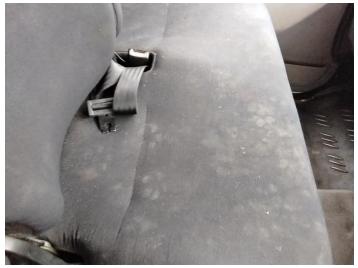
11: Seat Base Cover nsf Soiled Heavy
