VEHICLE INSPECTION REPORT

WX66KWU

Isuzu D-Max 2.5 TD

Non	Runner

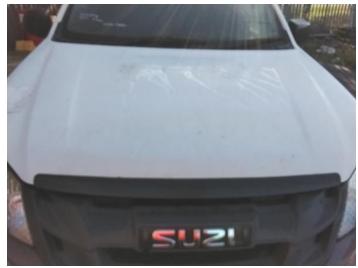
1: Bonnet Chipped Multiple Chips

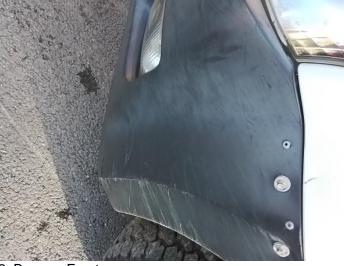
2: Bumper Front Scratched Over 100mm Thru Paint

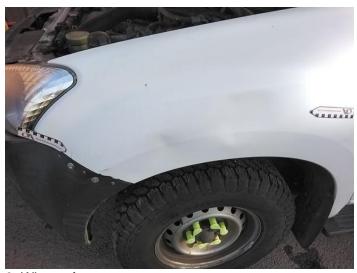
3: Wing nsf Dented Over 30% Of Panel

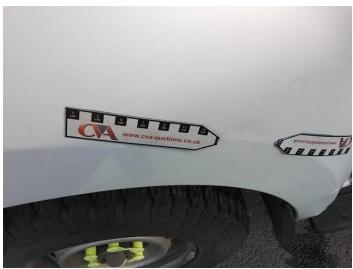
4: Wing nsf Dented Over 30mm

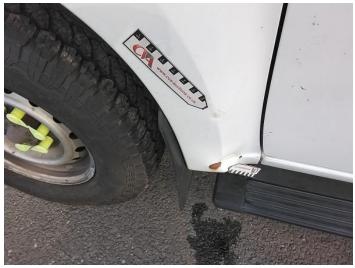
5: Wing nsf Dented With Paint Damage

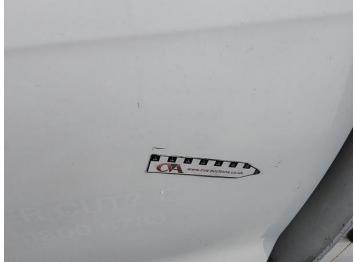
6: Qtr Panel nsr Scratched Over 25mm Thru Paint

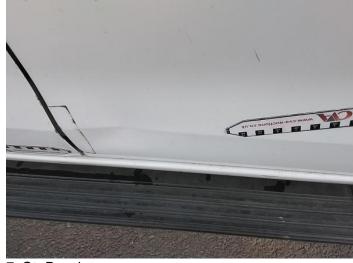
7: Qtr Panel nsr Dented Over 30mm

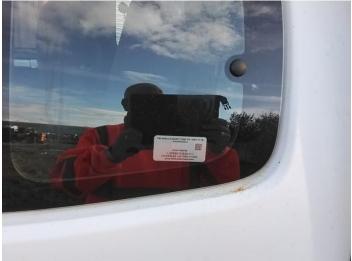
8: Qtr Panel nsr Chipped Multiple Chips

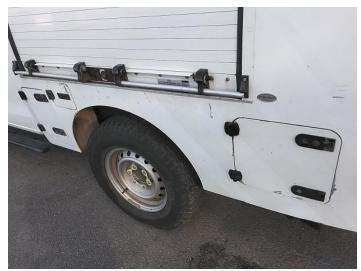
9: Qtr Panel nsr Chipped Multiple Chips

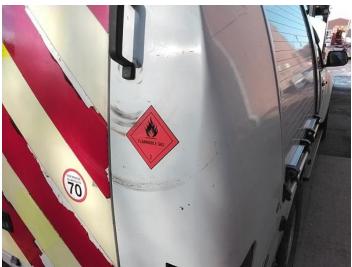
10: Qtr Panel osr Scratched Over 25mm Thru Paint

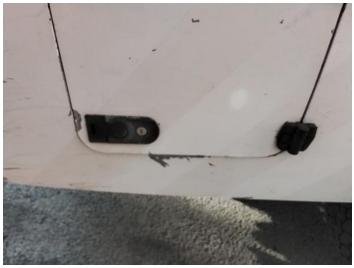
11: Qtr Panel osr Dented Over 30mm

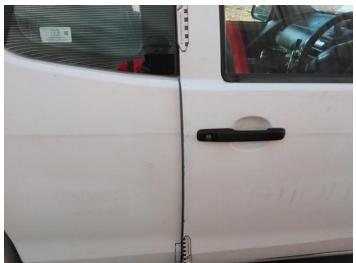
12: Door osf Dented With Paint Damage

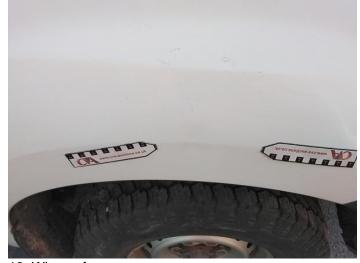
13: Wing osf Dented Over 30mm

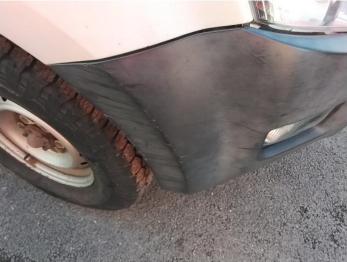
14: Bumper Front Scratched Over 100mm Thru Paint

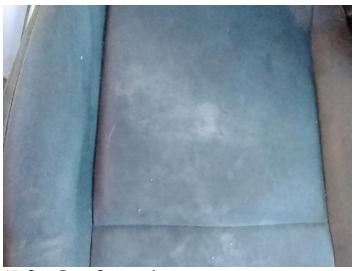
15: Seat Base Cover osf Soiled Heavy

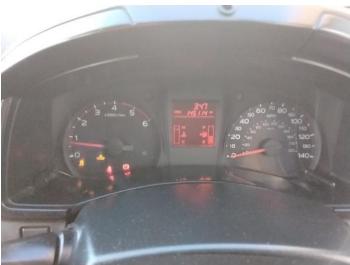
16: Dash Warning Lights Displayed No Action
