# VEHICLE INSPECTION REPORT

**CU64FKG**

## Ford Transit 350 2.2 TDCI 100PS

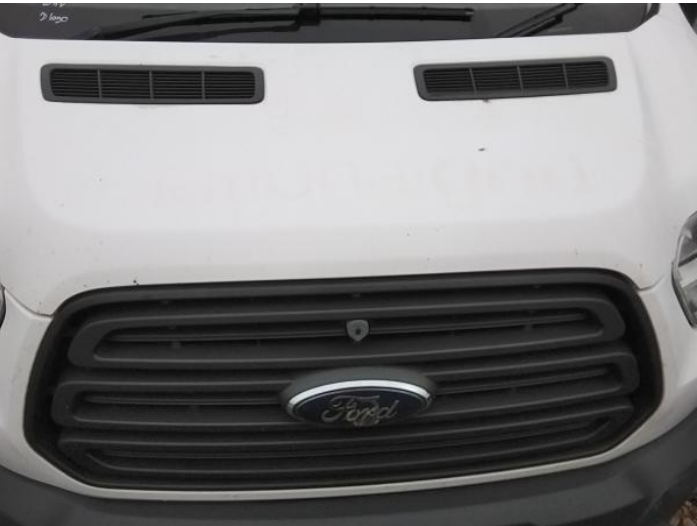
1: Bonnet  
Chipped  
Multiple Chips

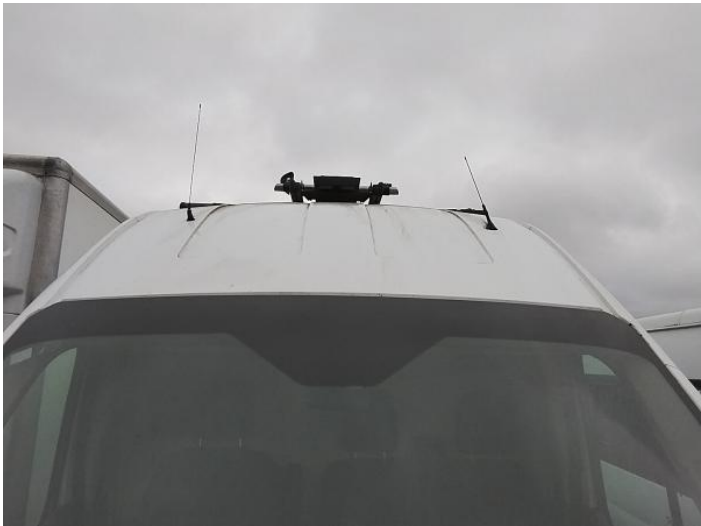
2: Roof  
Chipped  
Multiple Chips

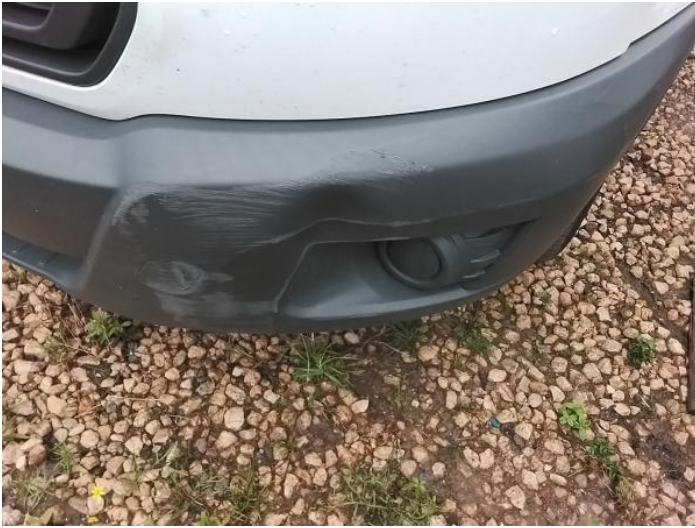
3: Bumper Front  
Dented  
With Paint Damage

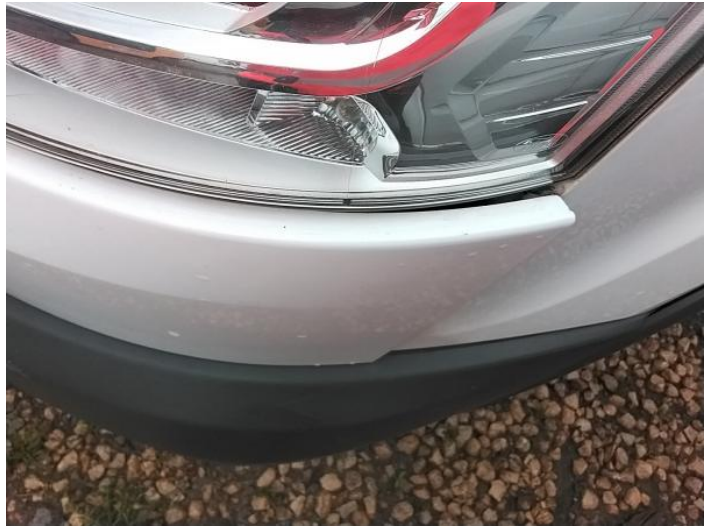
4: Panel Front  
Dented  
Over 30mm

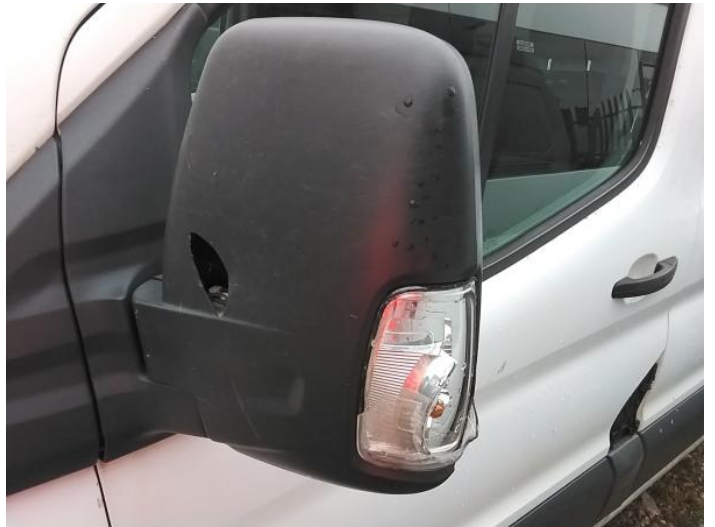
6: Door Mirror Assy nsf  
Broken  
Replace

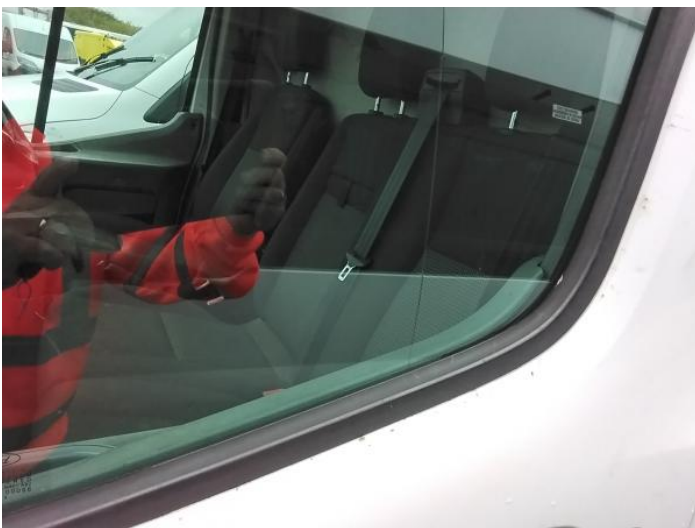
7: Door nsf  
Chipped  
Multiple Chips

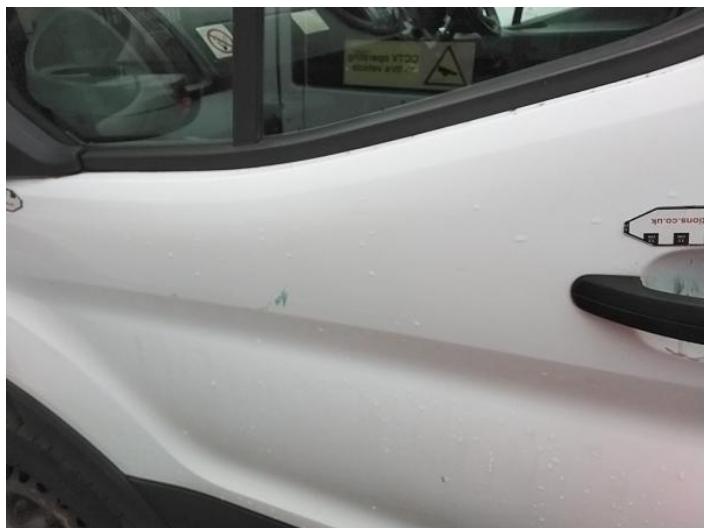
8: Door nsf  
Scratched  
Over 25mm Thru Paint

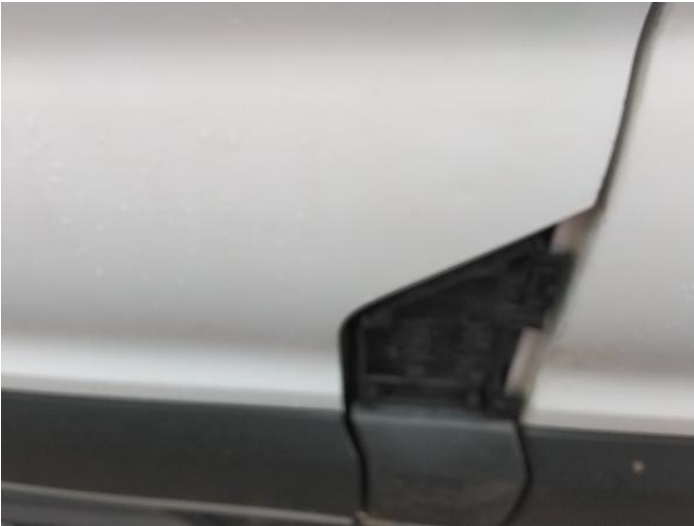
9: Fuel Flap  
Missing  
Replace

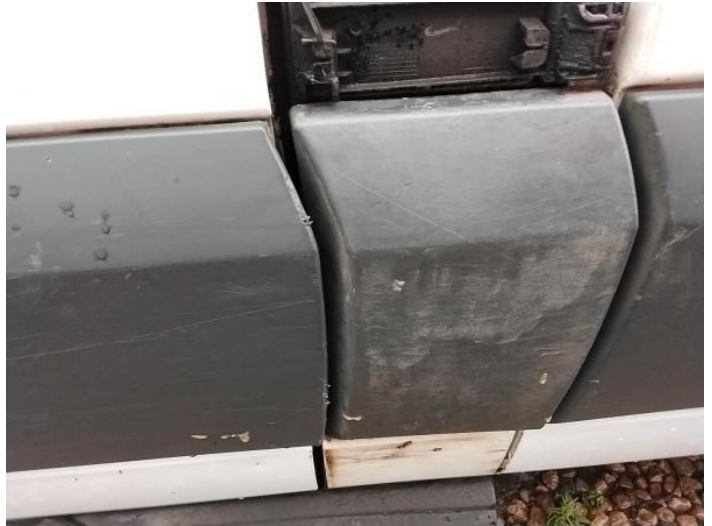
10: Door Moulding nsf  
Scuffed (Unpainted)  
UpTo 100mm

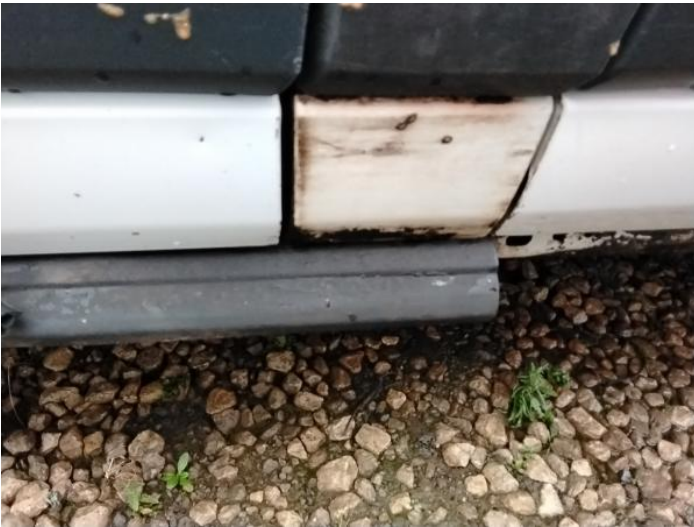
11: B Post ns  
Dented  
With Paint Damage

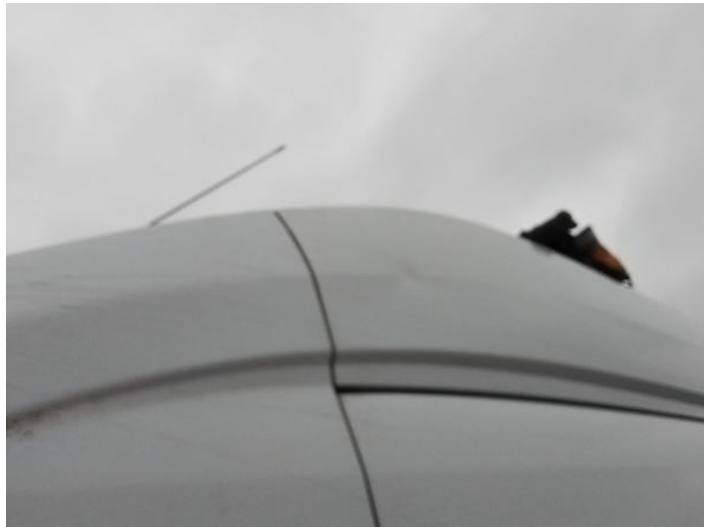
12: Roof  
Dented  
Over 30mm

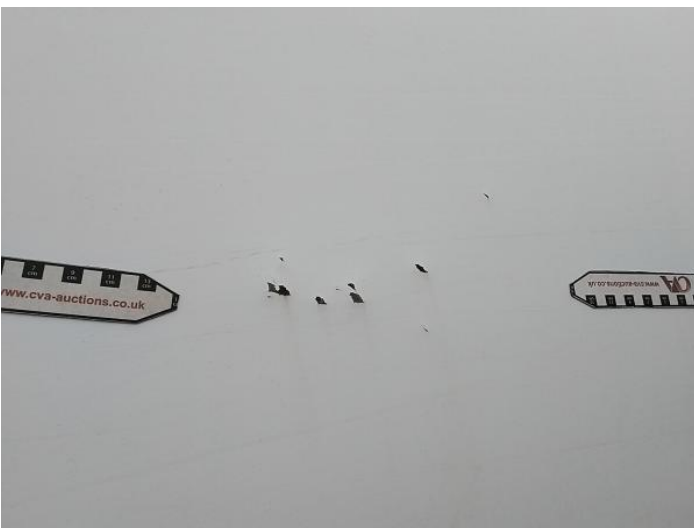
13: Qtr Panel nsr  
Dented  
With Paint Damage

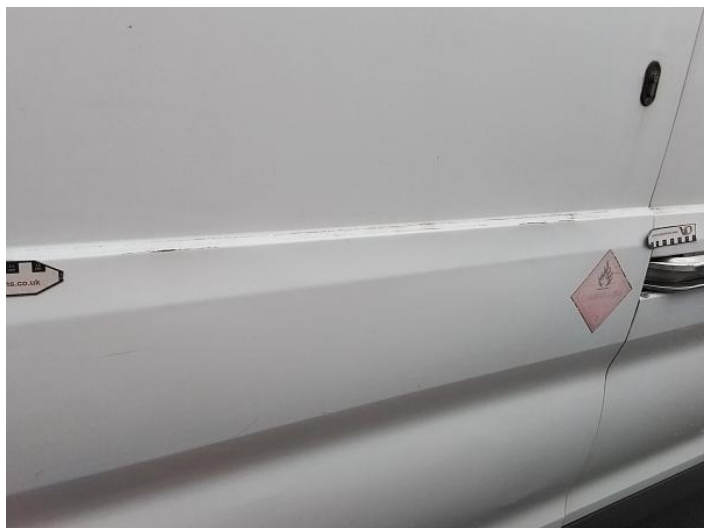
14: Qtr Panel nsr  
Dented  
With Paint Damage

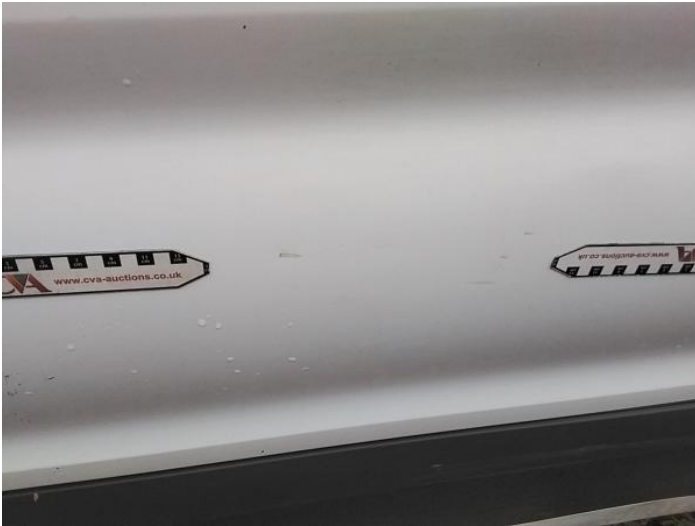
15: Qtr Panel nsr  
Dented  
With Paint Damage

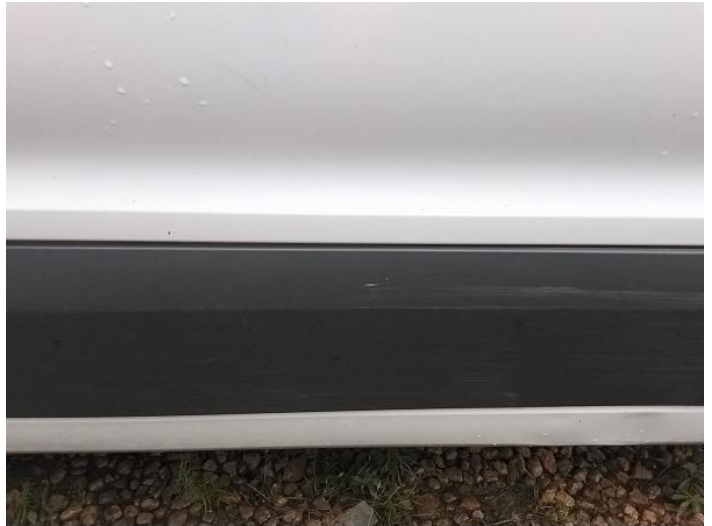
16: Qtr Panel Moulding ns  
Scuffed (Unpainted)  
Over 100mm

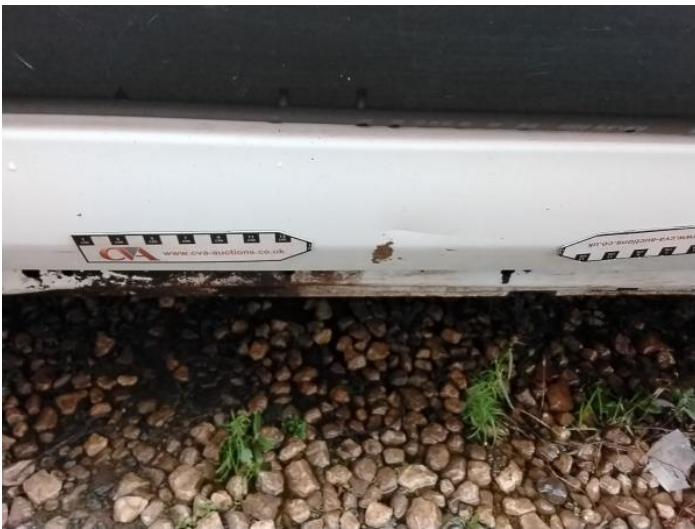
17: Qtr Panel nsr  
Dented  
With Paint Damage

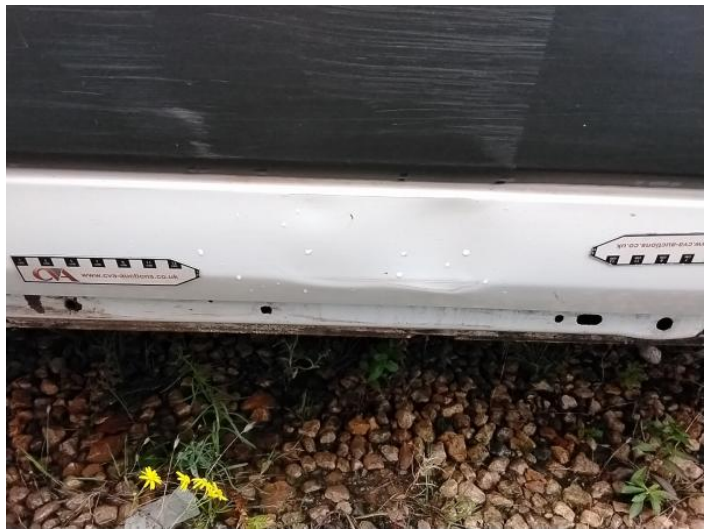
18: Qtr Panel nsr  
Dented  
With Paint Damage

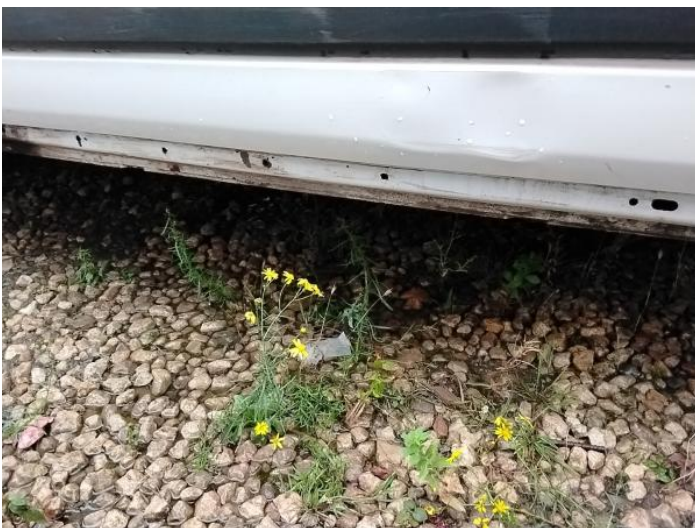
19: Qtr Panel Moulding ns  
Missing  
Replace

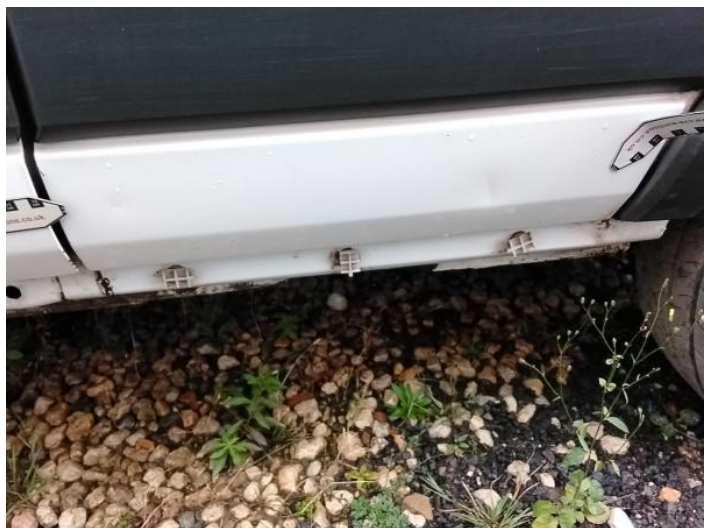
20: Qtr Panel nsr  
Dented  
Over 30mm

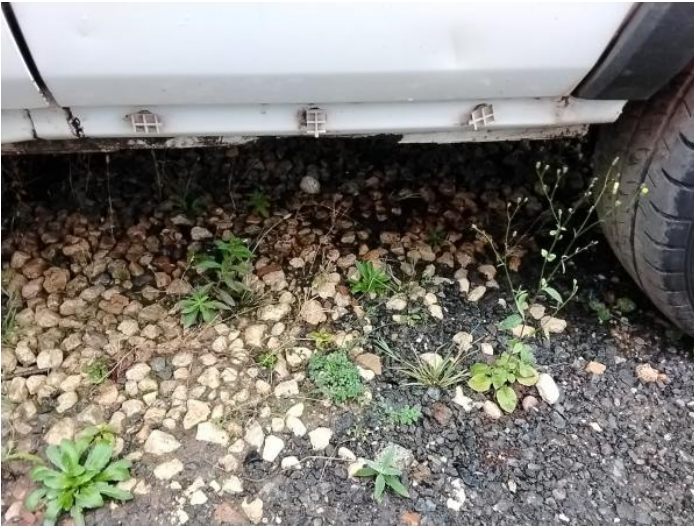
21: Qtr Panel Moulding ns  
Missing  
Replace

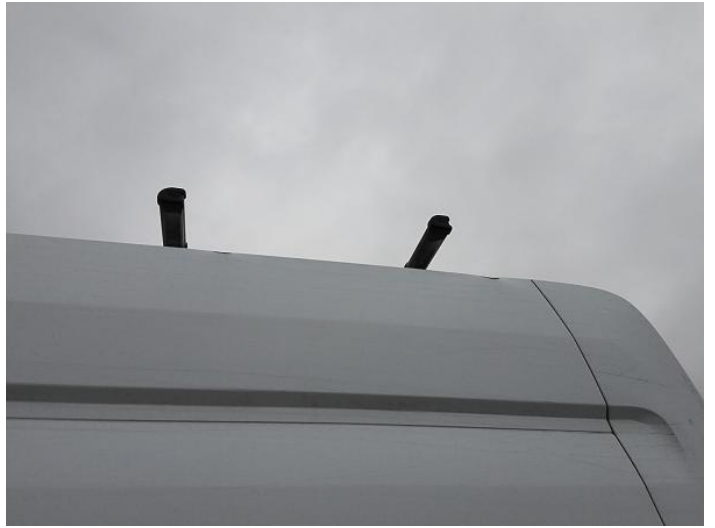
22: Roof  
Dented  
With Paint Damage

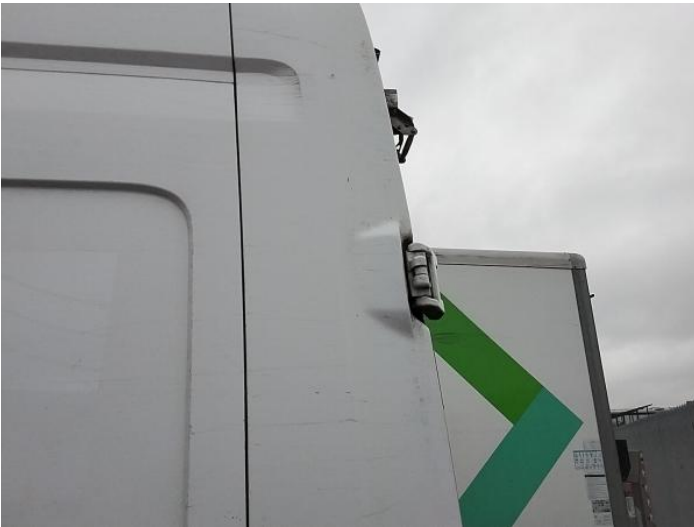
23: C Post ns  
Scratched  
Over 25mm Thru Paint

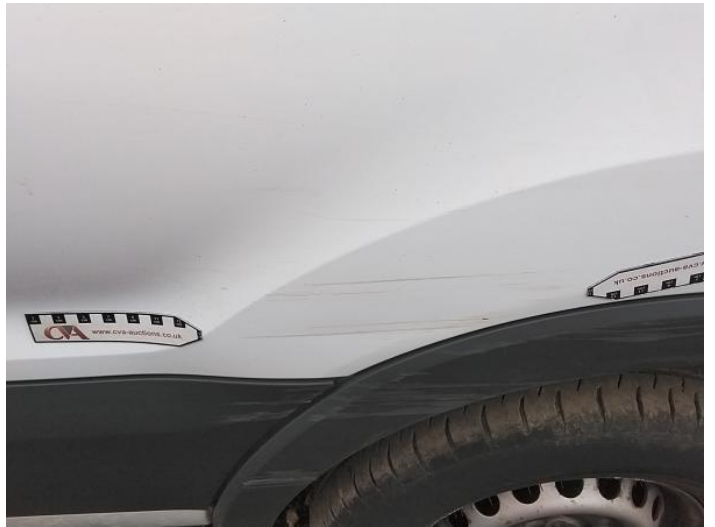
24: Qtr Panel nsr  
Dented  
With Paint Damage

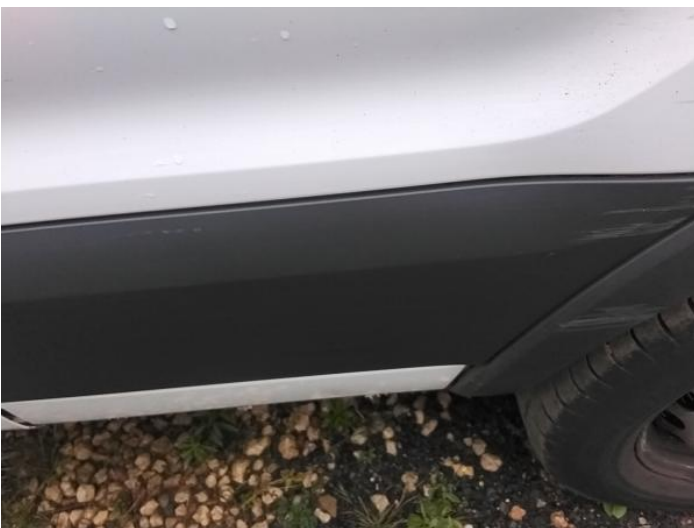
25: Qtr Panel Moulding ns  
Scuffed (Unpainted)  
Over 100mm

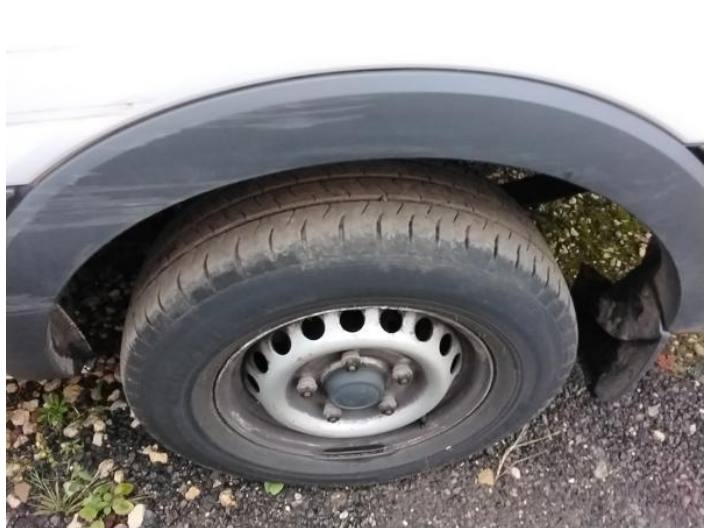
26: Qtr Panel Moulding ns  
Scuffed (Unpainted)  
Over 100mm

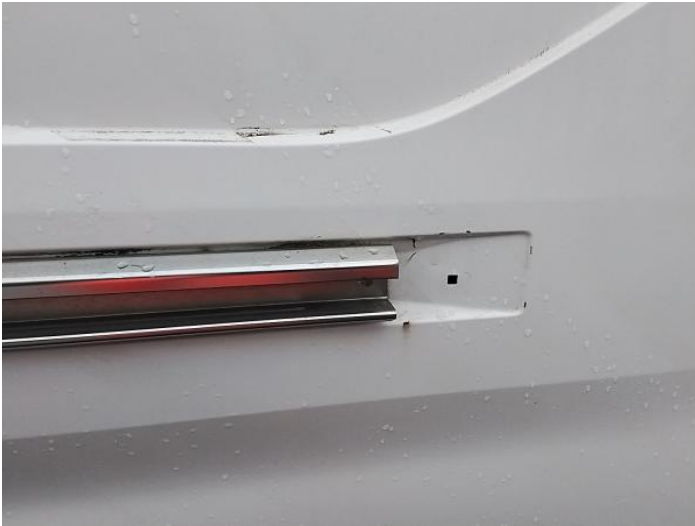
27: Qtr Panel Trim ns  
Missing  
Replace

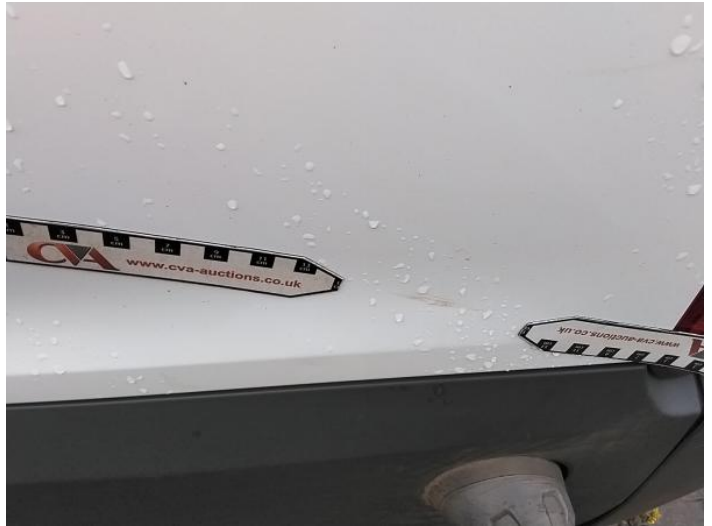
28: Qtr Panel nsr  
Dented  
With Paint Damage

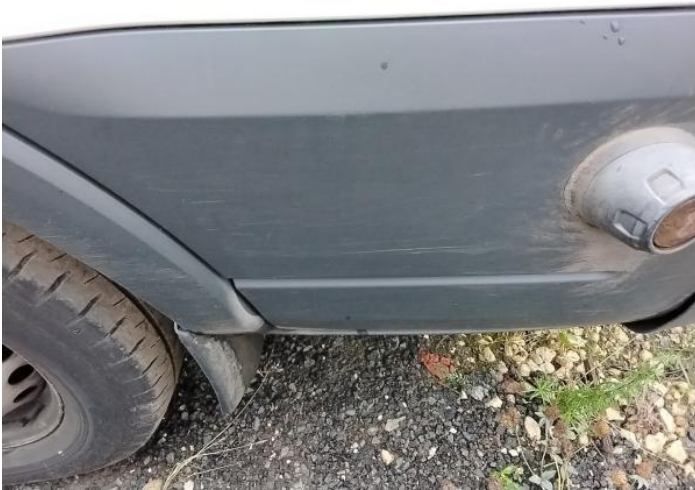
29: Qtr Panel Moulding ns  
Scuffed (Unpainted)  
Over 100mm

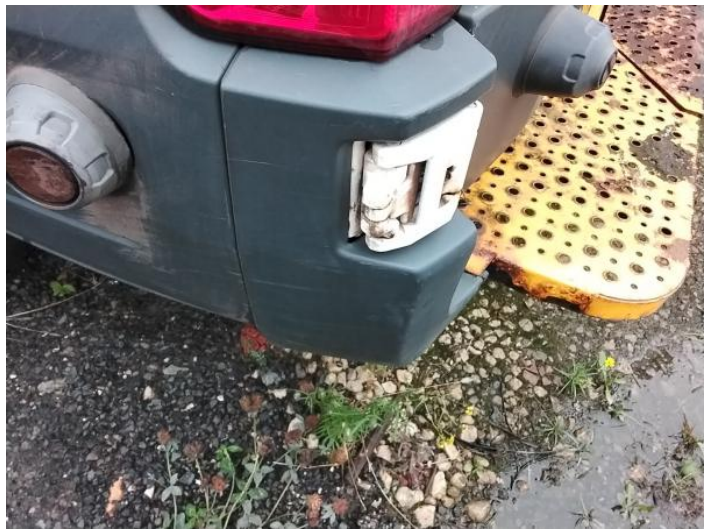
30: Bumper Rear Moulding  
Scuffed (Unpainted)  
Over 100mm

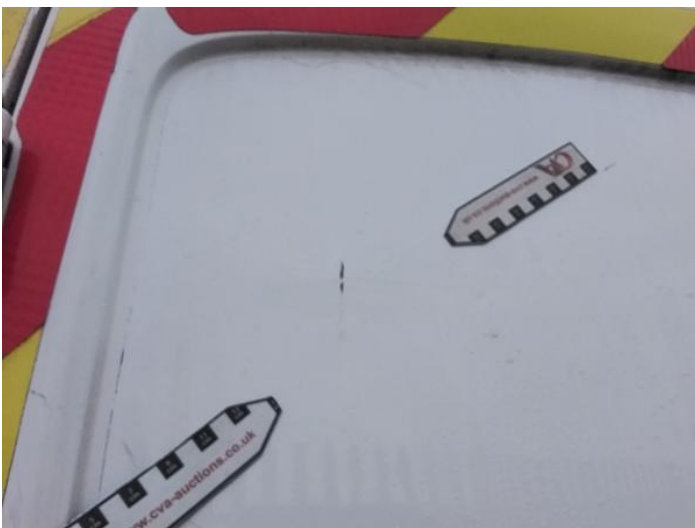
31: Door nsr  
Dented  
With Paint Damage

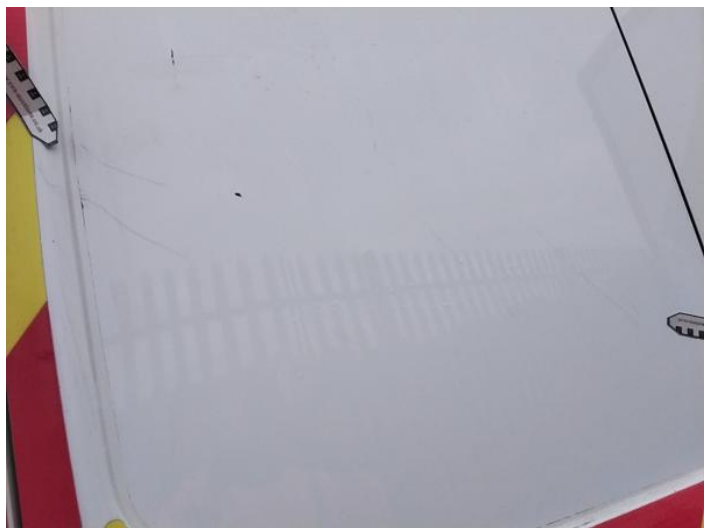
32: Door nsr  
Scratched  
Over 25mm Thru Paint

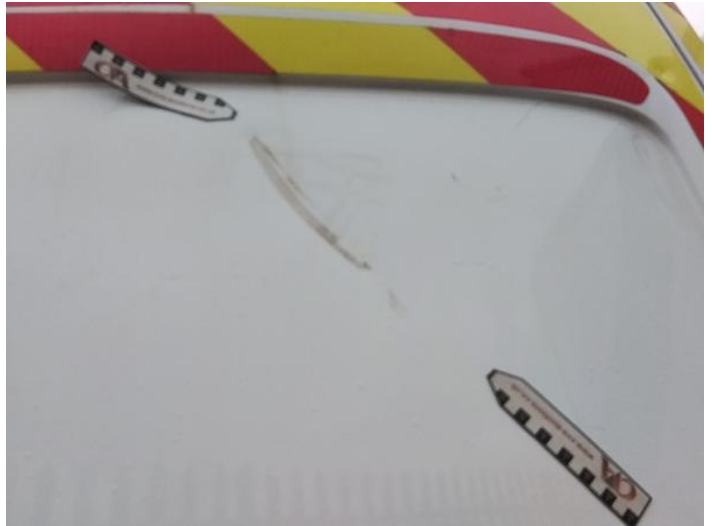
34: Door osr  
Dented  
With Paint Damage

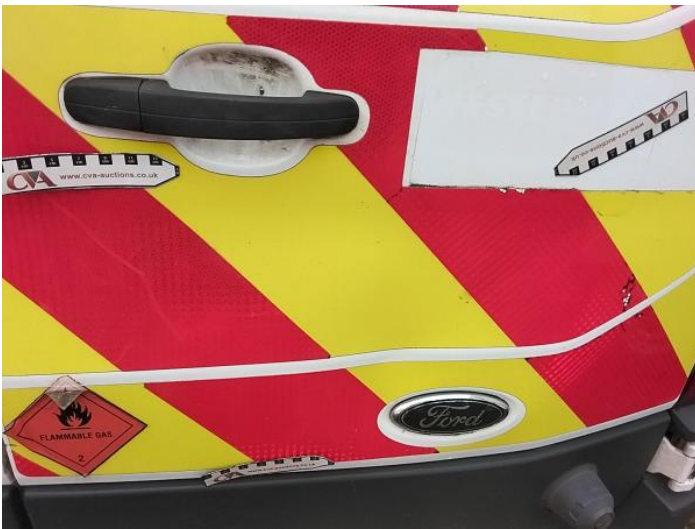
35: Door osr  
Dented  
Over 30mm

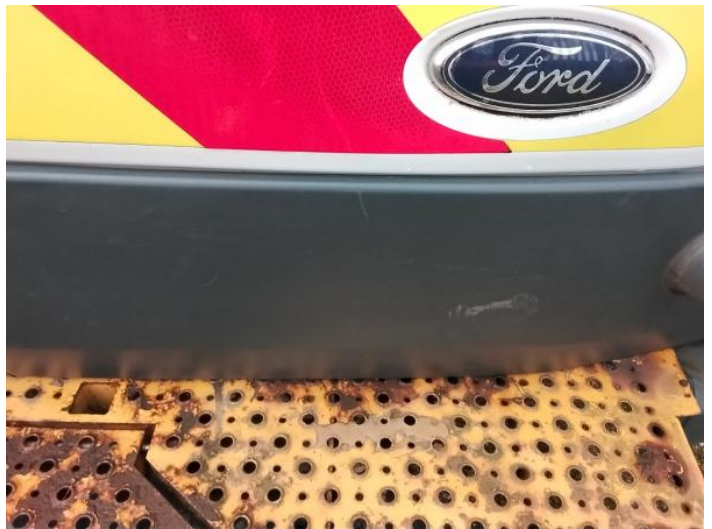
36: Door Moulding osr  
Scuffed (Unpainted)  
Over 100mm

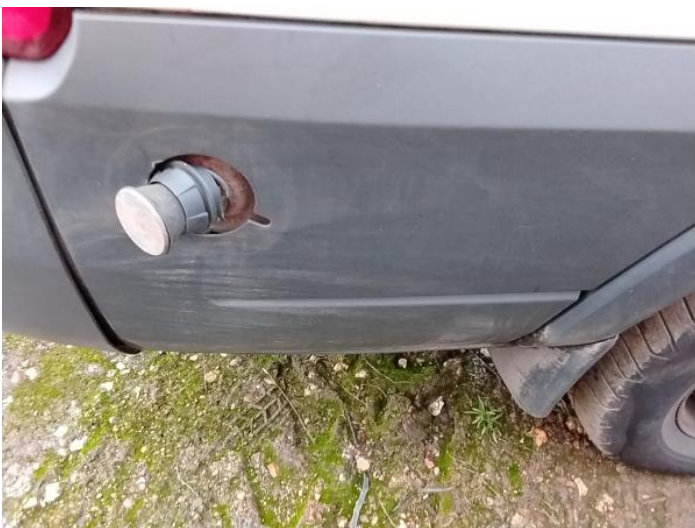
37: Qtr Panel Moulding os  
Scuffed (Unpainted)  
Over 100mm

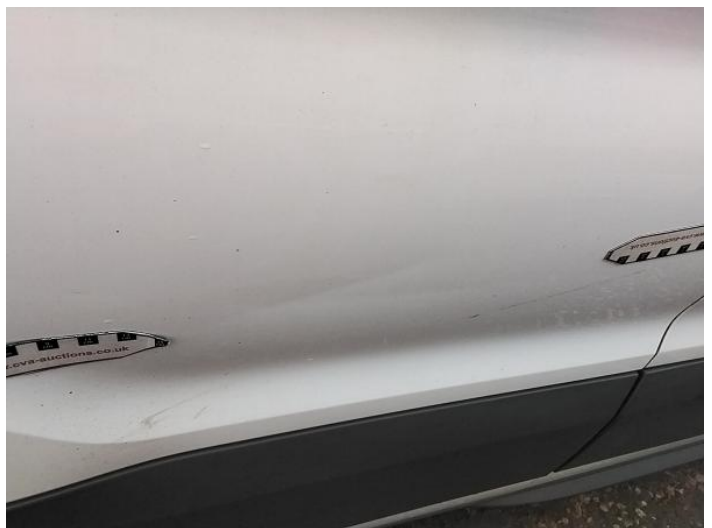
38: Qtr Panel osr  
Dented  
Over 30mm

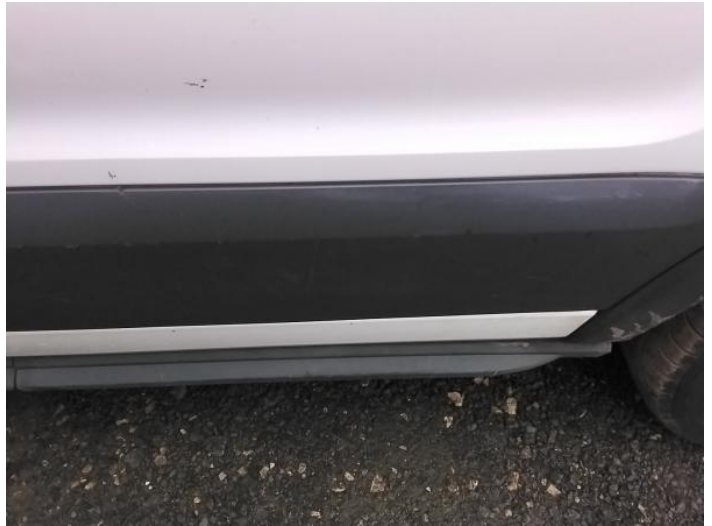
40: Door Moulding osf  
Scuffed (Unpainted)  
Over 100mm

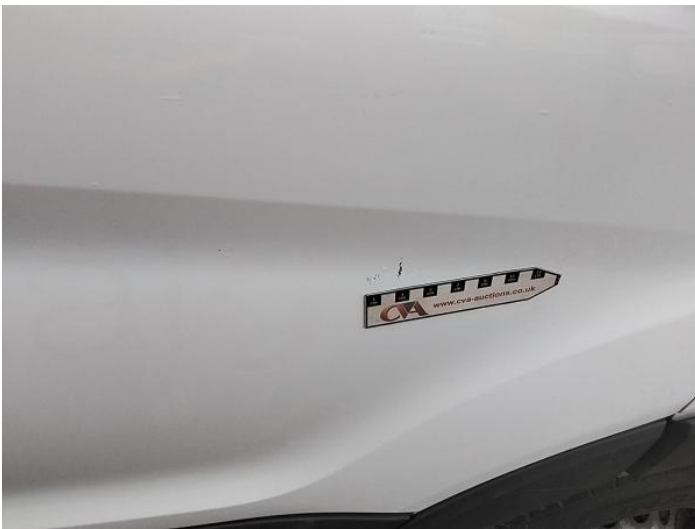
41: Door osf  
Scratched  
Over 25mm Thru Paint

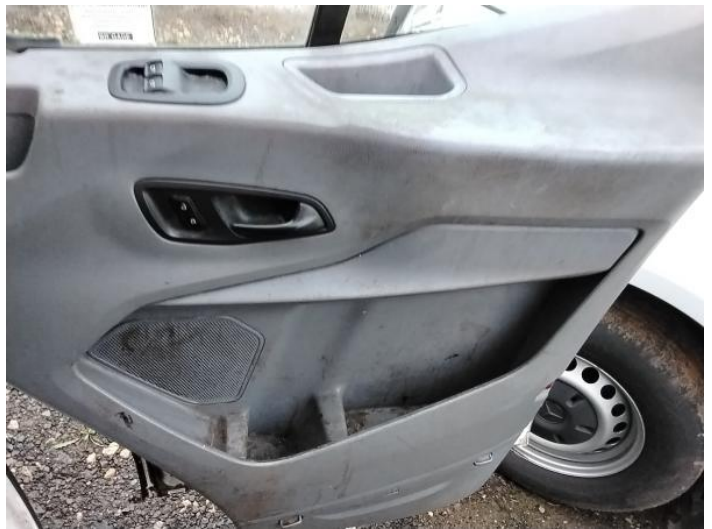
42: Door Pad osf  
Soiled  
Heavy

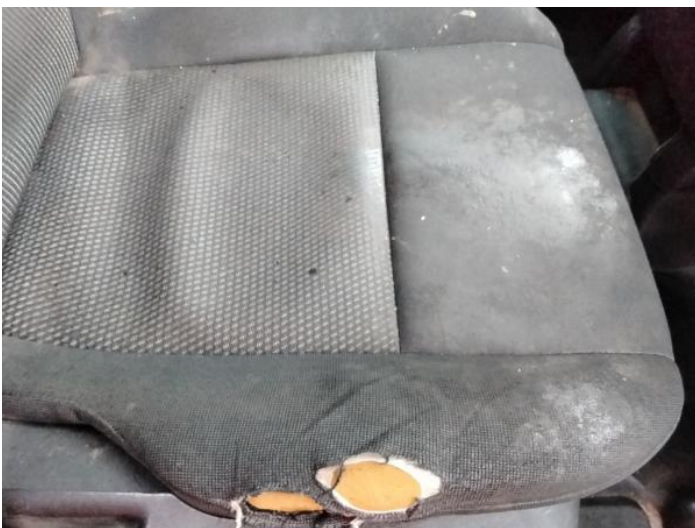
43: Seat Base Cover osf  
Torn  
Over 3mm

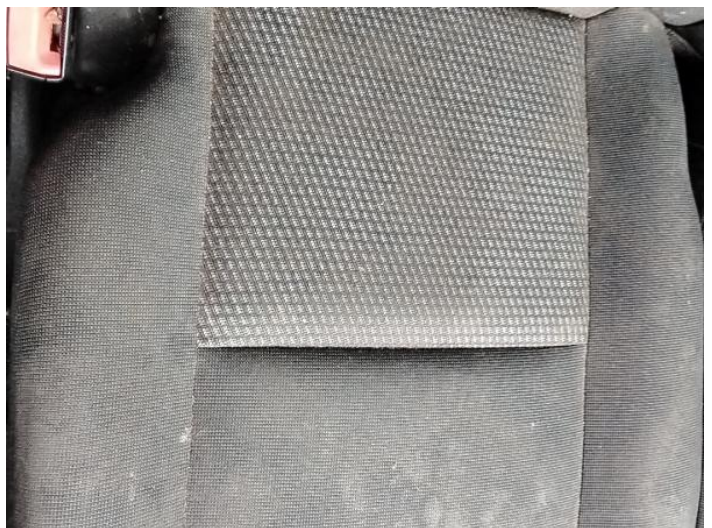
44: Seat Base Cover nsf  
Soiled  
Heavy

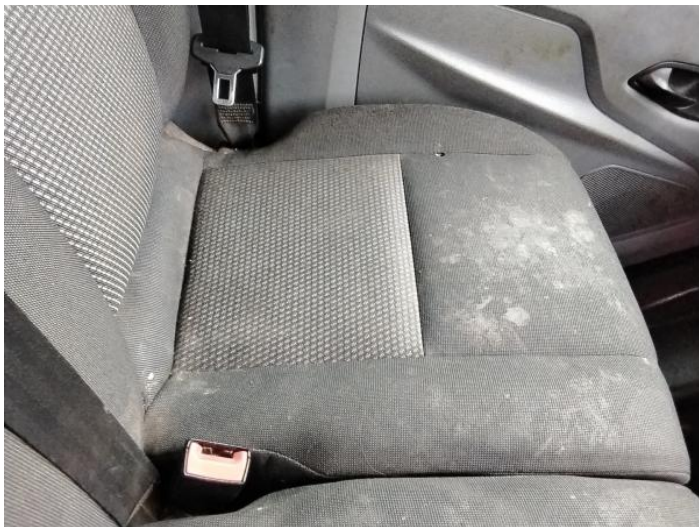
45: Seat Base Cover nsf  
Soiled  
Heavy

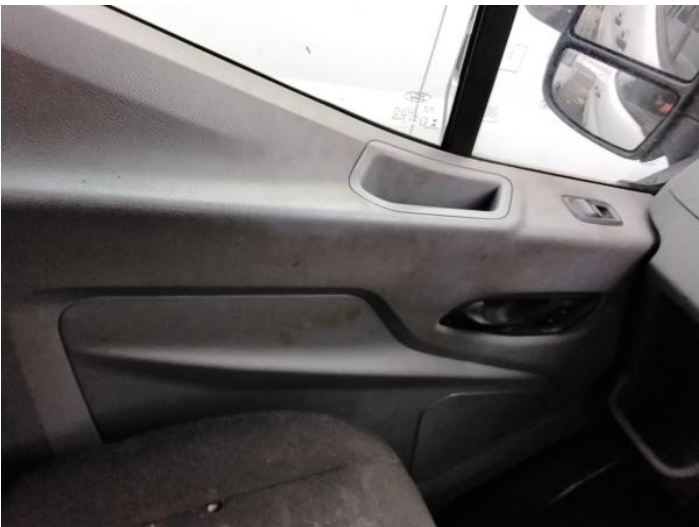
46: Door Pad nsf  
Soiled  
Heavy

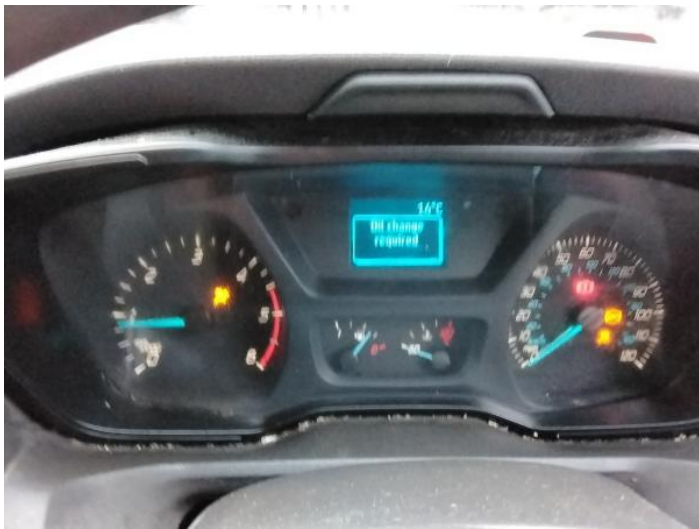
47: Dash Warning Lights  
Displayed  
No Action
