# VEHICLE INSPECTION REPORT

**FN70AYA**

## Daf CF 340

### Inspection

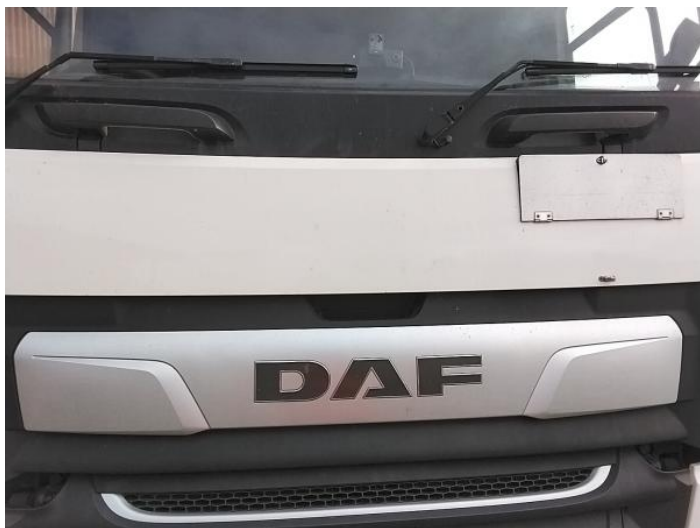
1: Bonnet  
Chipped  
Multiple Chips

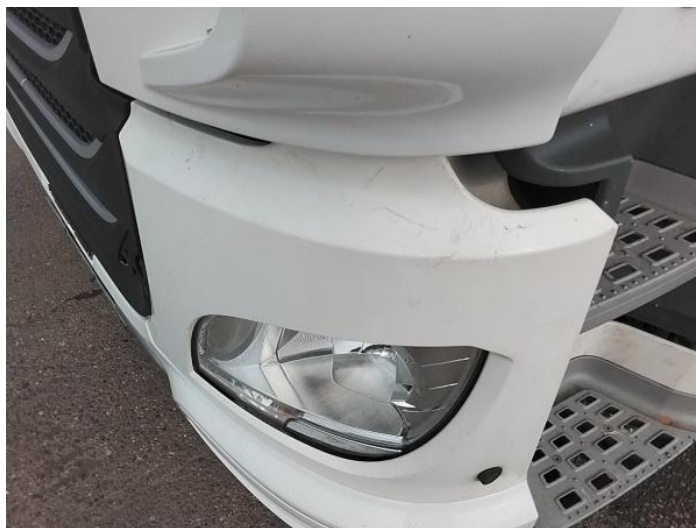
2: Panel Front  
Scratched  
Over 25mm Thru Paint

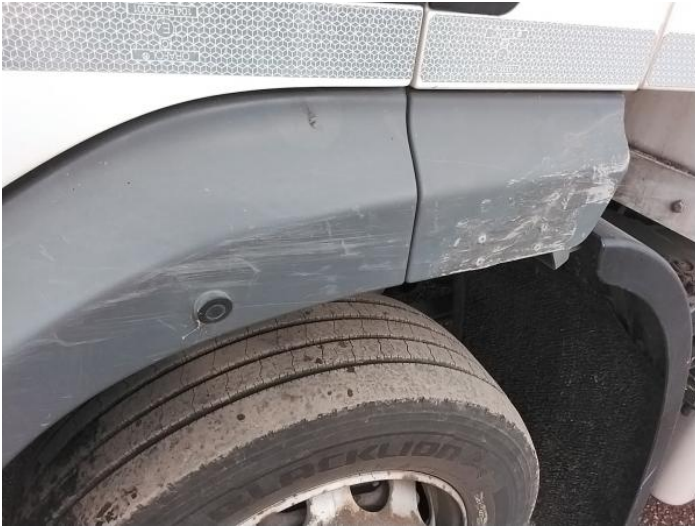
3: Wing nsf  
Poor Previous Repair  
Rippled Up To 30%

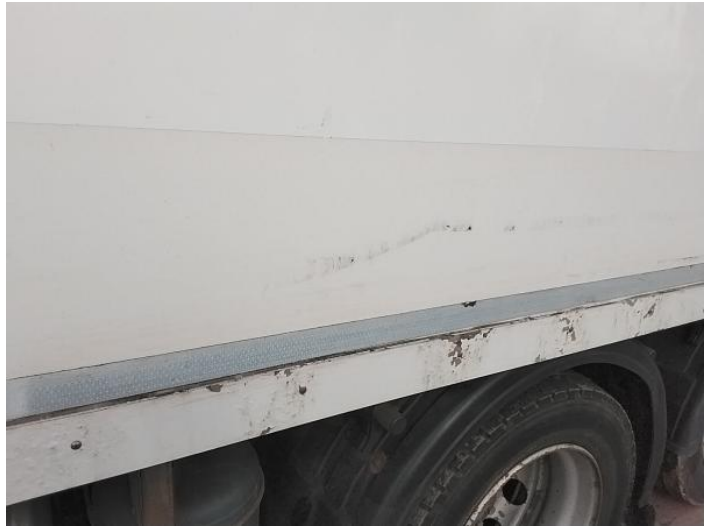
4: Qtr Panel nsr  
Scratched  
Over 25mm Thru Paint

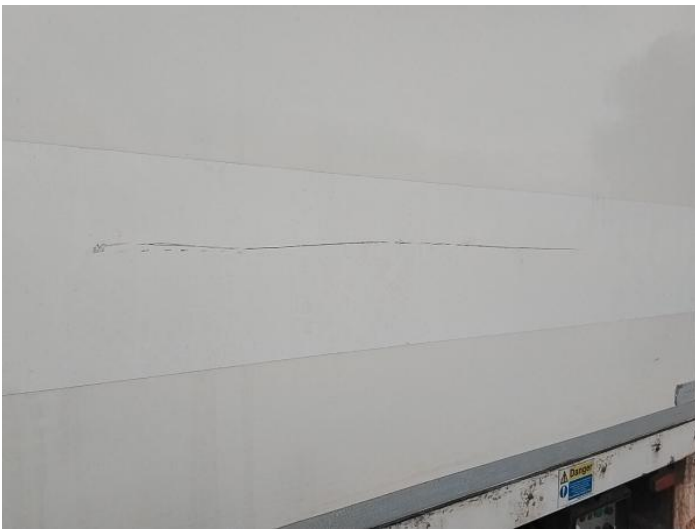
5: Qtr Panel nsr  
Scratched  
Over 25mm Thru Paint

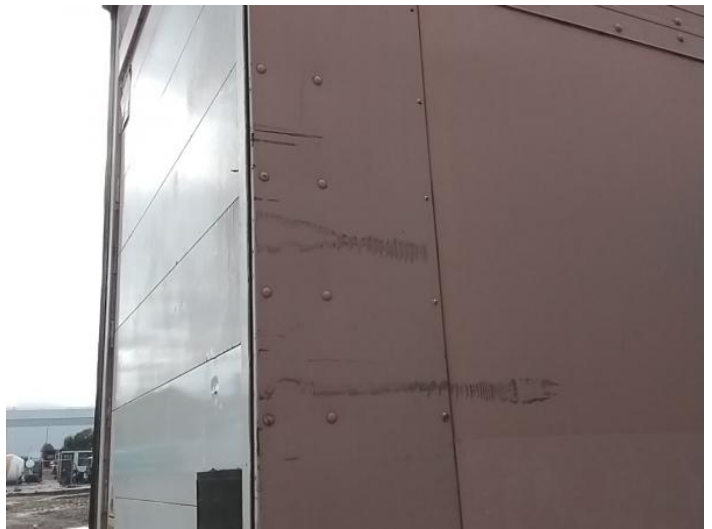
6: Qtr Panel Trim os  
Scuffed  
Over 25mm

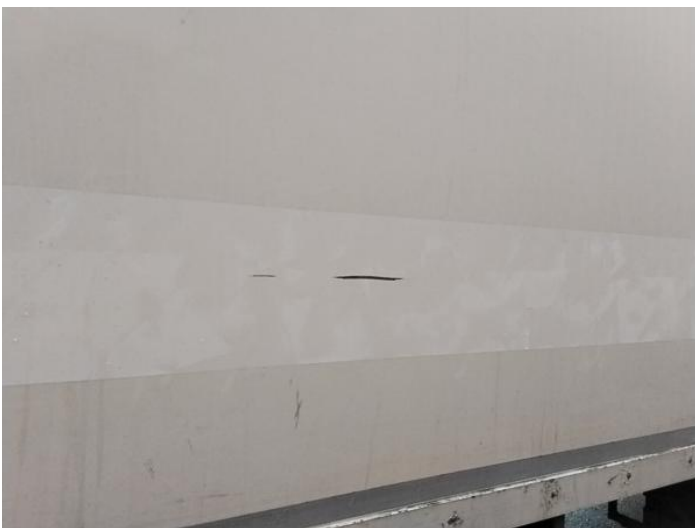
7: Qtr Panel osr  
Scratched  
Over 25mm Thru Paint

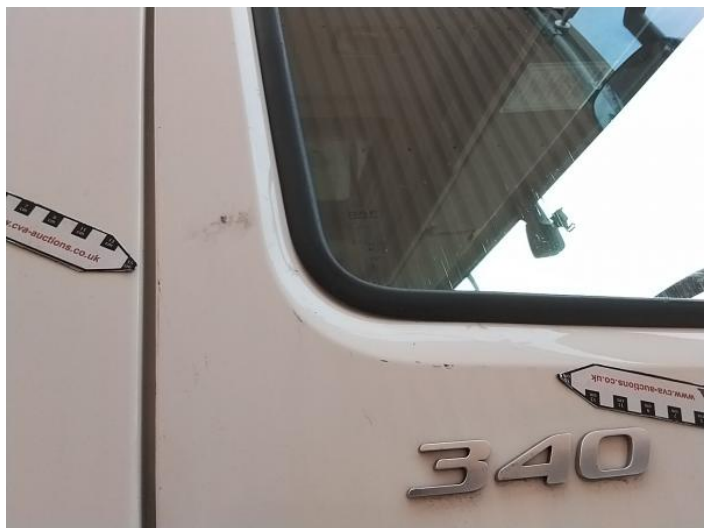
8: Door osf  
Scratched  
Over 25mm Thru Paint

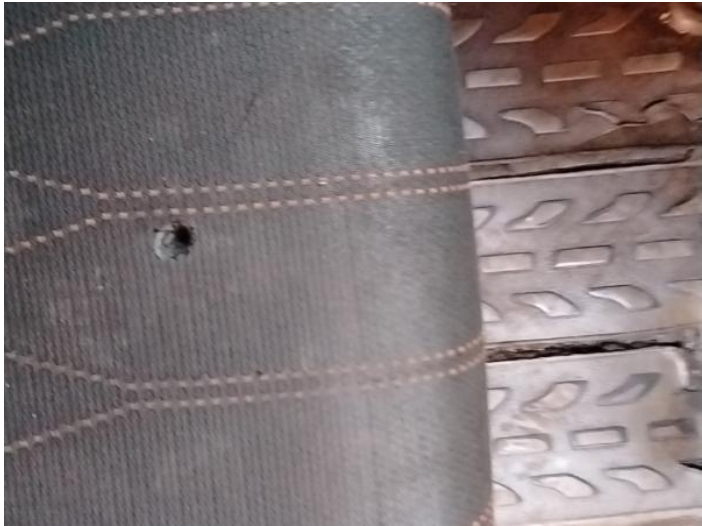
9: Seat Base Cover of  
Burn  
Over 3mm

| Seat Condition | Poor | Odour | - |
