# VEHICLE INSPECTION REPORT

**VN16PJJ**

## Dennis Elite 6

Body Style Refuse Collector

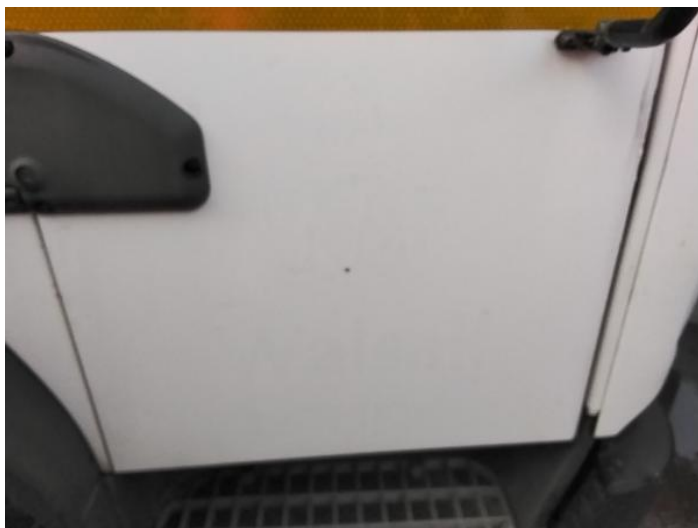
1: Door osf  
Chipped  
Multiple Chips

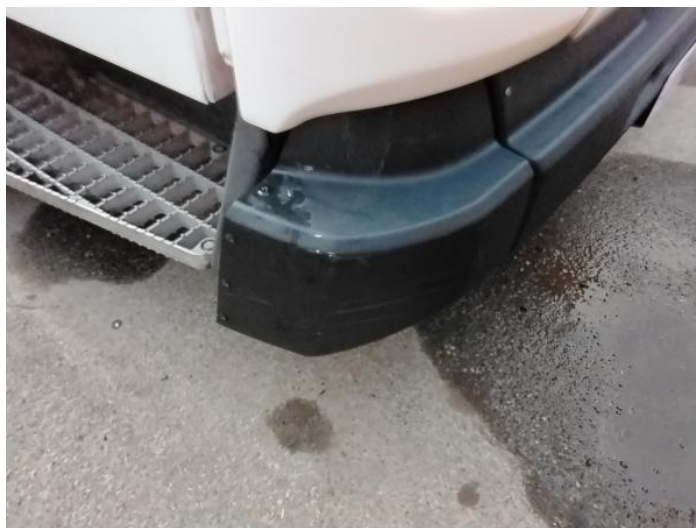
2: Bumper Front  
Scratched  
25 to 100mm Thru Paint

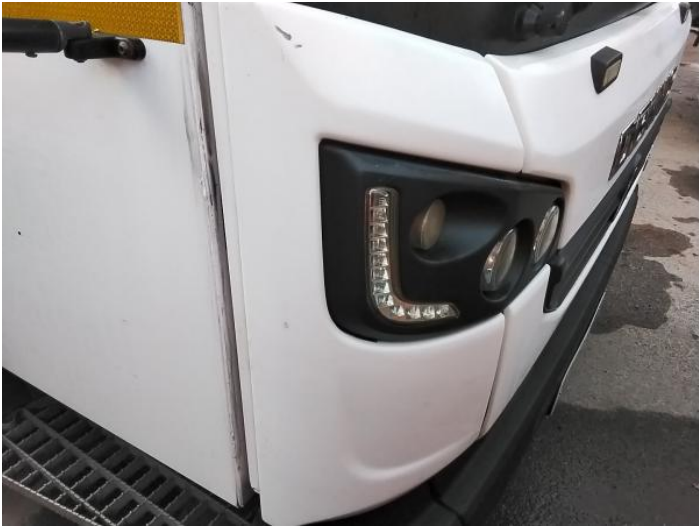
3: Panel Front  
Chipped  
Multiple Chips

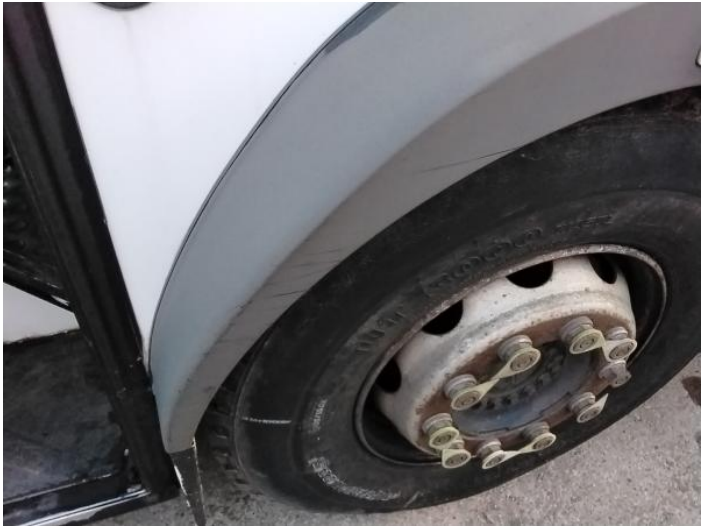
4: Wing nsf  
Scratched  
Over 25mm Thru Paint

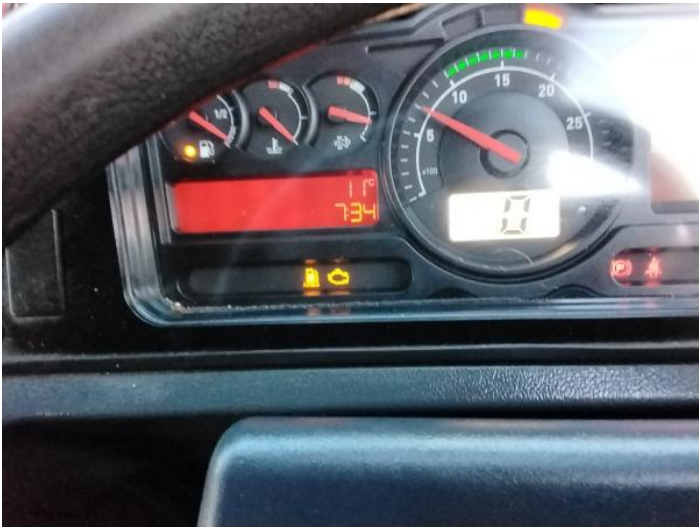
5: Dash Warning Lights  
Displayed  
No Action

| EML light illuminated | | Fault | DPF light illuminated | | Fault |
