# VEHICLE INSPECTION REPORT

**VN16PKO**

## Dennis Elite 6

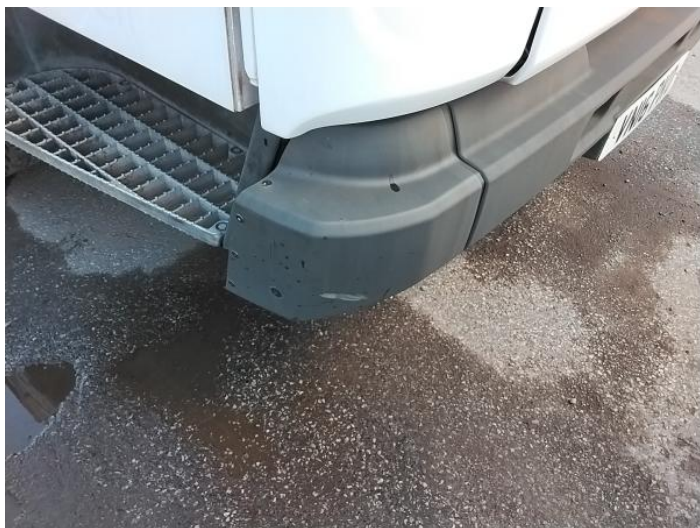
1: Bumper Front  
Scratched  
25 to 100mm Thru Paint

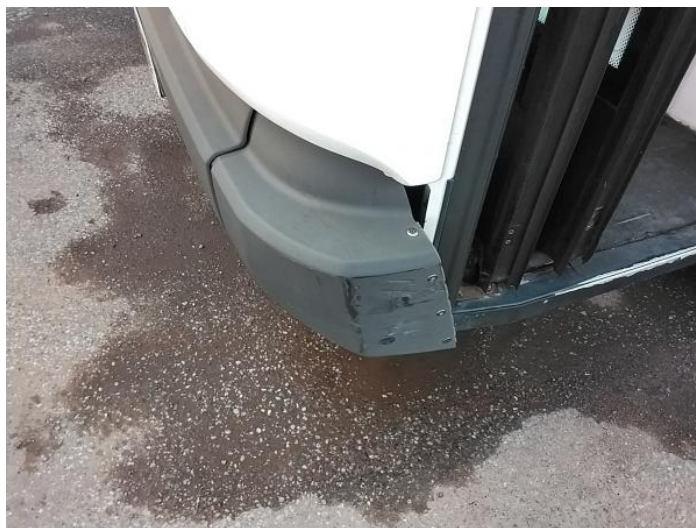
2: Bumper Front  
Scratched  
Over 100mm Thru Paint

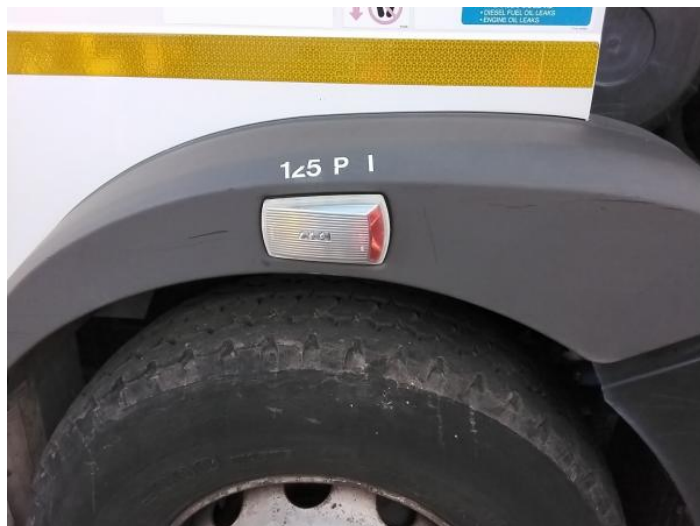
3: Wing nsf  
Scratched  
Over 25mm Thru Paint
