VEHICLE INSPECTION REPORT

DA70WVL

Man TGS 26.330

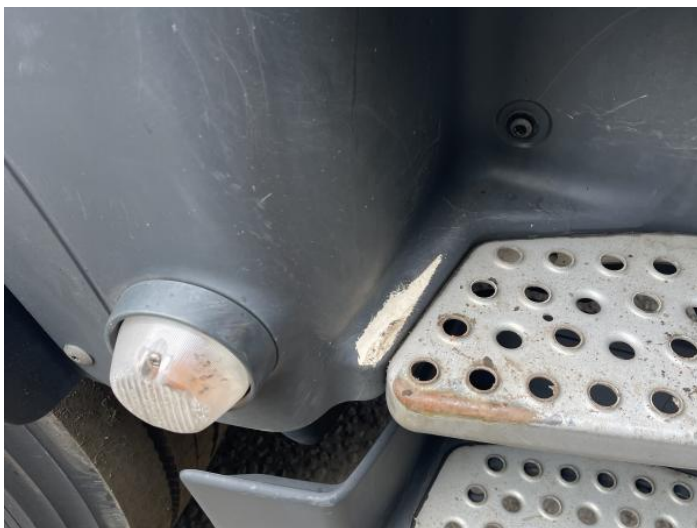
1: Door Moulding osf
Scuffed (Unpainted)
Over 100mm

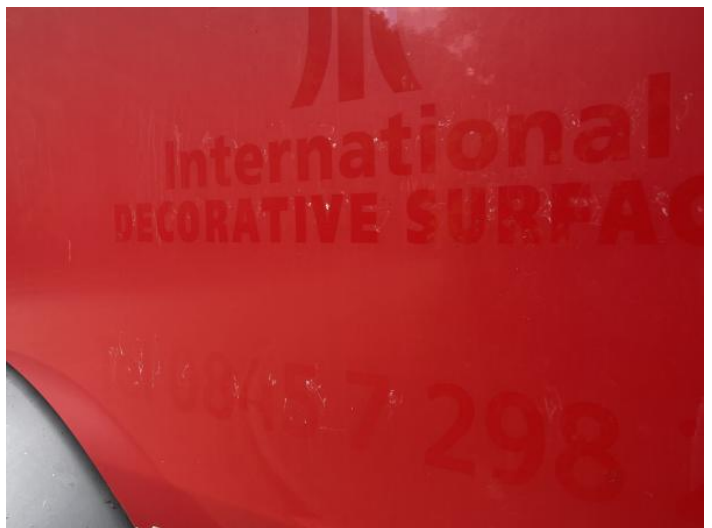
2: Door Moulding osf
Scratched (Painted)
Over 25mm Thru Paint

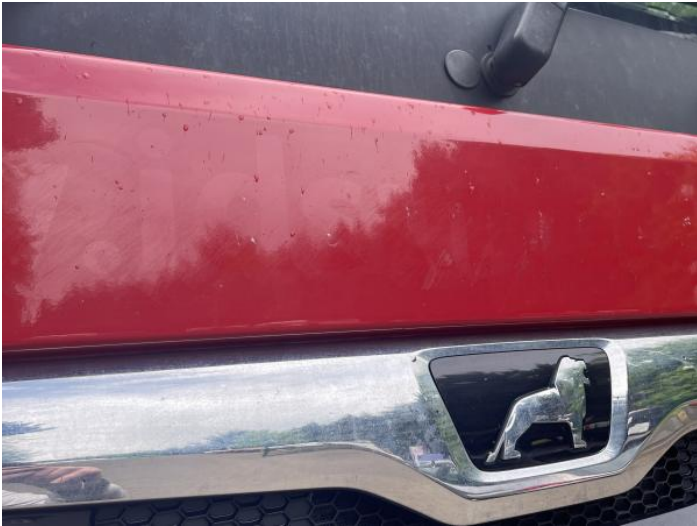
3: Bonnet
Scratched
Over 25mm Not Thru Paint

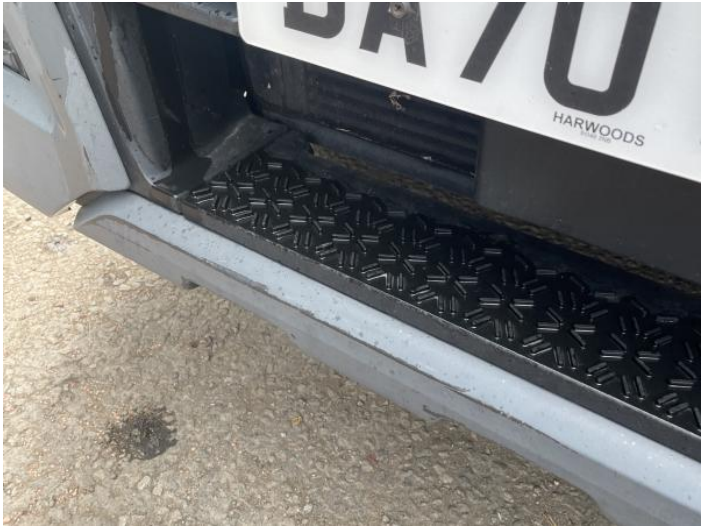
4: Bumper Front Moulding
Scuffed (Unpainted)
Over 100mm

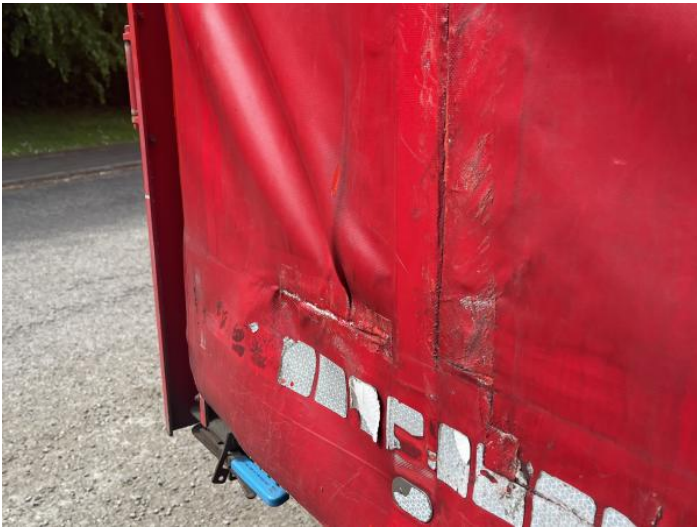
5: Qtr Panel osr
Dented
With Paint Damage

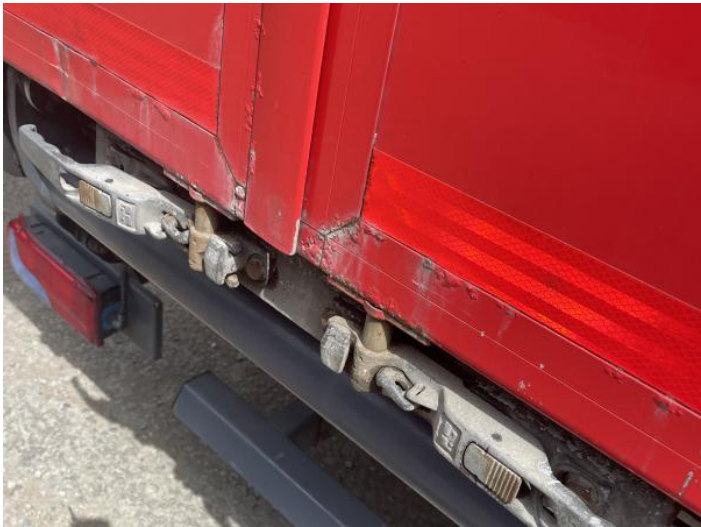
6: Tailgate
Rusted
Over 5mm
