VEHICLE INSPECTION REPORT

PK67VFZ

Daf CF 450

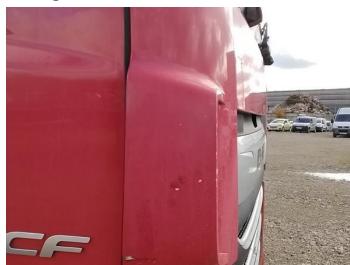
1: Wing osf Scratched Over 25mm Thru Paint

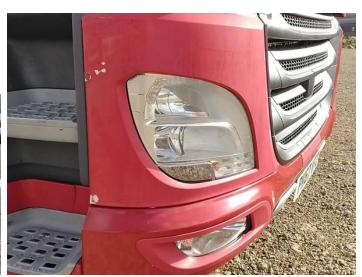
2: Fog Lamp Surround os Broken Replace

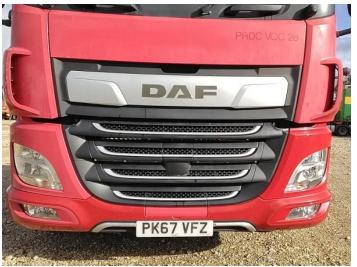
3: Bumper Front Chipped Multiple Chips

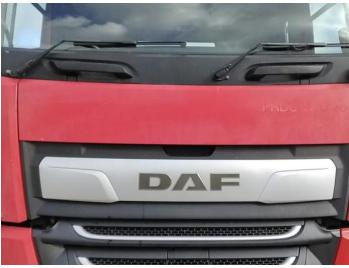
4: Bonnet Chipped Multiple Chips

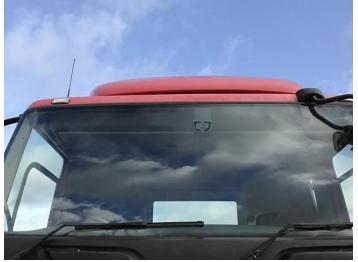
5: Screen Front Chipped UpTo 10mm

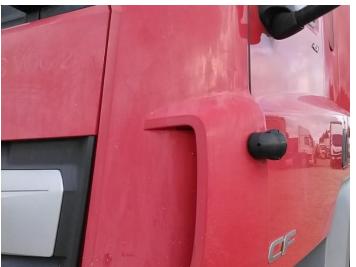
6: Wing nsf Cracked Replace

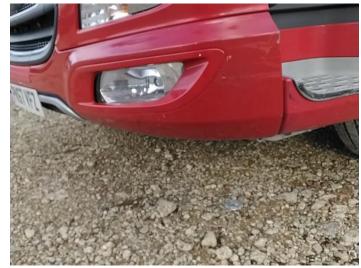
7: Bumper Front Moulding Scratched (Painted) Over 25mm Thru Paint

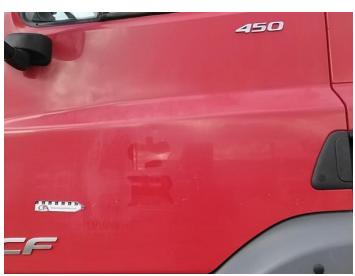
10: Door nsf Scratched UpTo 25mm Thru Paint

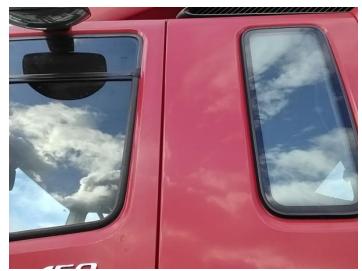
11: B Post ns Scratched Over 25mm Not Thru Paint

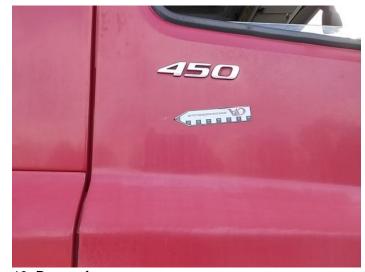
13: Door osf Chipped Over 5mm

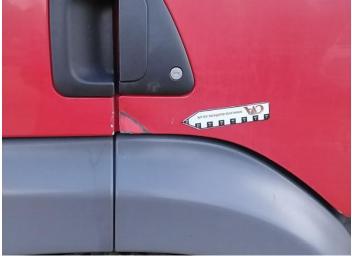
14: Door osf Dented With Paint Damage

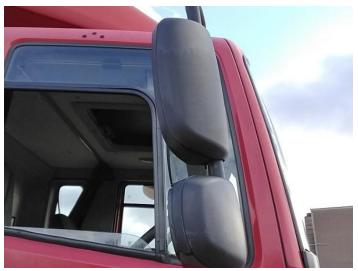
15: Door Mirror Assy osf Broken Replace
