# VEHICLE INSPECTION REPORT

**PO70YBC**

## Fiat Ducato 35 2.3 MULTIJET 140PS

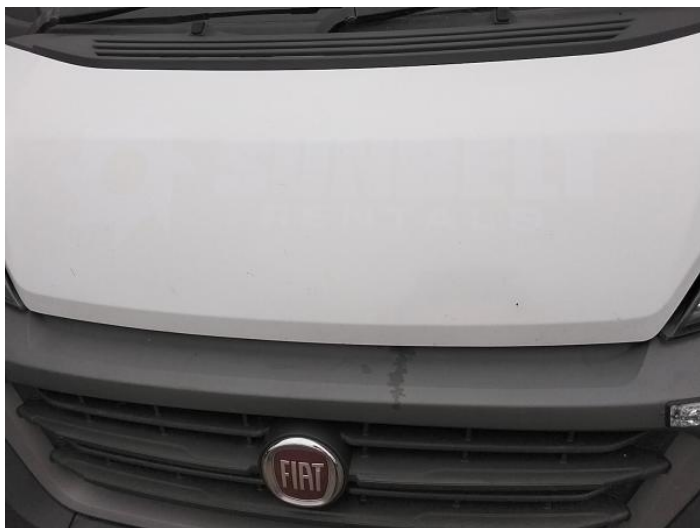
1: Bonnet  
Chipped  
Multiple Chips

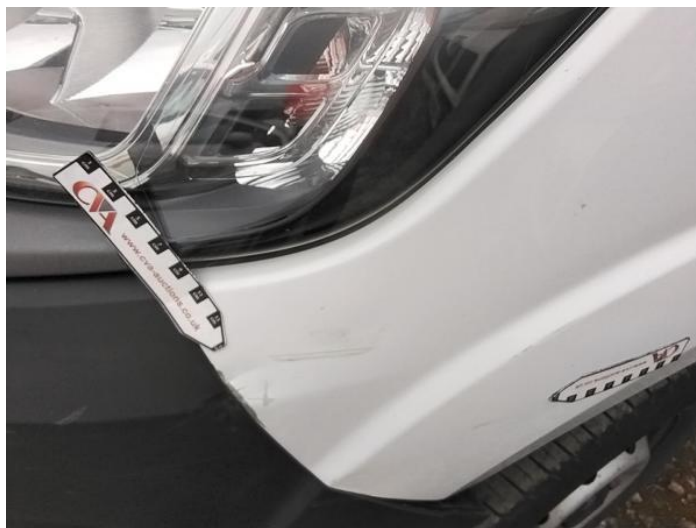
2: Wing nsf  
Dented  
With Paint Damage

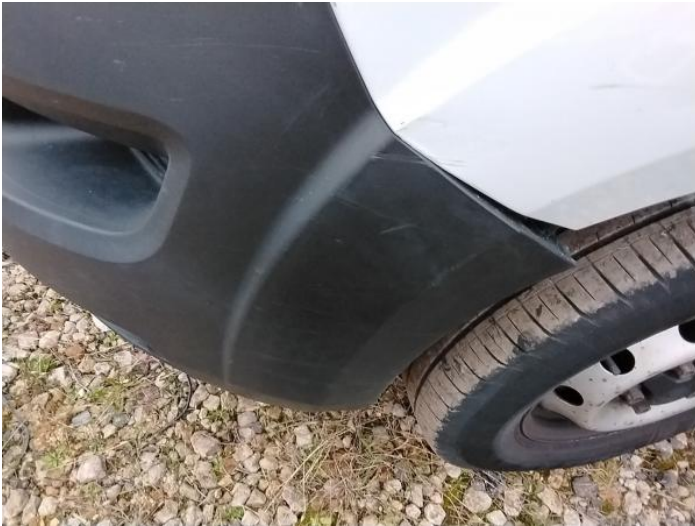
3: Bumper Front  
Insecure  
Action Required

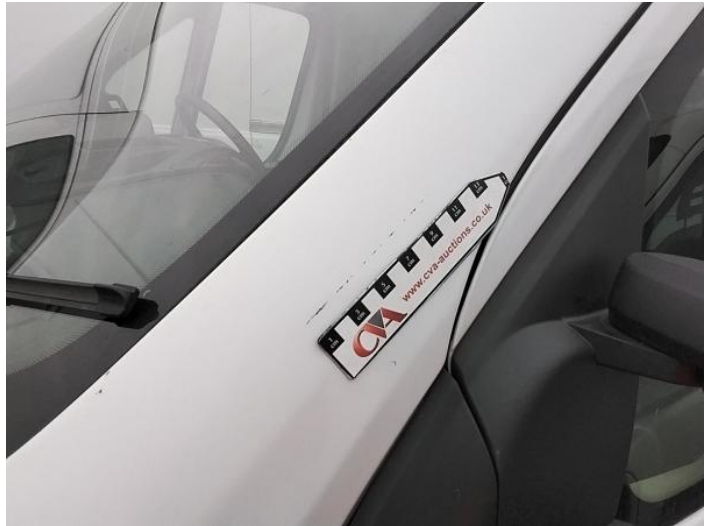
4: A Post ns  
Scratched  
Over 25mm Thru Paint

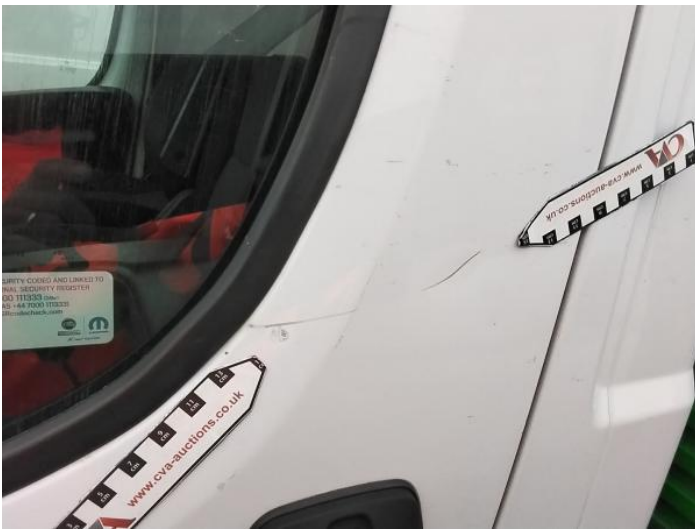
5: Door nsf  
Dented  
With Paint Damage

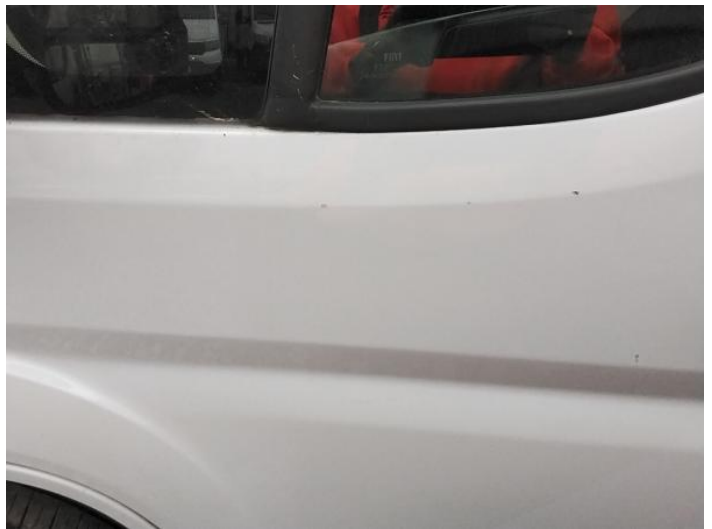
6: Door nsf  
Chipped  
Multiple Chips

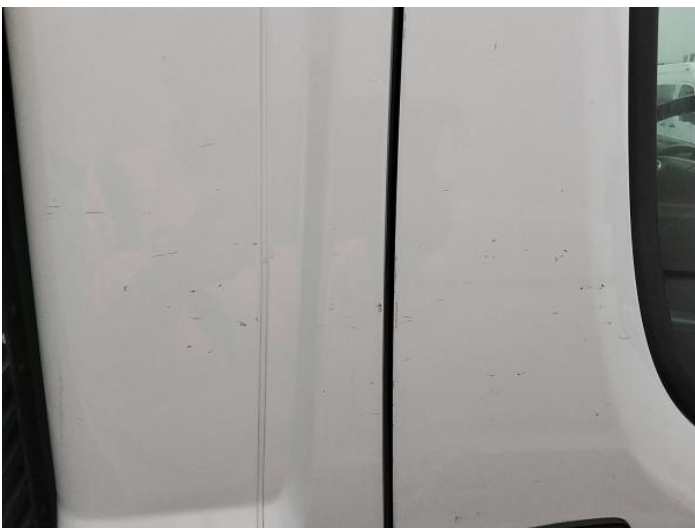
7: Door osf  
Chipped  
Multiple Chips

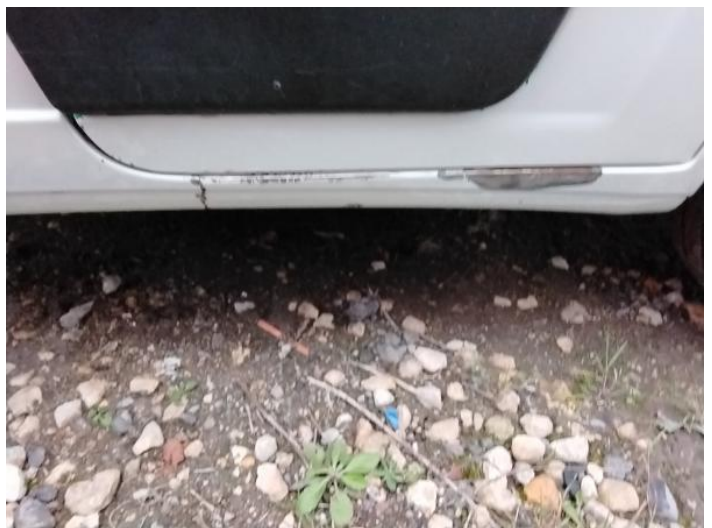
8: Sill os  
Scratched  
Over 25mm Thru Paint

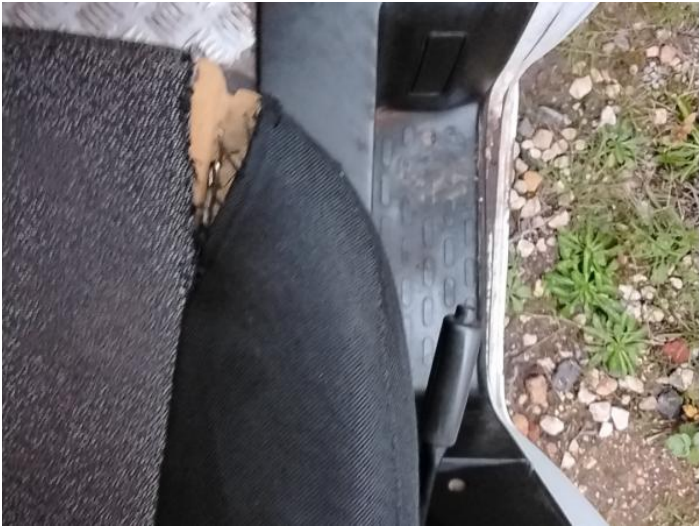
9: Seat Base Cover osf  
Torn  
Over 3mm

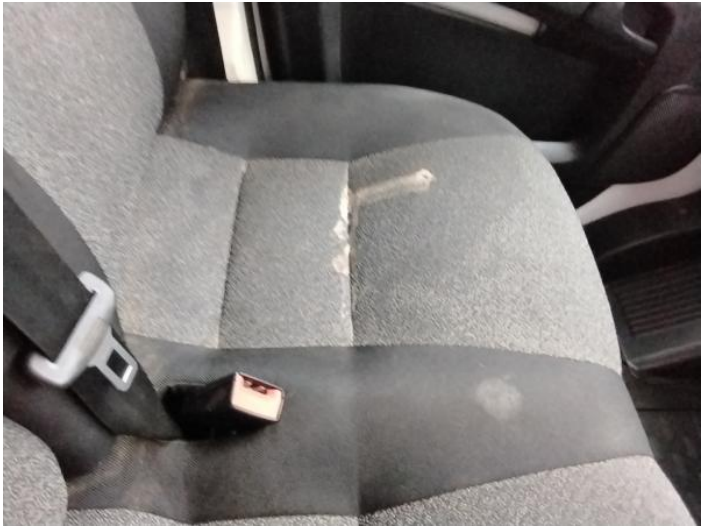
10: Seat Base Cover nsf  
Soiled  
Heavy
