# VEHICLE INSPECTION REPORT

**FN17BRX**

## Daf LF 260

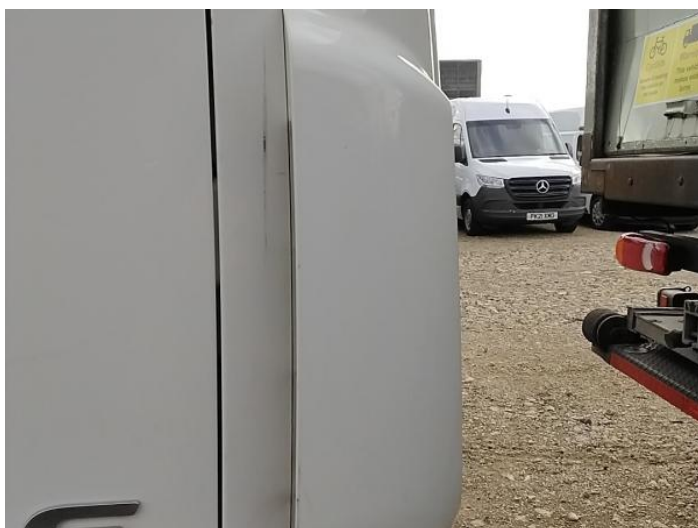
1: Wing osf  
Scratched  
UpTo 25mm Thru Paint

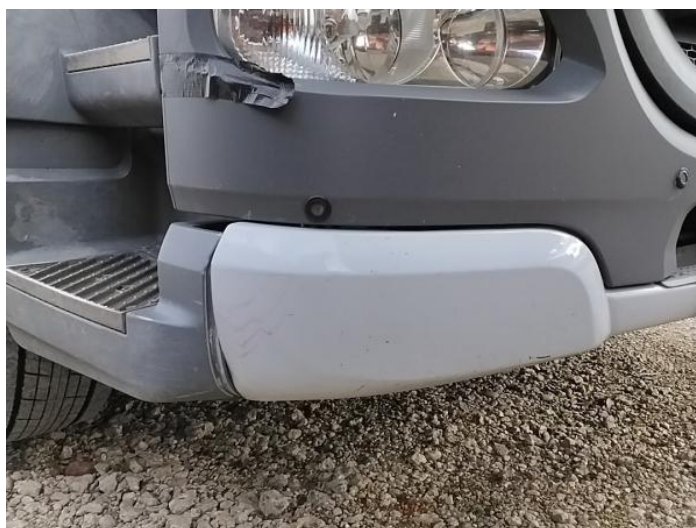
2: Bumper Front Moulding  
Scratched (Painted)  
UpTo 25mm Not Thru Paint

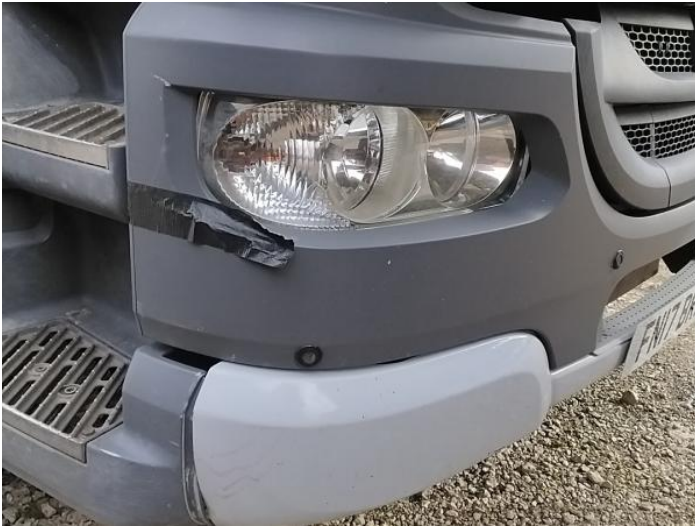
3: Fog Lamp Surround os  
Broken  
Replace

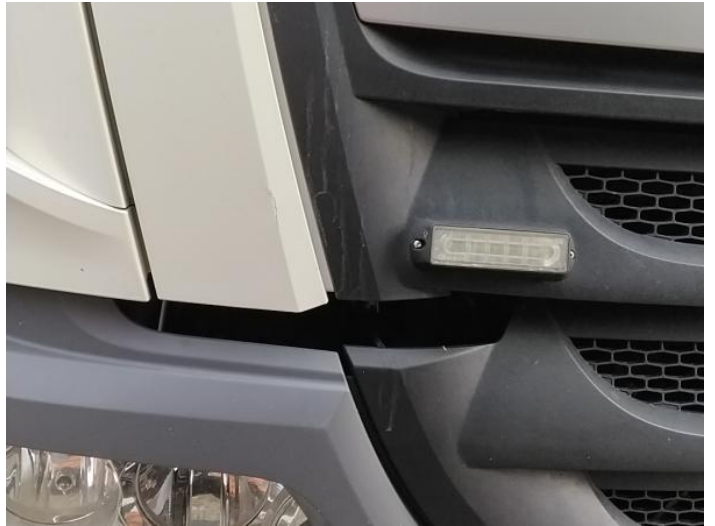
4: Bonnet  
Cracked  
Replace

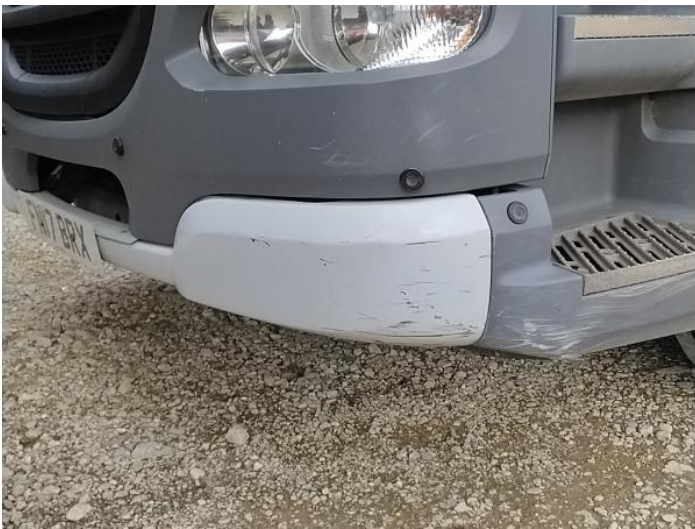
5: Bumper Front Moulding  
Scratched (Painted)  
Over 25mm Thru Paint

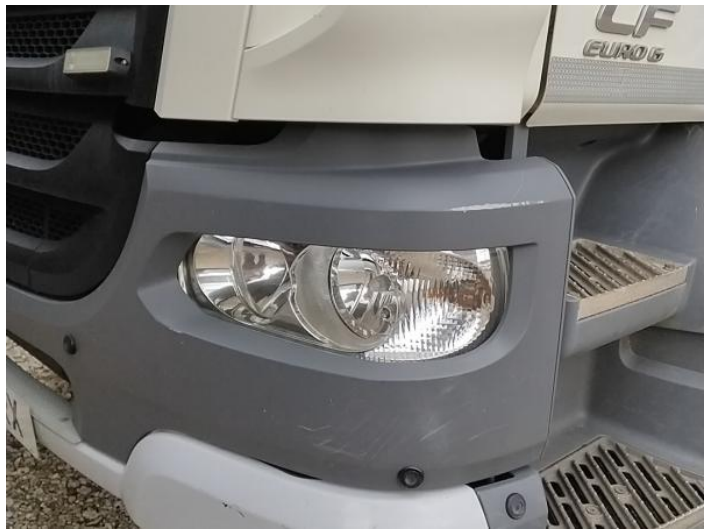
6: Fog Lamp Surround ns  
Scuffed (Unpainted)  
UpTo 100mm

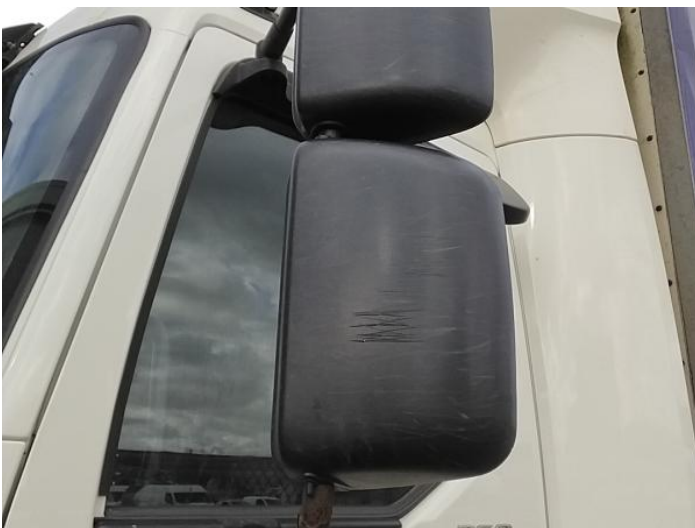
7: Door Mirror Assy nsf  
Scuffed (Unpainted)  
UpTo 100mm

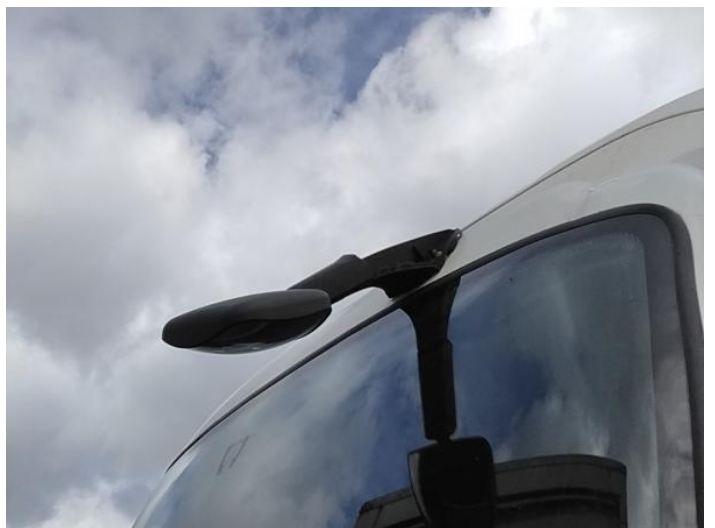
8: Door Mirror Assy nsf  
Missing  
Replace

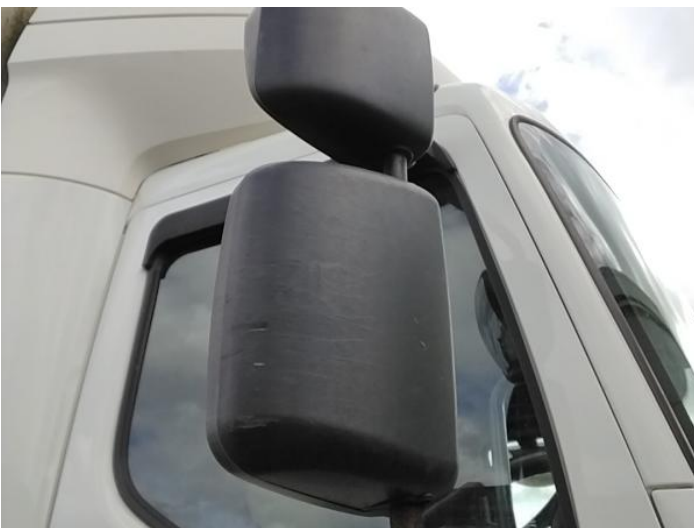
13: Door Mirror Assy osf  
Scuffed (Unpainted)  
UpTo 100mm

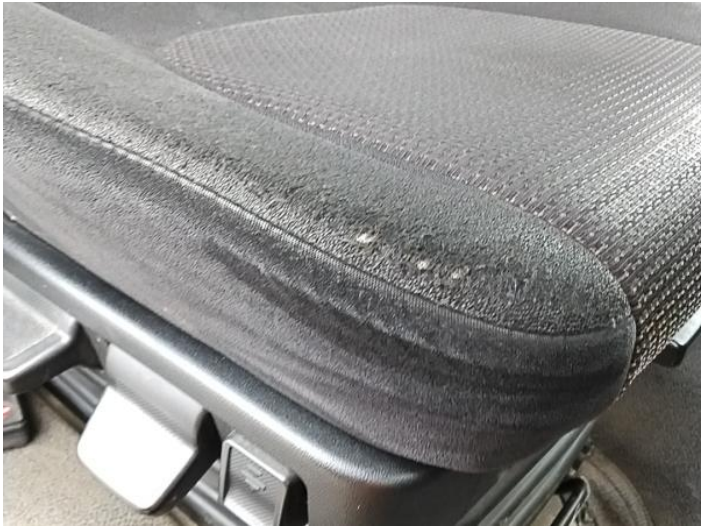
16: Seat Base Cover osf  
Holed  
Over 3mm
