# VEHICLE INSPECTION REPORT

**DG14SYZ**

## Man TGL 12.180

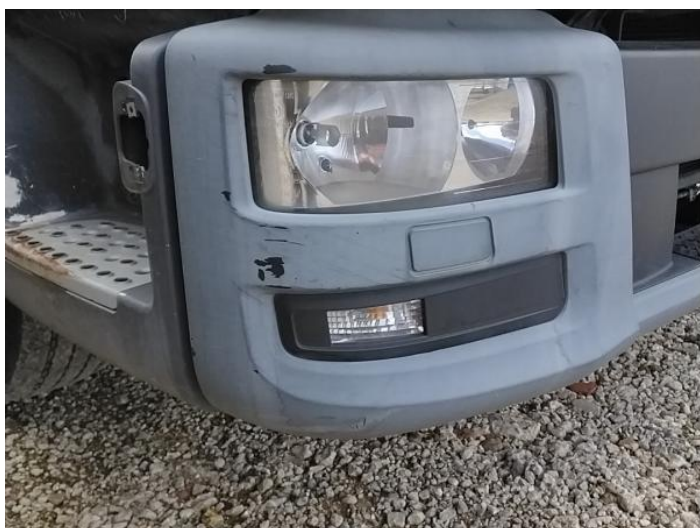
1: Fog Lamp Surrounds  
Scuffed (Unpainted)  
Up To 100mm

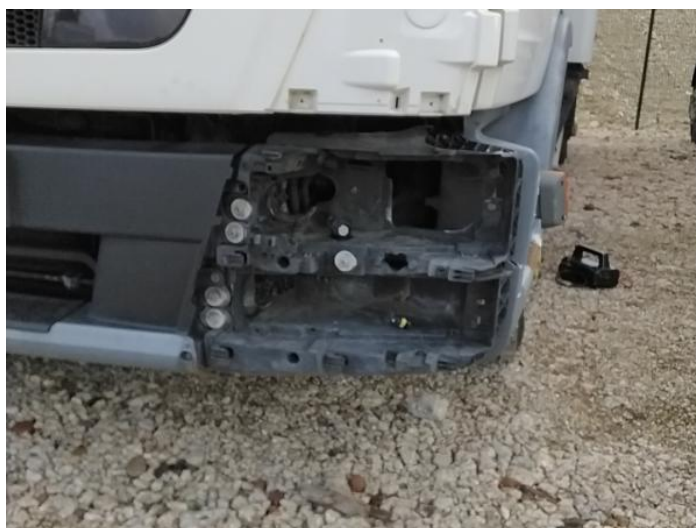
2: Headlamps  
Missing  
Replace

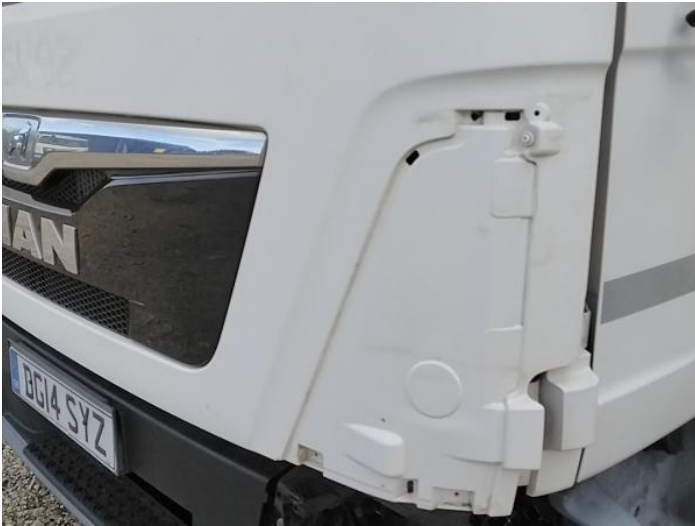
3: Wing nsf  
Missing  
Replace

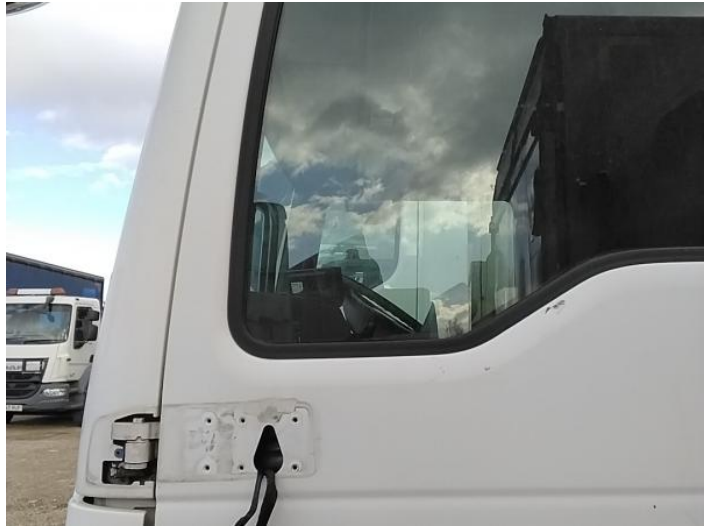
4: Door Mirror Assy nsf  
Missing  
Replace

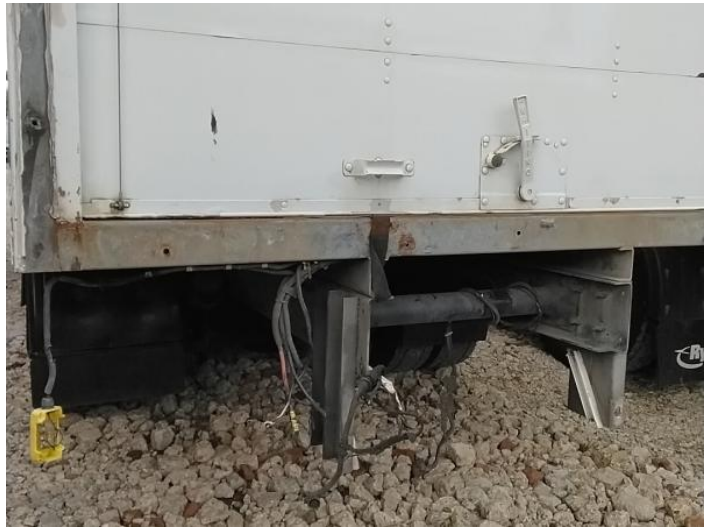
6: Lamp nsr  
Missing  
Replace

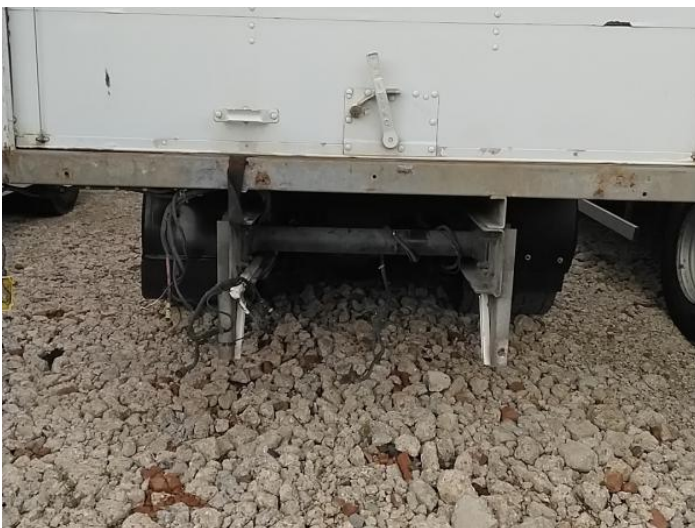
7: Bumper Rear  
Missing  
Replace

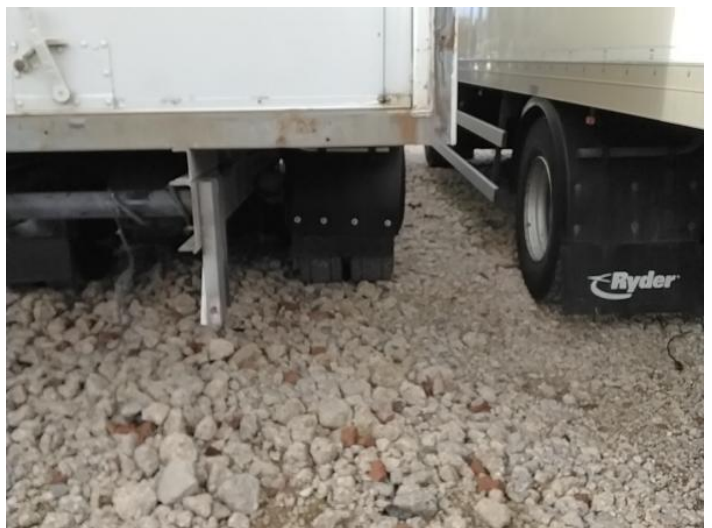
8: Lamp osr  
Missing  
Replace

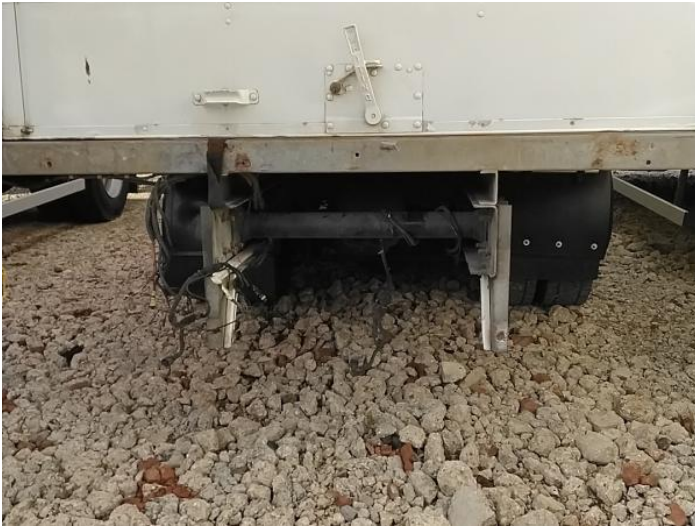
9: Number Plate Rear  
Missing  
Replace

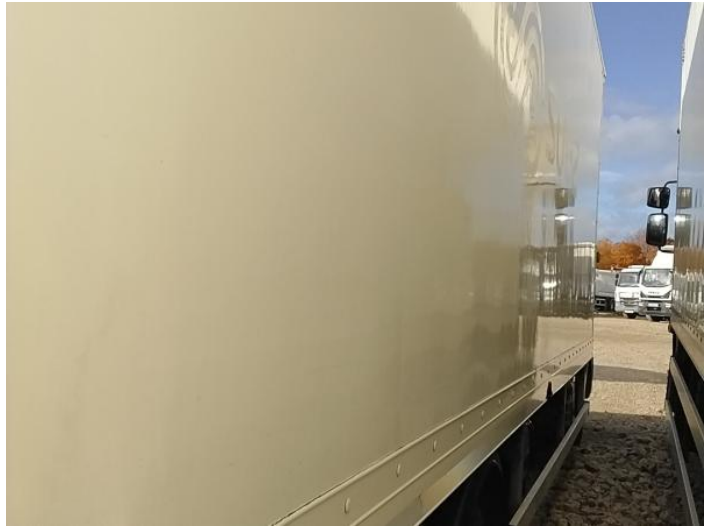
10: Qtr Panel osr  
Scratched  
Over 25mm Not Thru Paint

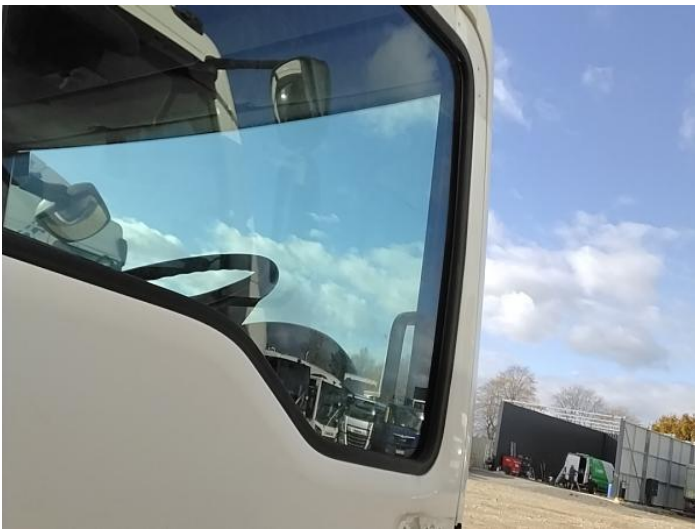
11: Door Mirror Assy osf  
Missing  
Replace

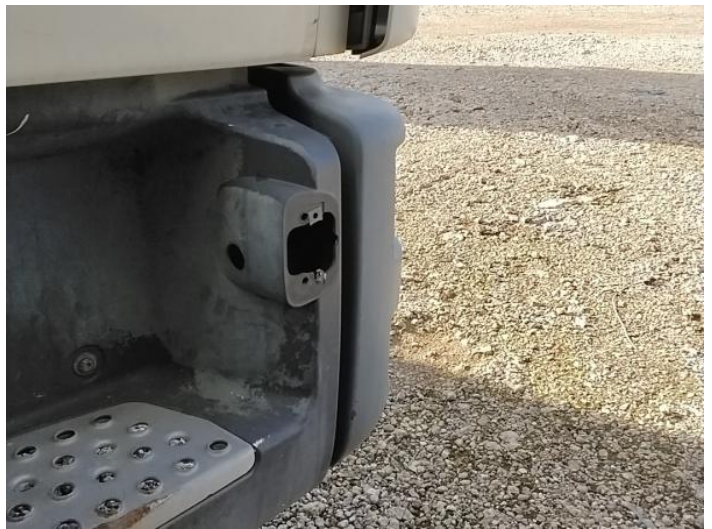
12: Flasher Side Repeater os  
Missing  
Replace

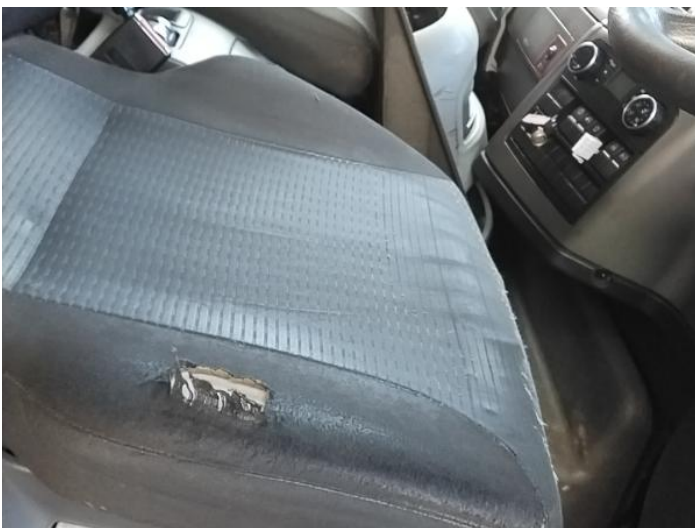
13: Seat Base Cover osf  
Holed  
Over 3mm

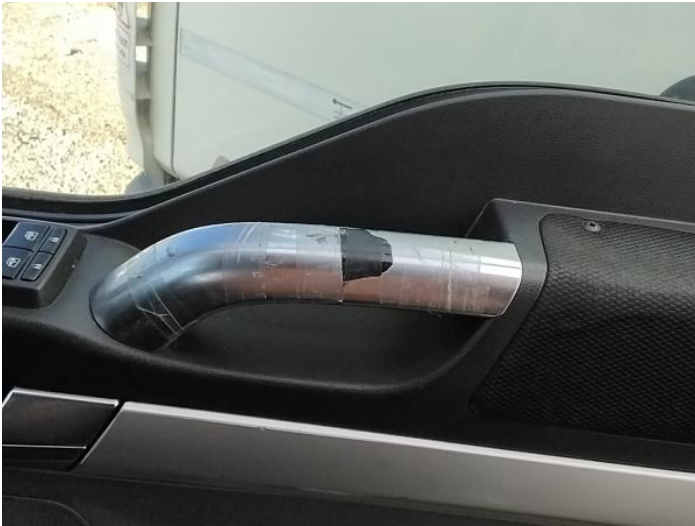
15: Handle Inner osf  
Damaged  
Replace

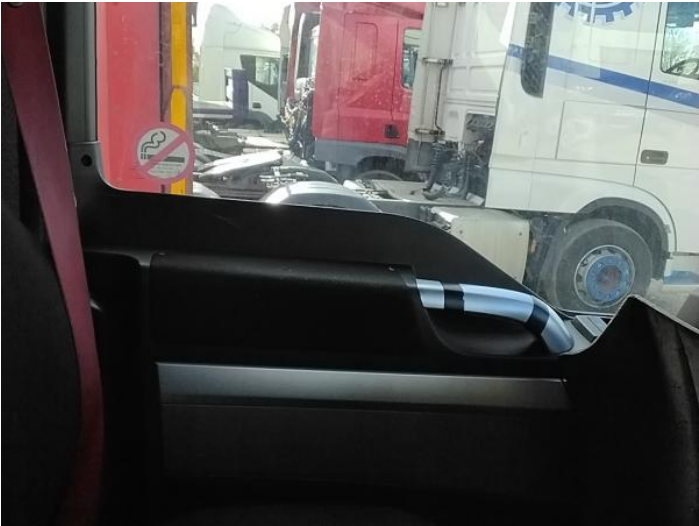
16: Handle Inner nsf  
Damaged  
Replace
