# VEHICLE INSPECTION REPORT

**VT19UKF**

## Vauxhall Movano 2.3 CDTI 130PS

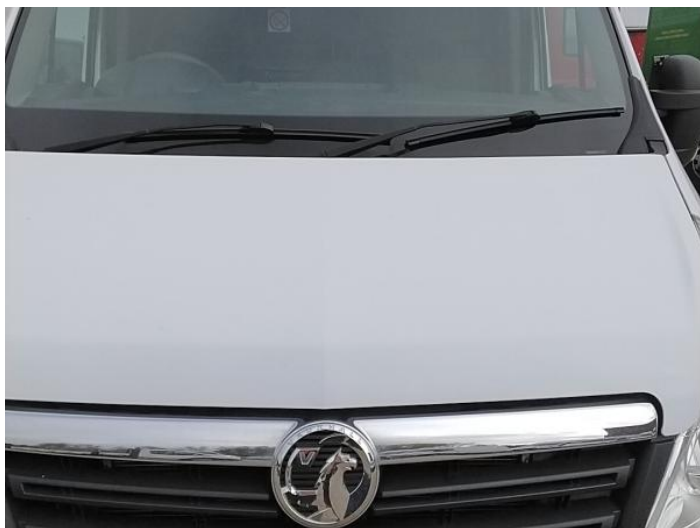
1: Bonnet  
Chipped  
Multiple Chips

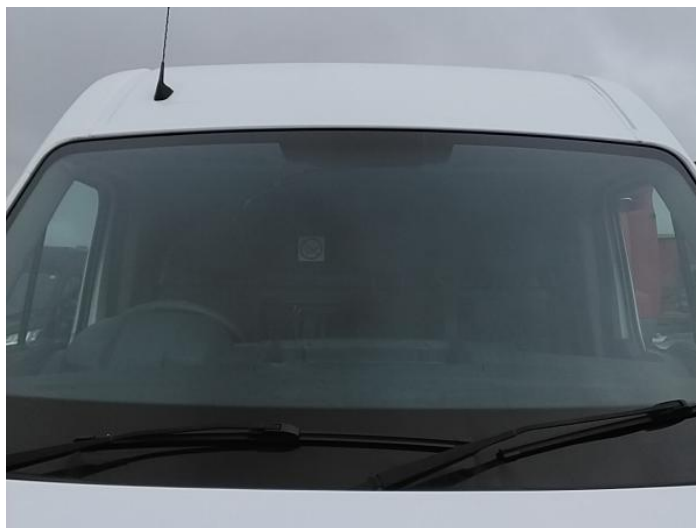
2: Screen Front  
Cracked  
Replace

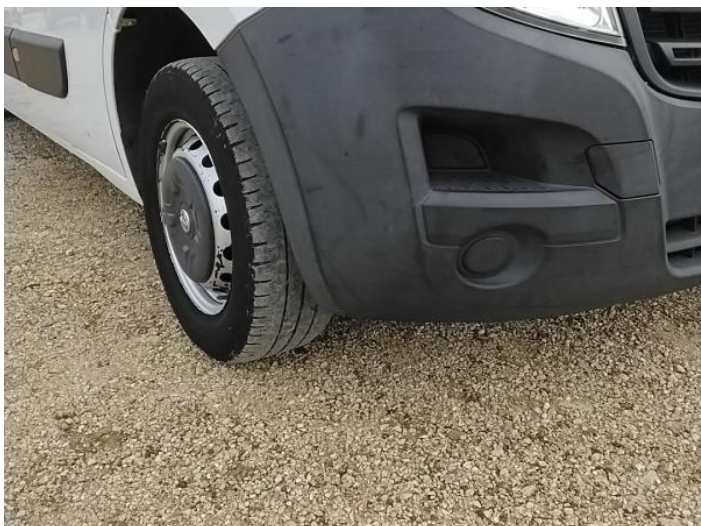
3: Bumper Front Moulding  
Scuffed (Unpainted)  
UpTo 100mm

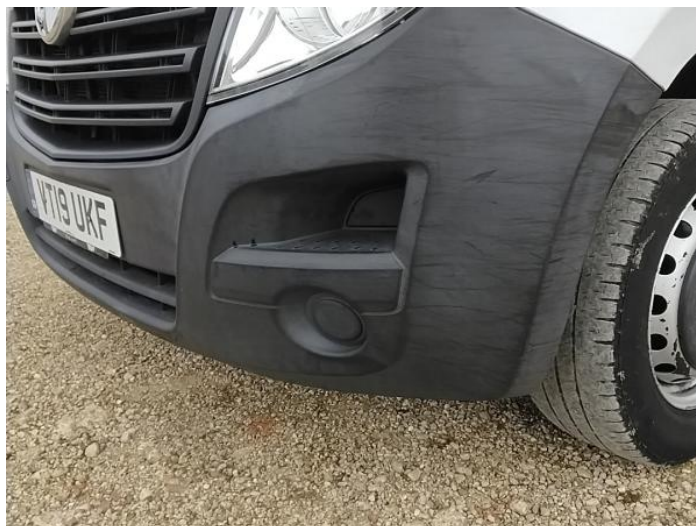
4: Bumper Front Moulding  
Scuffed (Unpainted)  
UpTo 100mm

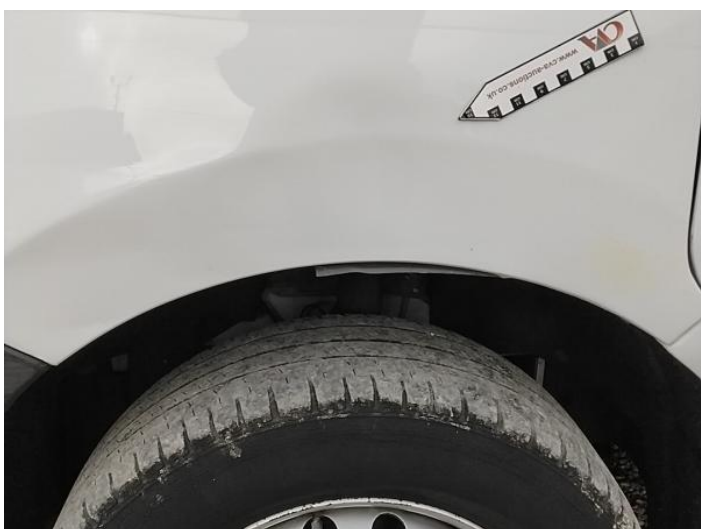
5: Wing nsf  
Dented  
Between 10mm + 30mm

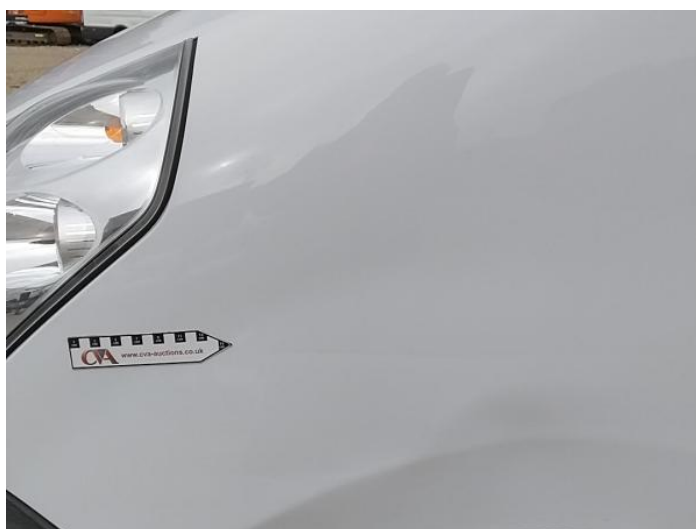
6: Wing nsf  
Scratched  
Over 25mm Not Thru Paint

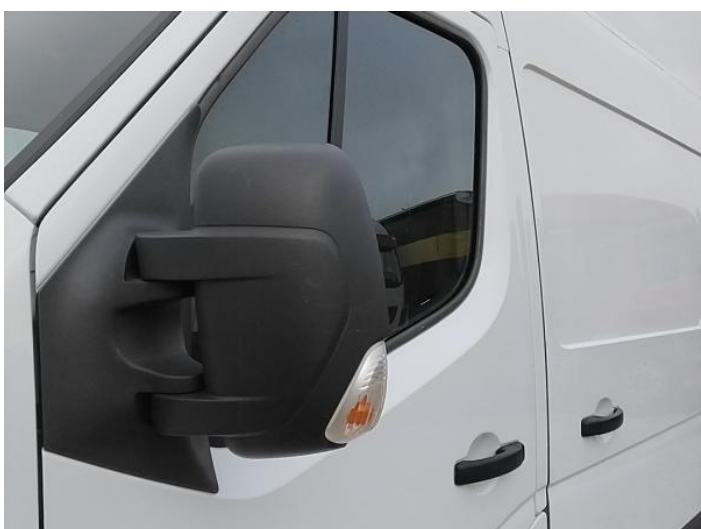
7: Door Mirror Assy nsf  
Scuffed (Unpainted)  
UpTo 100mm

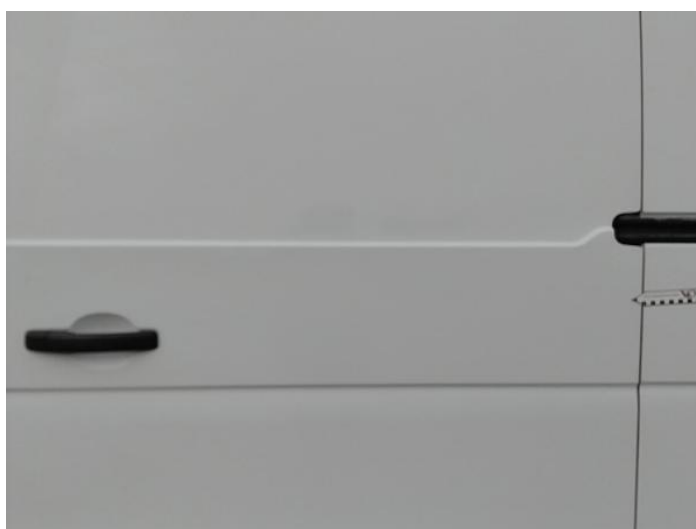
8: Door nsr  
Scratched  
Over 25mm Not Thru Paint

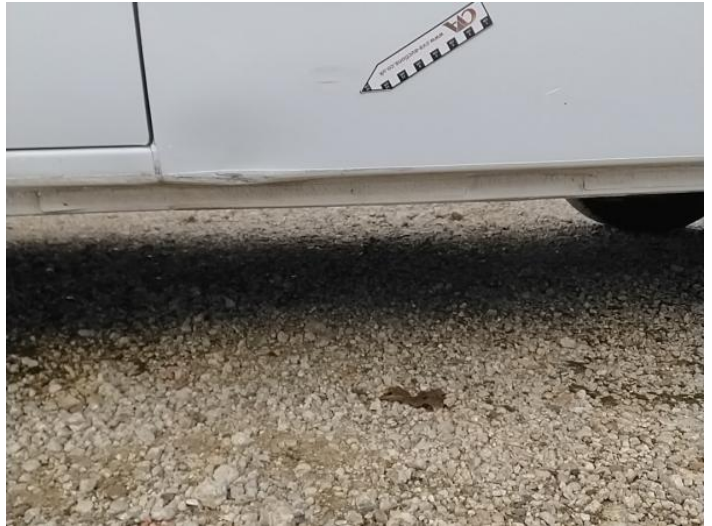
10: Sill ns  
Dented  
Between 10mm + 30mm

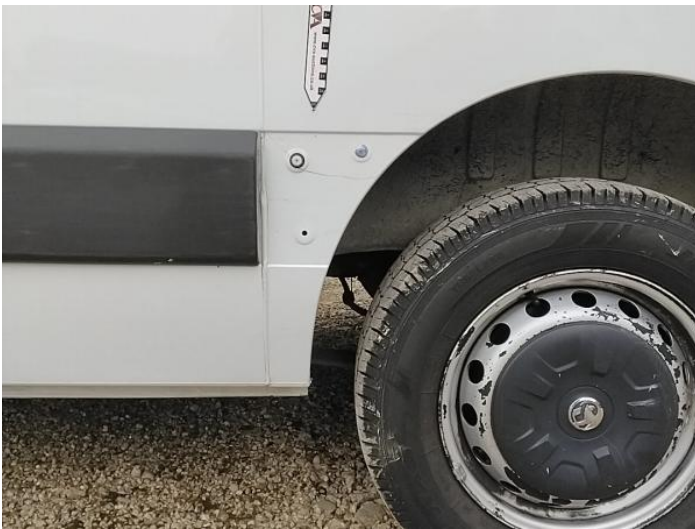
11: Qtr Panel Moulding ns  
Missing  
Replace

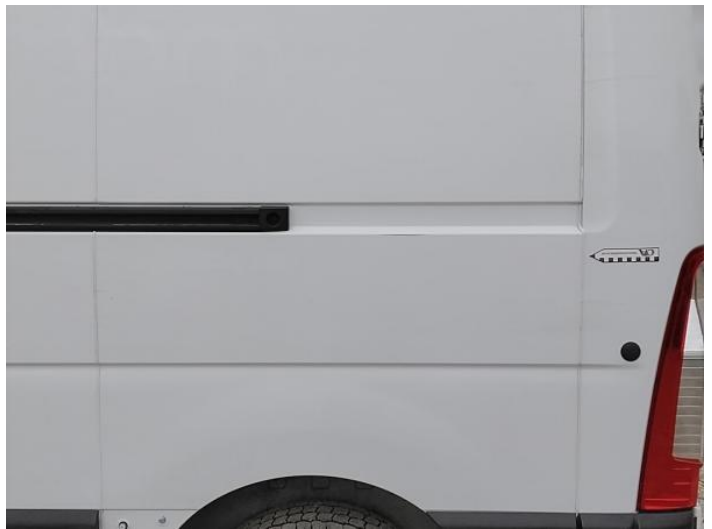
12: Qtr Panel nsr  
Scratched  
Over 25mm Not Thru Paint

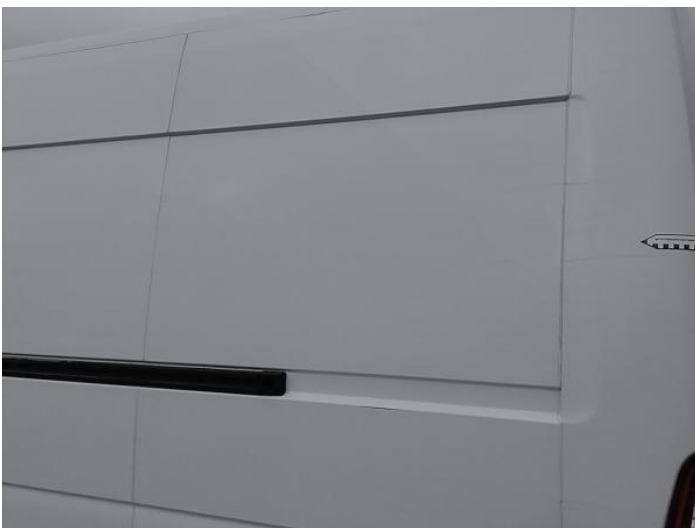
13: Qtr Panel nsr  
Scratched  
Over 25mm Not Thru Paint

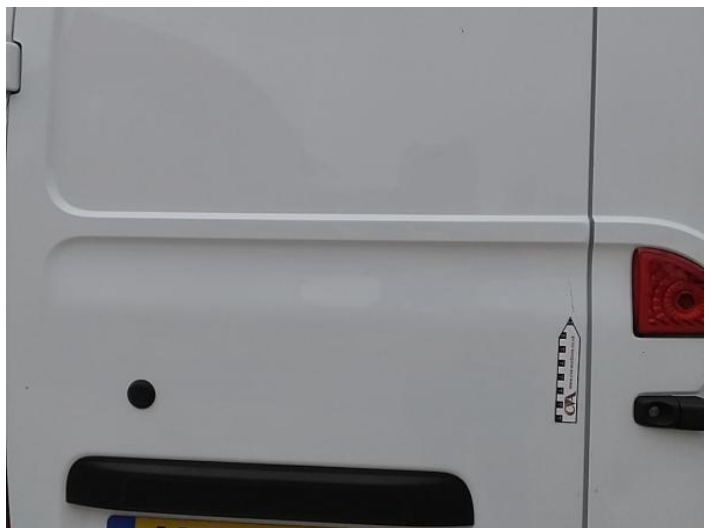
14: Door nsr  
Scratched  
UpTo 25mm Thru Paint

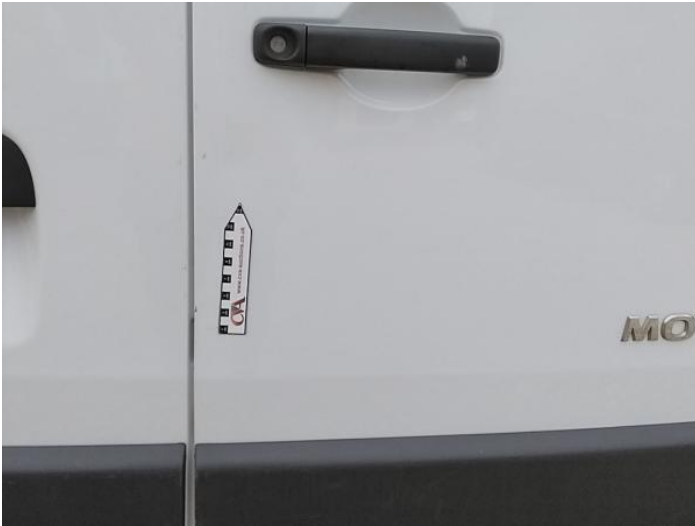
15: Door osr  
Dented  
Between 10mm + 30mm

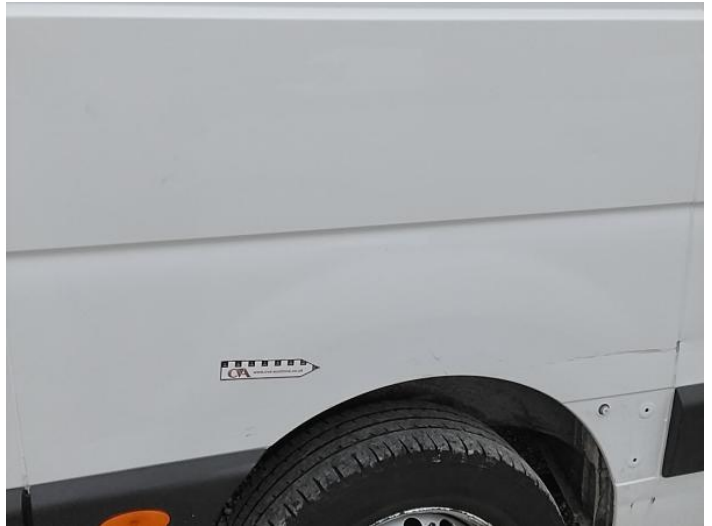
16: Qtr Panel osr  
Scratched  
Over 25mm Not Thru Paint

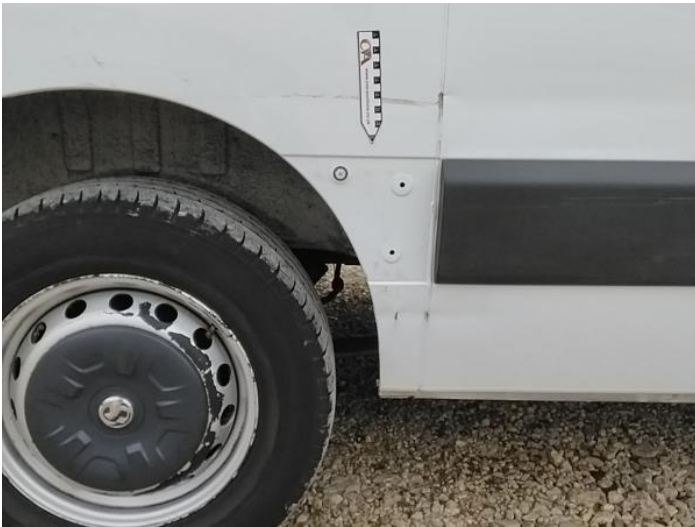
17: Qtr Panel Moulding os  
Missing  
Replace

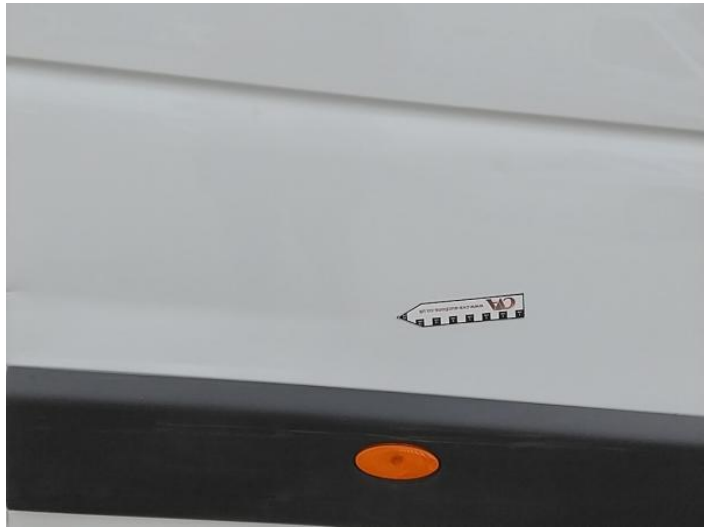
18: Qtr Panel osr  
Dented  
Between 10mm + 30mm

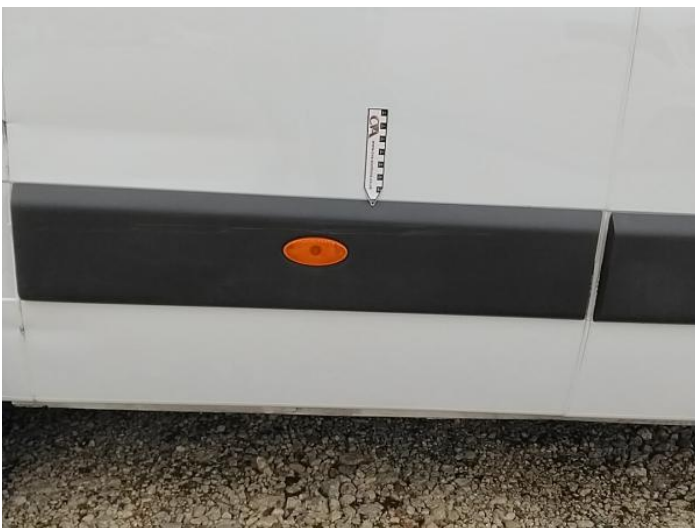
19: Qtr Panel Moulding os  
Scuffed (Unpainted)  
UpTo 100mm

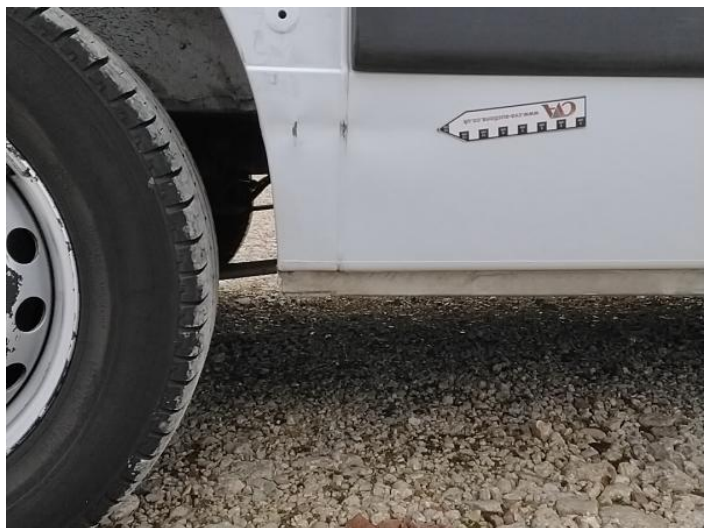
20: Qtr Panel osr  
Dented  
With Paint Damage

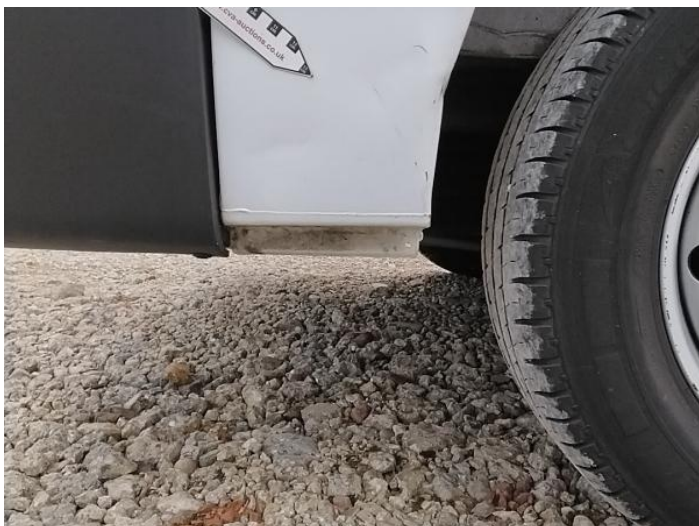
21: Qtr Panel osr  
Dented  
With Paint Damage

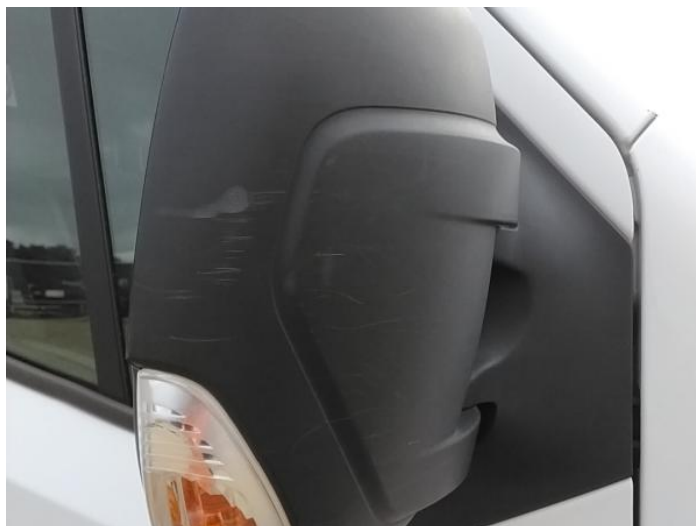
22: Door Mirror Assy osf  
Scuffed (Unpainted)  
UpTo 100mm
