VEHICLE INSPECTION REPORT

BC18ACF

Iveco Stralis 460

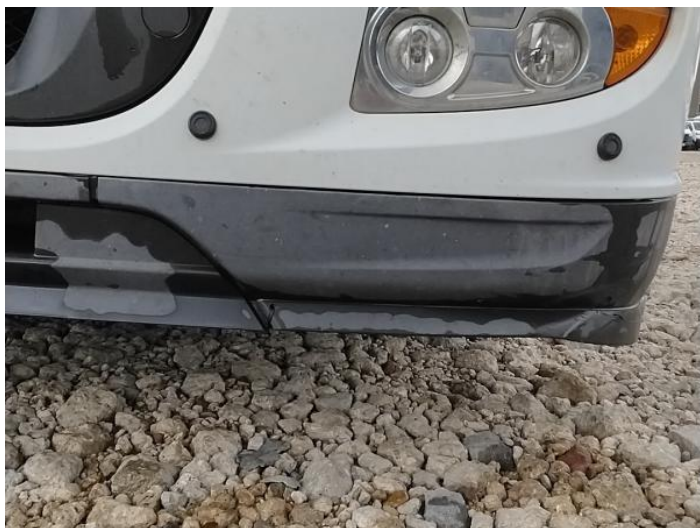
1: Bumper Front Moulding
Broken
Replace

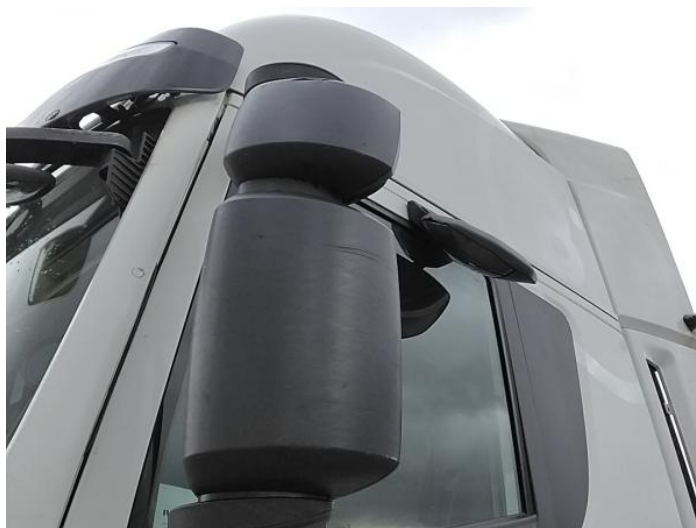
2: Door Mirror Assy nsf
Scuffed (Unpainted)
UpTo 100mm

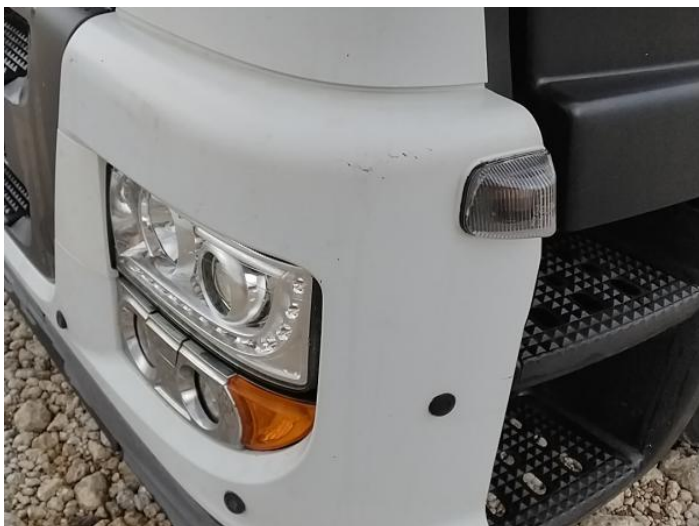
3: Fog Lamp Surround ns
Scratched (Painted)
UpTo 25mm Thru Paint

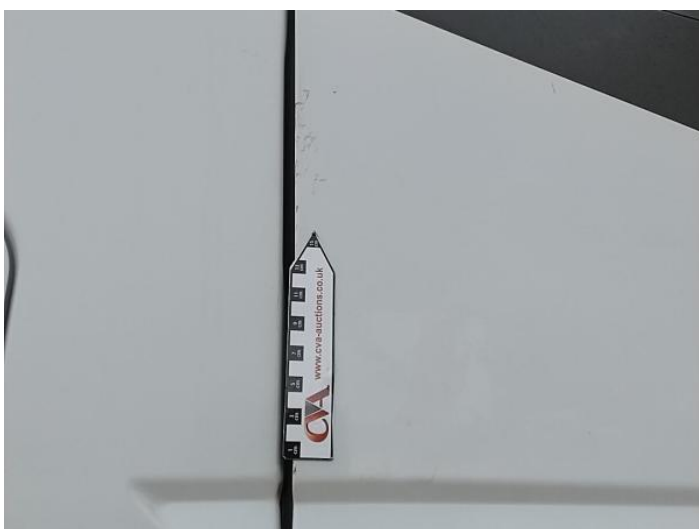
5: Door osf
Scratched
UpTo 25mm Thru Paint
