# VEHICLE INSPECTION REPORT

**BL68OVF**

## Iveco Eurocargo 180-250

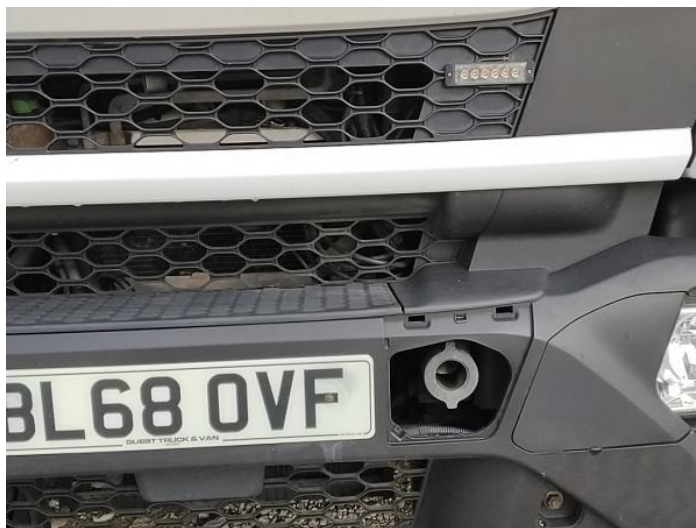
2: Front TowEye Cvr  
Missing  
Replace

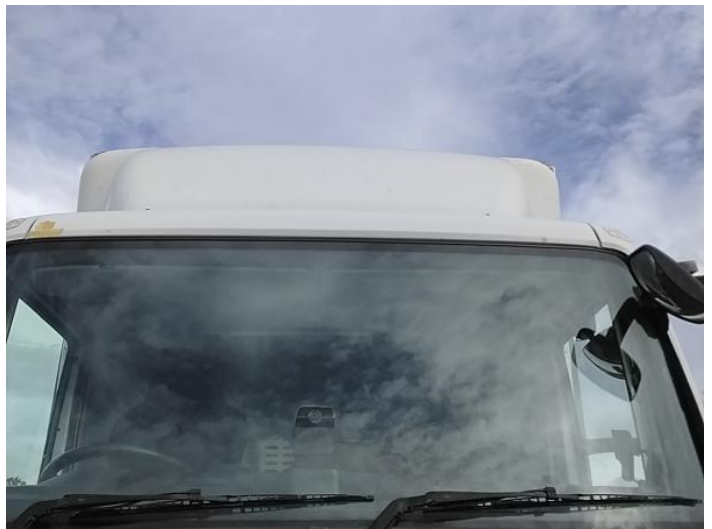
4: Screen Front  
Chipped  
UpTo 10mm

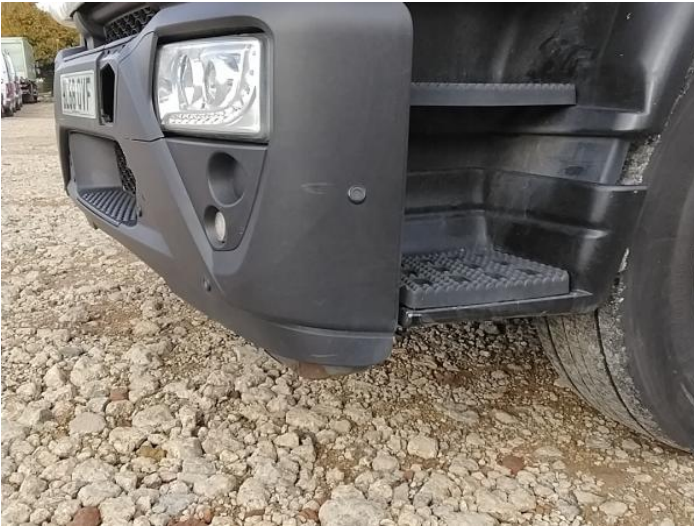
9: Bumper Front Moulding  
Scuffed (Unpainted)  
UpTo 100mm

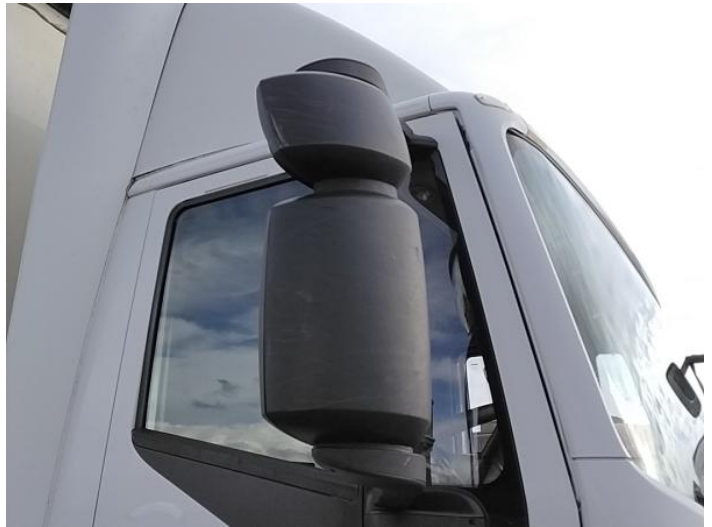
12: Door Mirror Assy osf  
Scuffed (Unpainted)  
UpTo 100mm
