# VEHICLE INSPECTION REPORT

**LL19OES**

## Isuzu N75 190

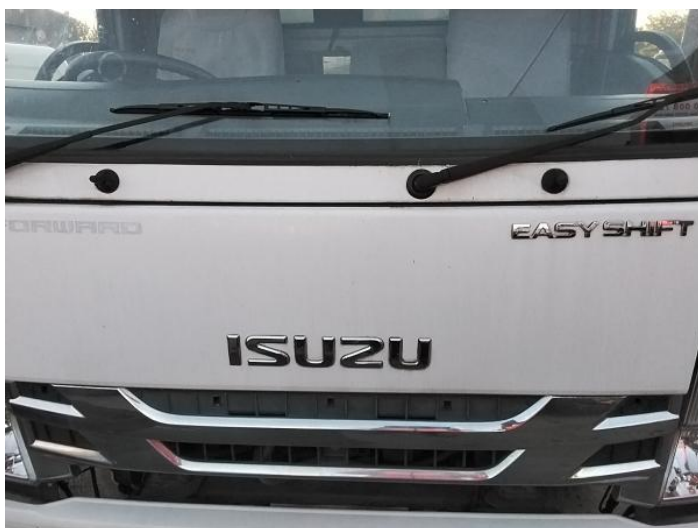
1: Bonnet  
Chipped  
Multiple Chips

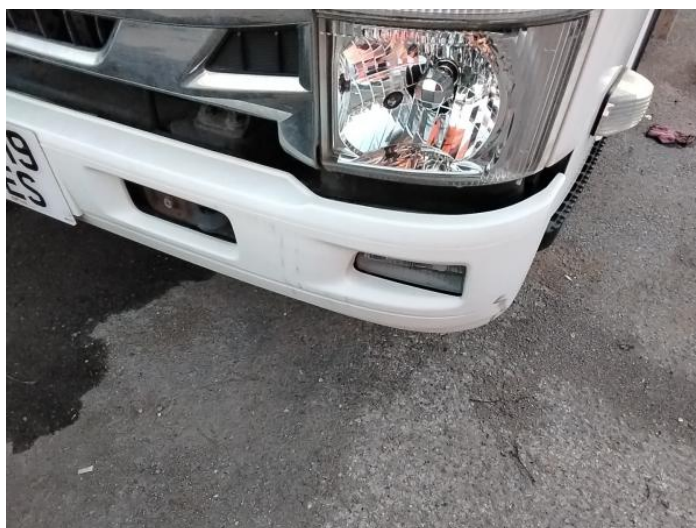
2: Bumper Front  
Scratched  
Over 100mm Thru Paint

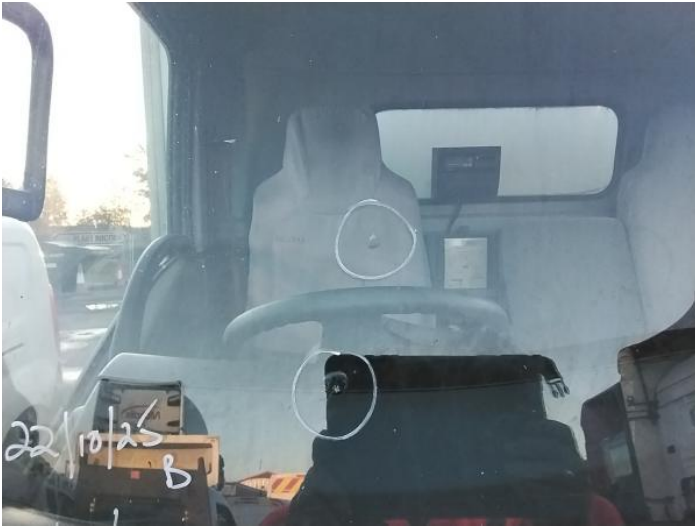
3: Screen Front  
Chipped  
Over 10mm

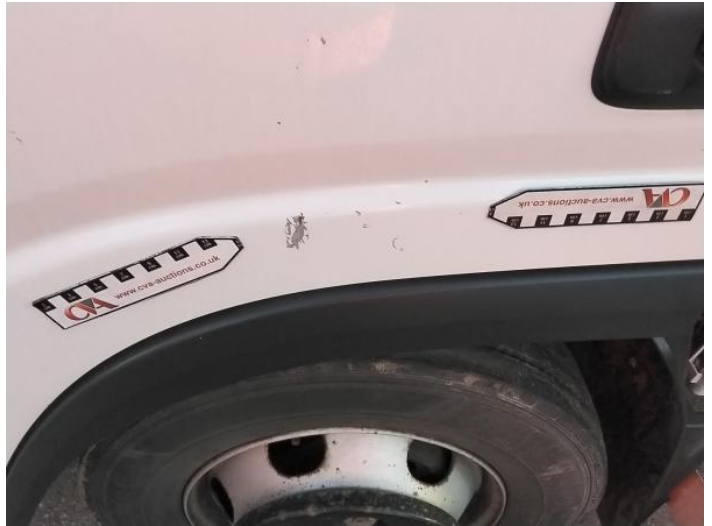
4: Door nsf  
Scratched  
Over 25mm Thru Paint

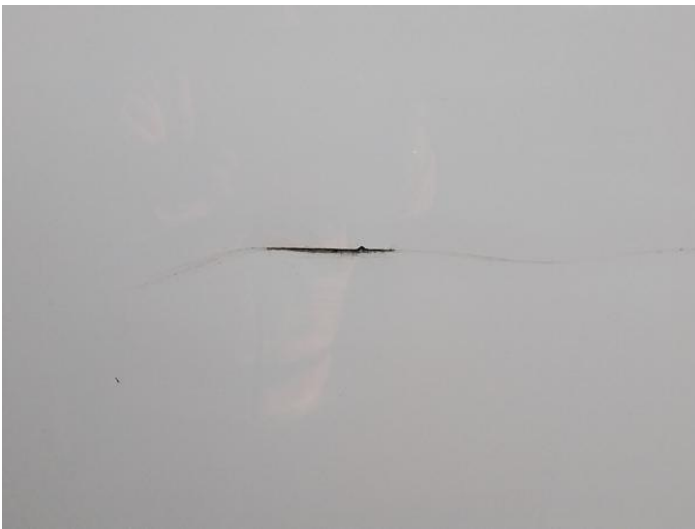
5: Qtr Panel nsr  
Cracked  
Replace

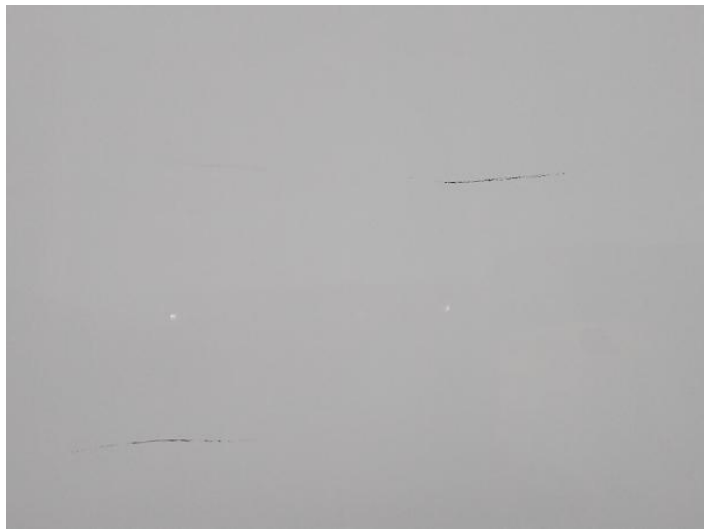
6: Qtr Panel osr  
Scratched  
Over 25mm Not Thru Paint

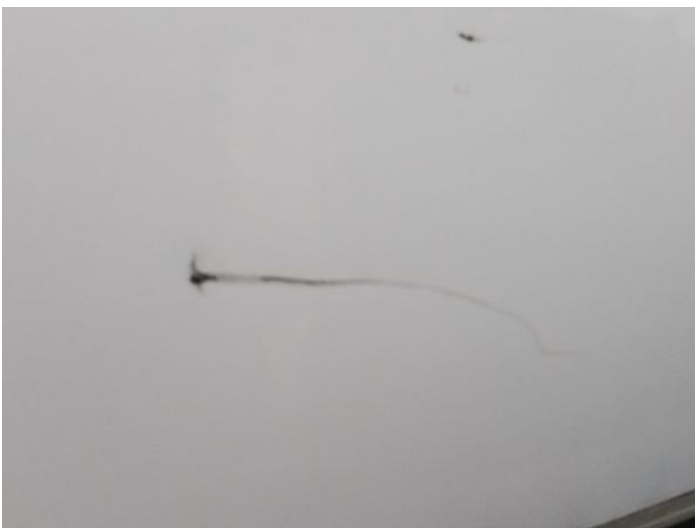
7: Qtr Panel osr  
Cracked  
Replace

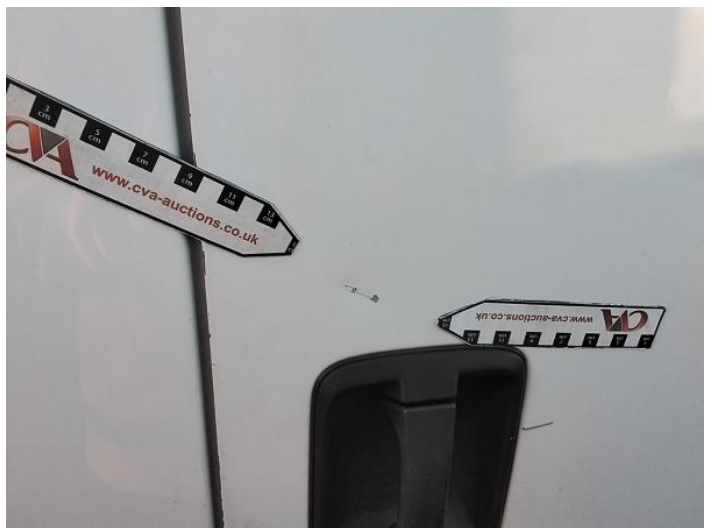
8: Door osf  
Dented  
With Paint Damage

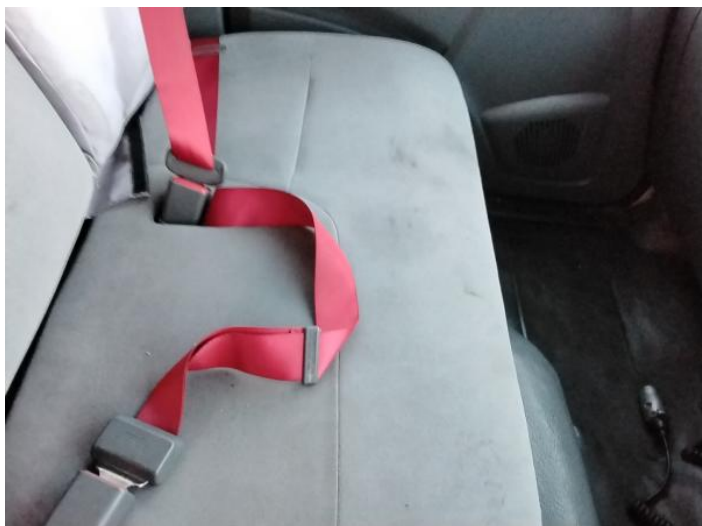
9: Seat Base Cover nsf  
Soiled  
Heavy

| Seat Condition | Poor | Odour | - |
