VEHICLE INSPECTION REPORT

CK67DPE

Mercedes-Benz Sprinter 3.5 CDI

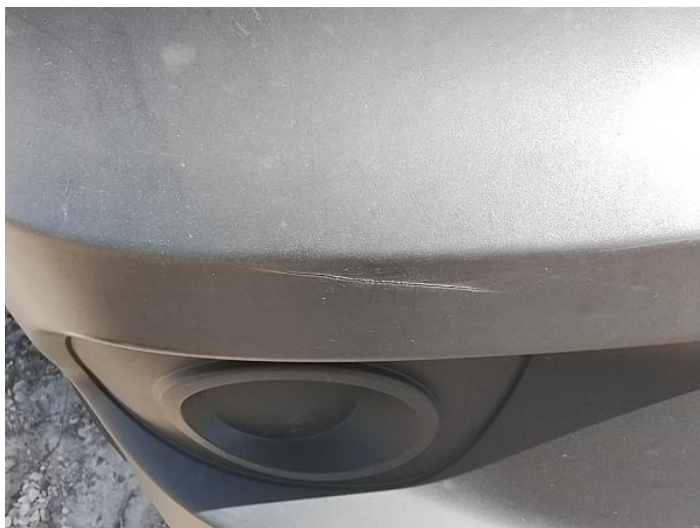
1: Bumper Front Moulding
Scuffed (Unpainted)
Over 100mm

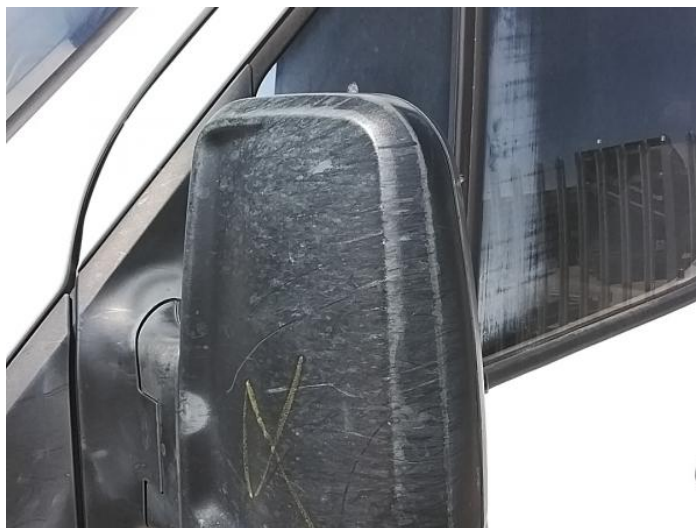
2: Door Mirror Assy osf
Scuffed (Unpainted)
Over 100mm

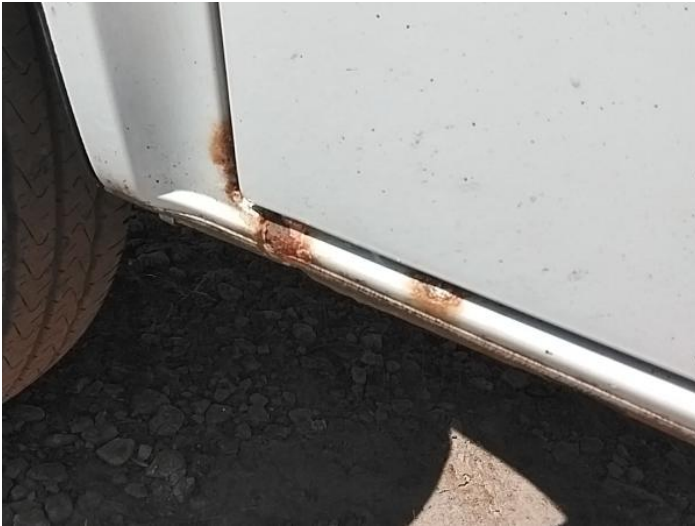
3: Sill os
Chipped
Multiple Chips

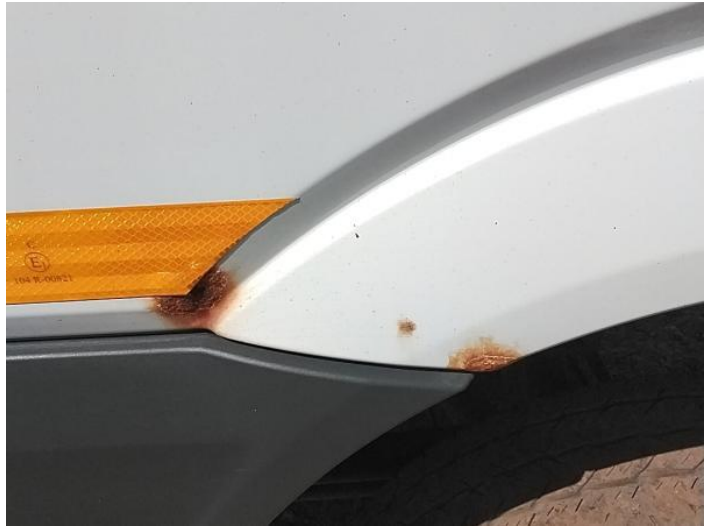
4: Qtr Panel osr
Chipped
Multiple Chips

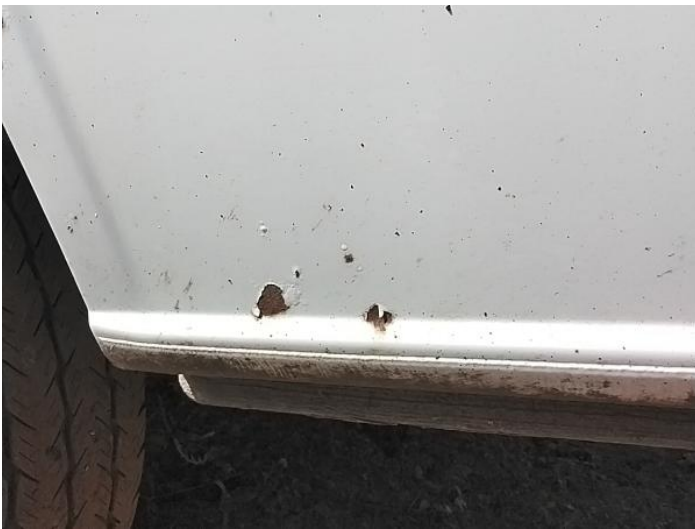
5: Qtr Panel osr
Chipped
Multiple Chips

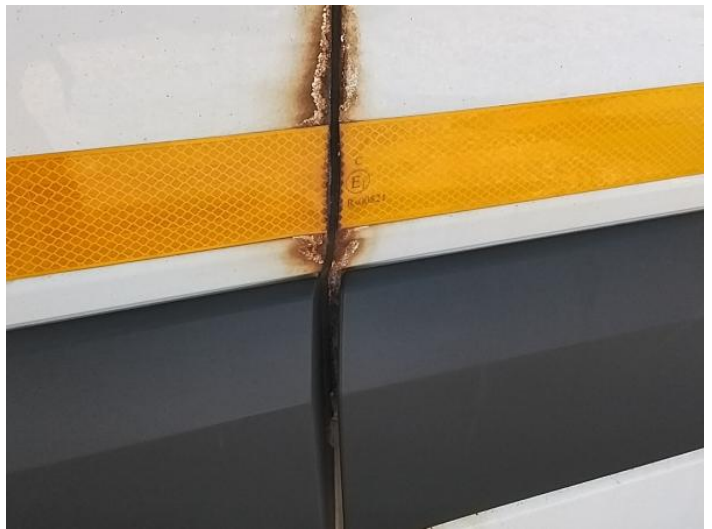
6: Qtr Panel nsr
Chipped
Multiple Chips

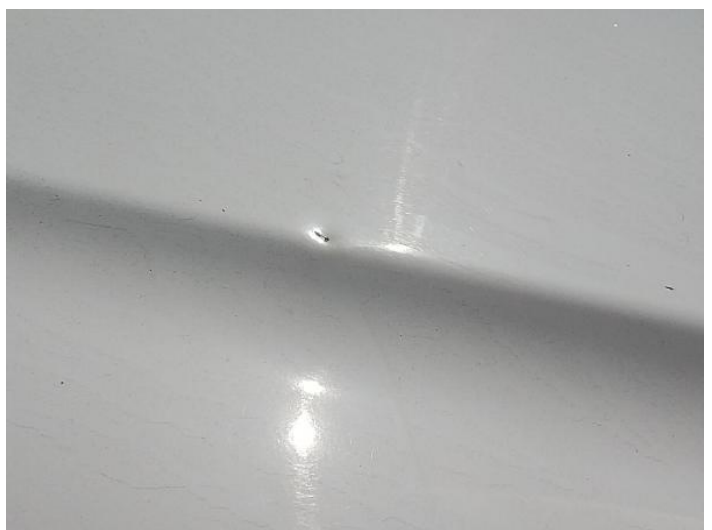
8: Bonnet
Dented
With Paint Damage
