# VEHICLE INSPECTION REPORT

**PN71BVK**

## Fiat Doblo Work Up 1.6 MULTIJET 16V

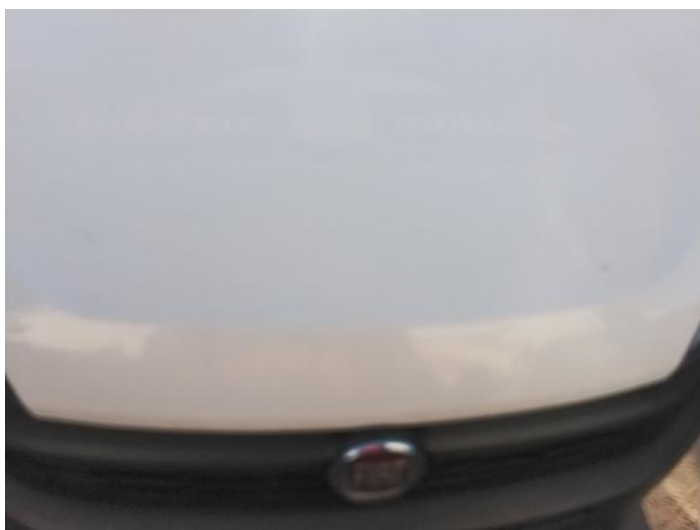
1: Bonnet  
Chipped  
Multiple Chips

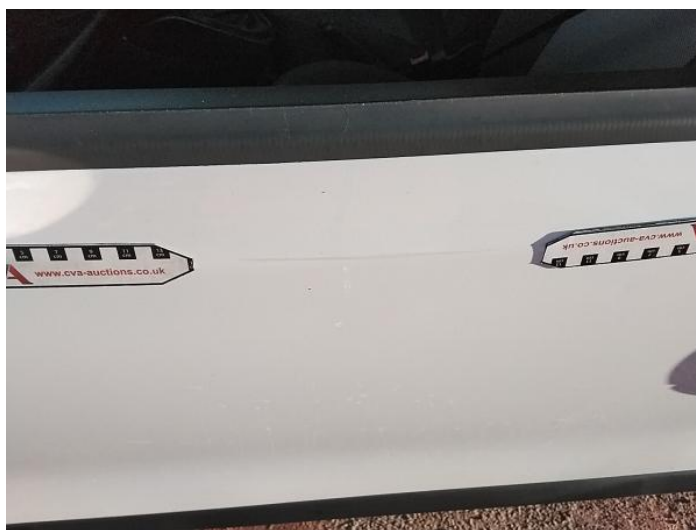
2: Door nsf  
Scratched  
Over 25mm Not Thru Paint

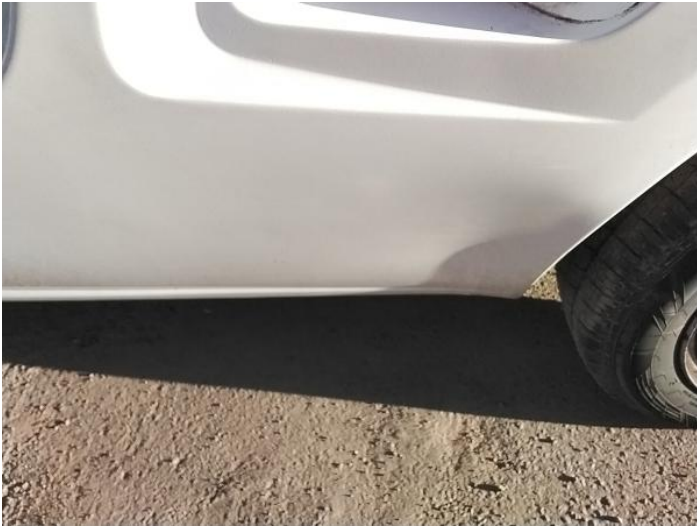
3: Qtr Panel nsr  
Dented  
Over 30mm

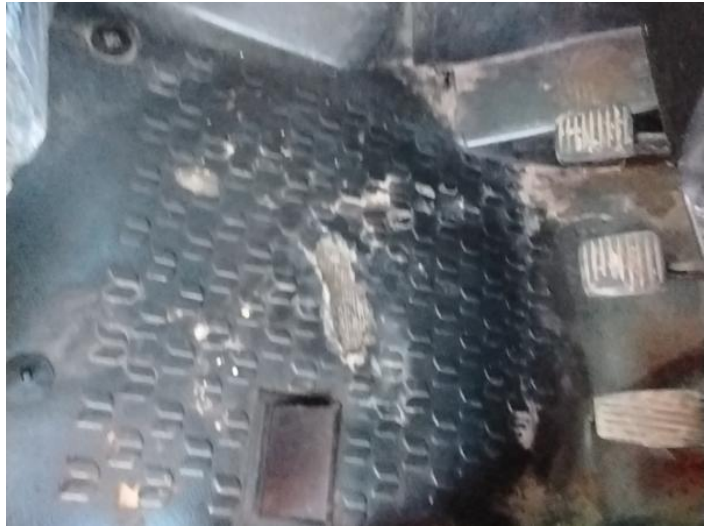
4: Carpets Front  
Holed  
Over 3mm

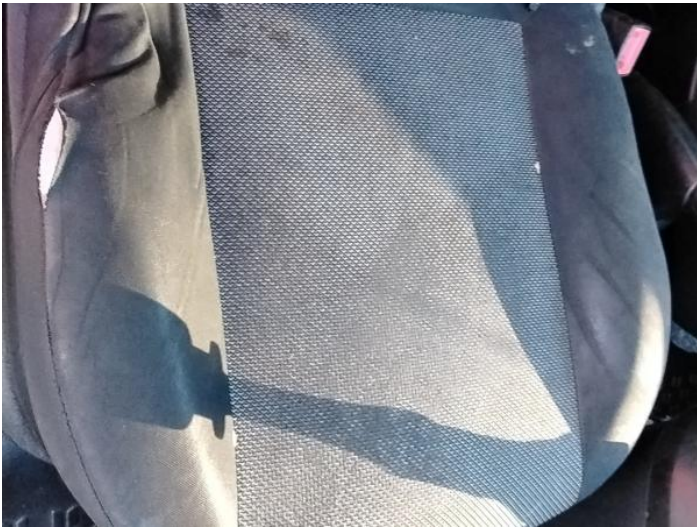
5: Seat Base Cover osf  
Holed  
Over 3mm

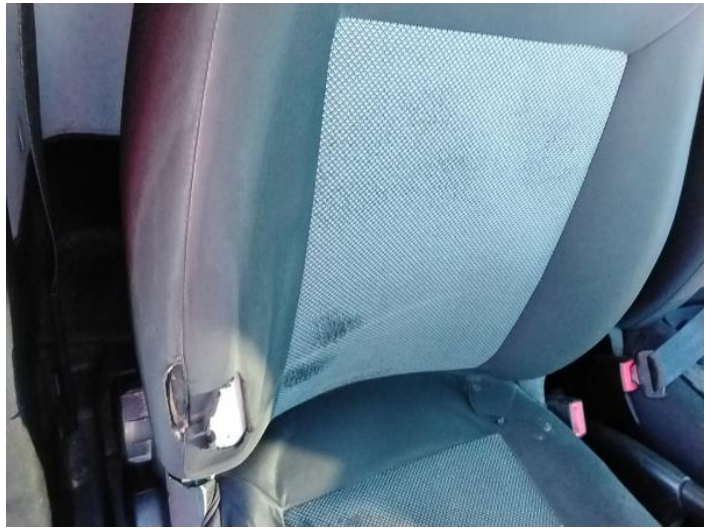
6: Seat Back Cover osf  
Torn  
Over 3mm

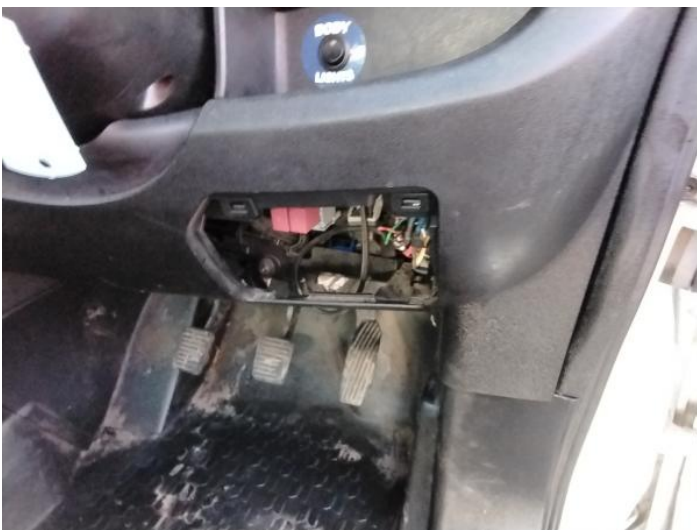
7: Fascia Panel  
Missing  
Replace

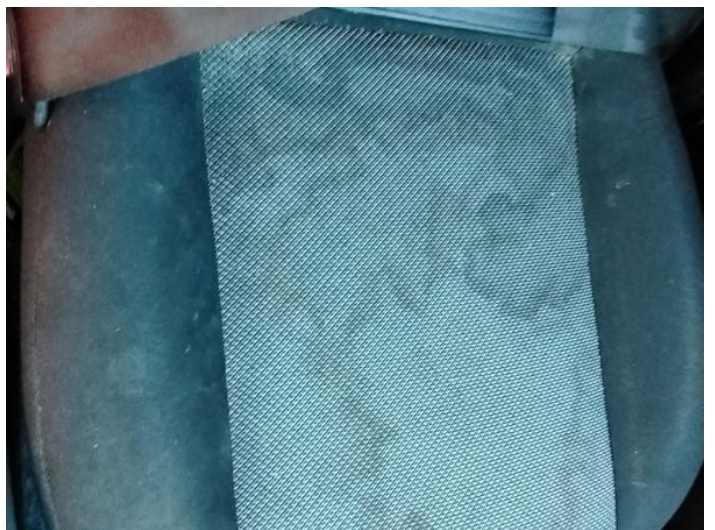
8: Seat Base Cover nsf  
Soiled  
Heavy

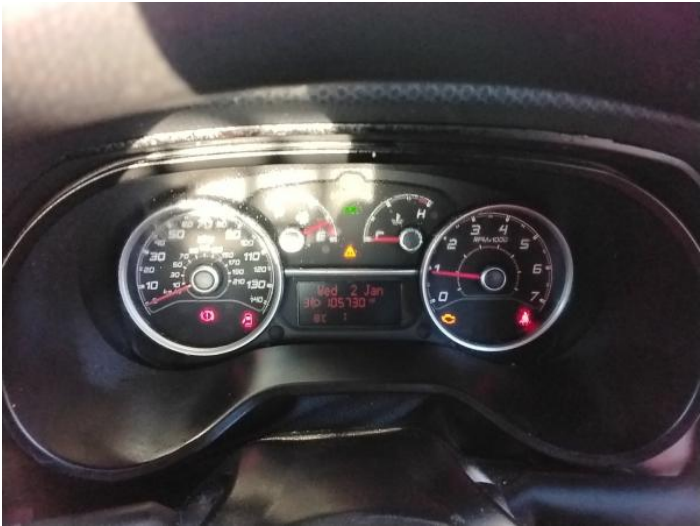
\*WARNING LIGHT ON DASH\* AD-BLUE

9: Dash Warning Lights  
Displayed  
No Action

| EML light illuminated | Fault | DPF light illuminated | OK |
