# VEHICLE INSPECTION REPORT

**SA71KJV**

## Fiat Doblo II 1.6 MULTIJET 16V

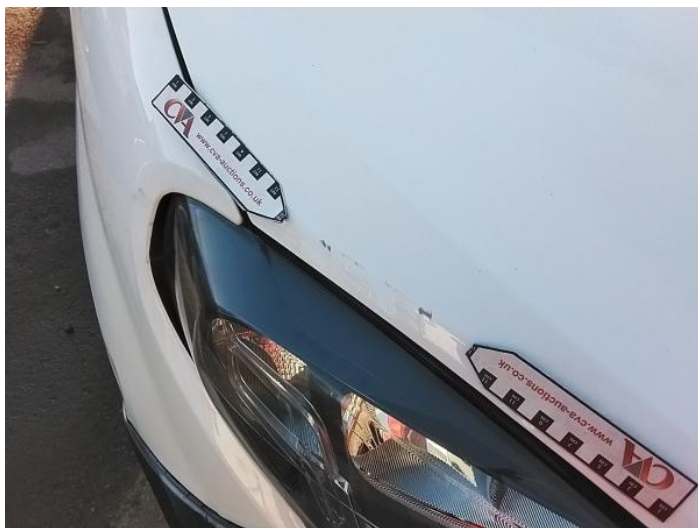
1: Bonnet  
Dented  
With Paint Damage

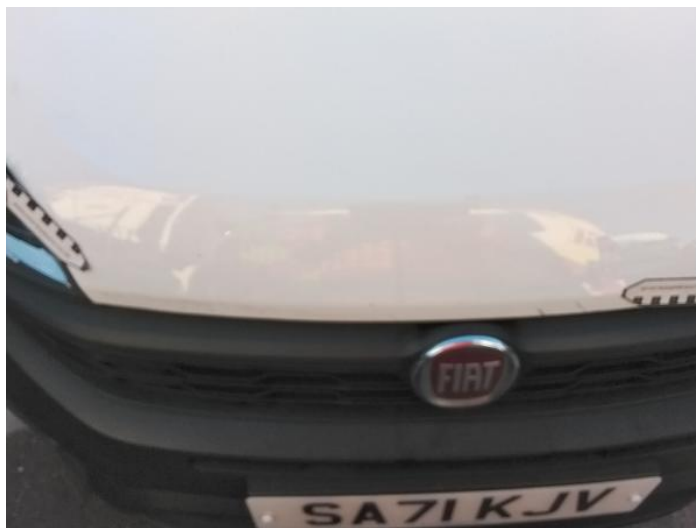
2: Bonnet  
Scratched  
Over 25mm Thru Paint

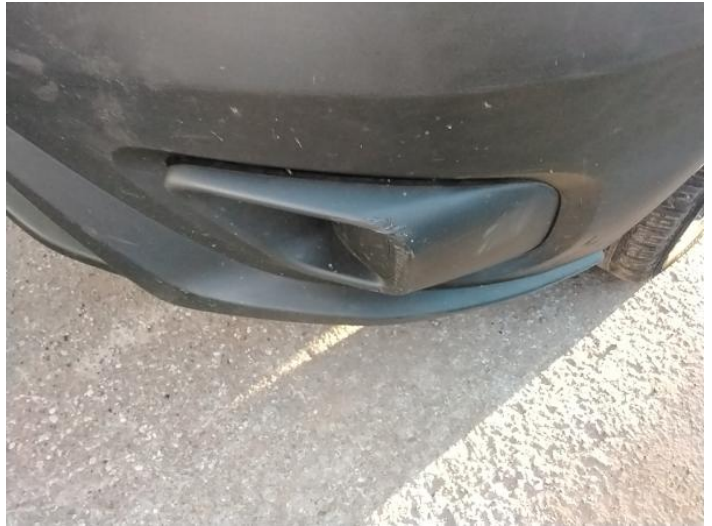
4: Bumper Front Moulding  
Scuffed (Unpainted)  
UpTo 100mm

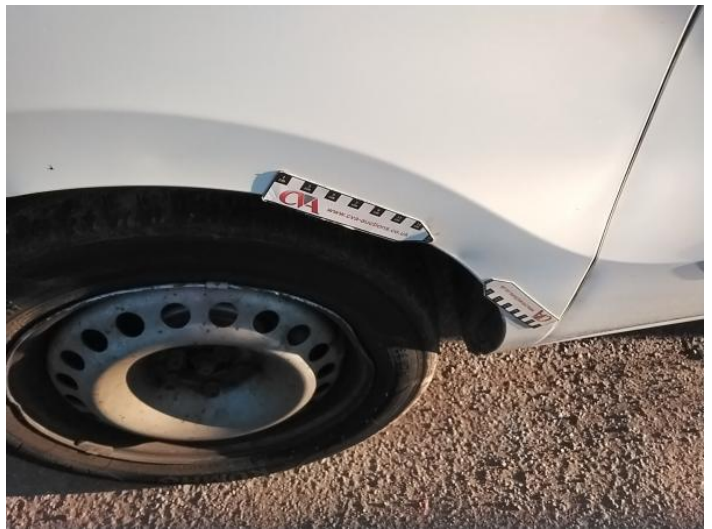
6: Wing nsf  
Dented  
Over 30mm

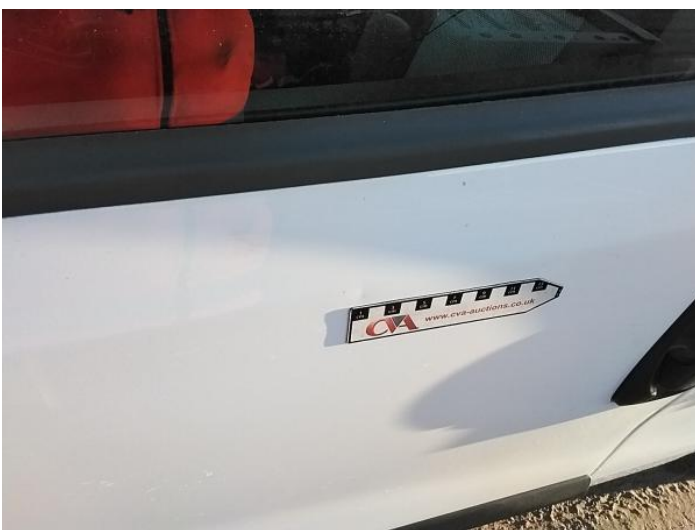
7: Door nsf  
Dented  
With Paint Damage

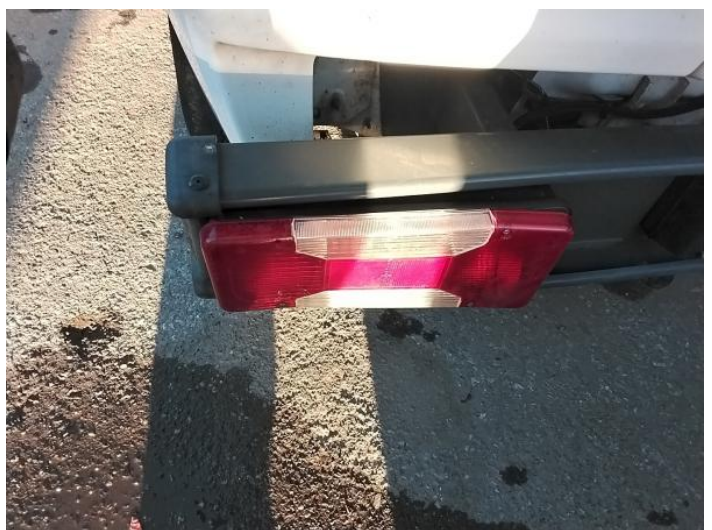
8: Lamp nsr  
Broken  
Replace

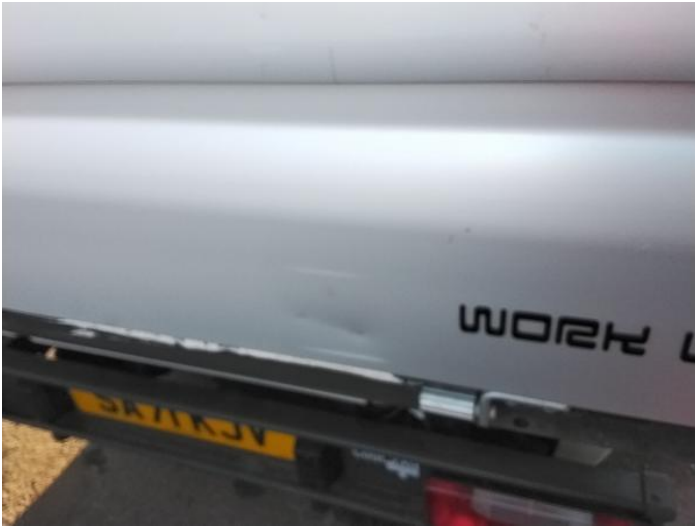
9: Tailgate  
Dented  
With Paint Damage

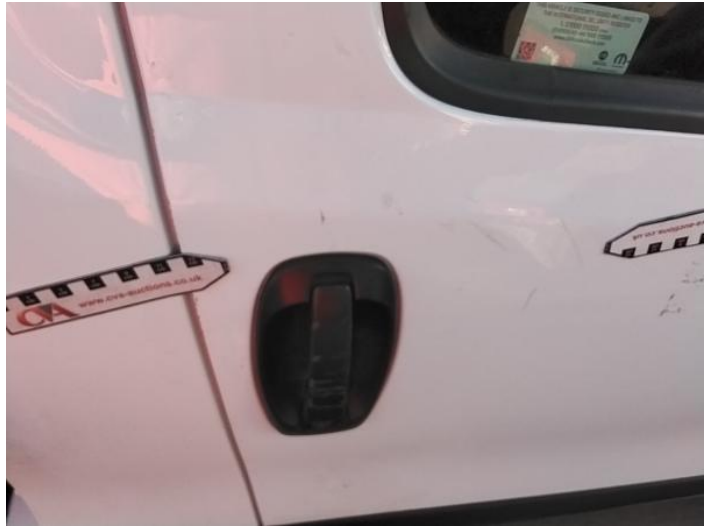
10: Door osf  
Scratched  
Over 25mm Thru Paint

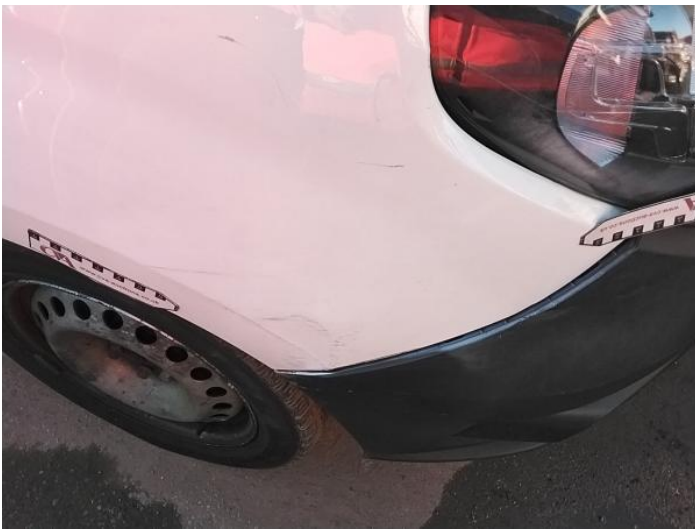
11: Wing osf  
Dented  
With Paint Damage

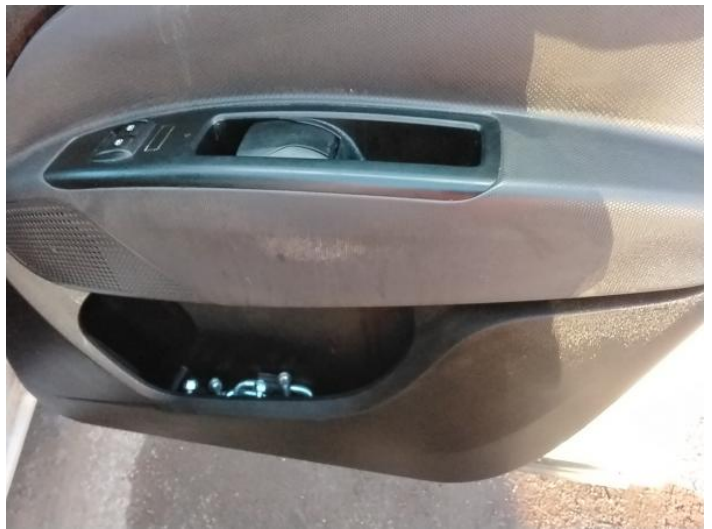
12: Door Pad osf  
Soiled  
Heavy

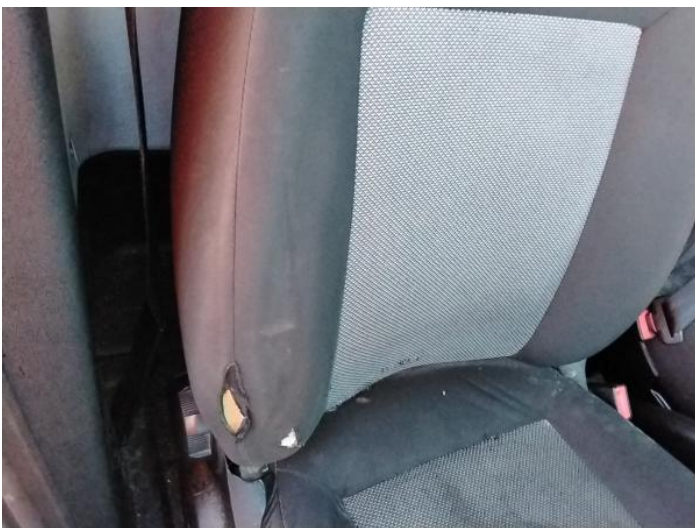
13: Seat Back Cover osf  
Torn  
Over 3mm

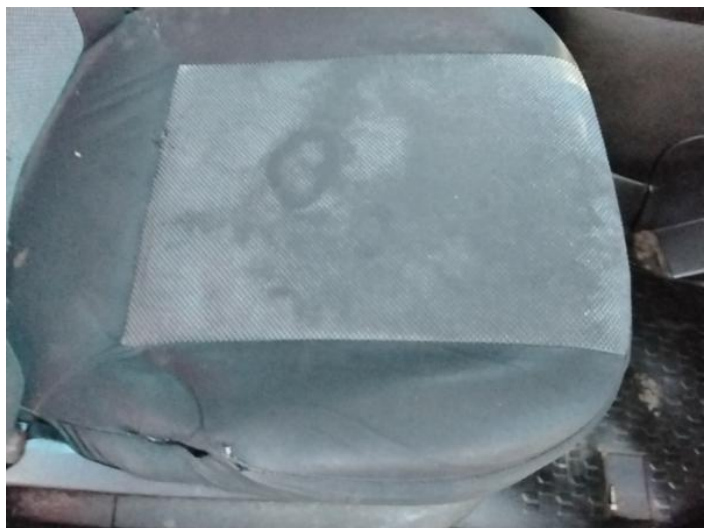
14: Seat Base Cover osf  
Soiled  
Heavy

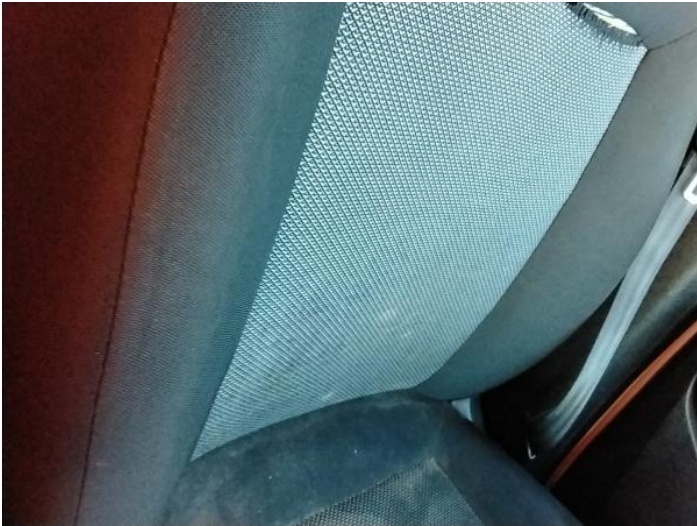
15: Seat Back Cover nsf  
Soiled  
Heavy

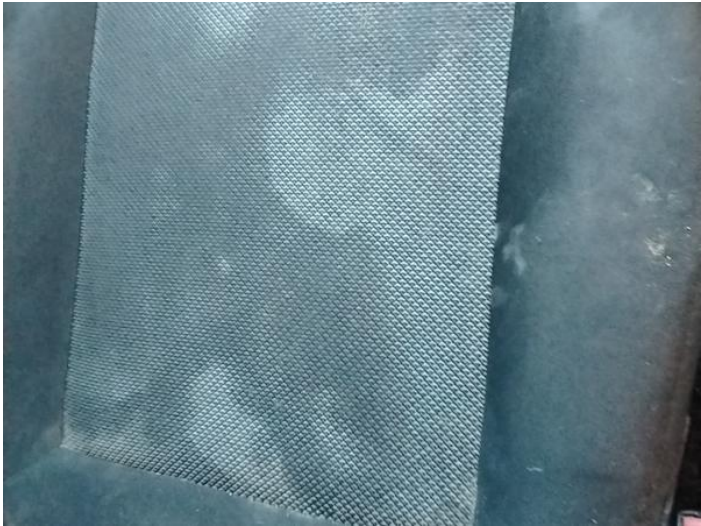
16: Seat Base Cover nsf  
Soiled  
Heavy

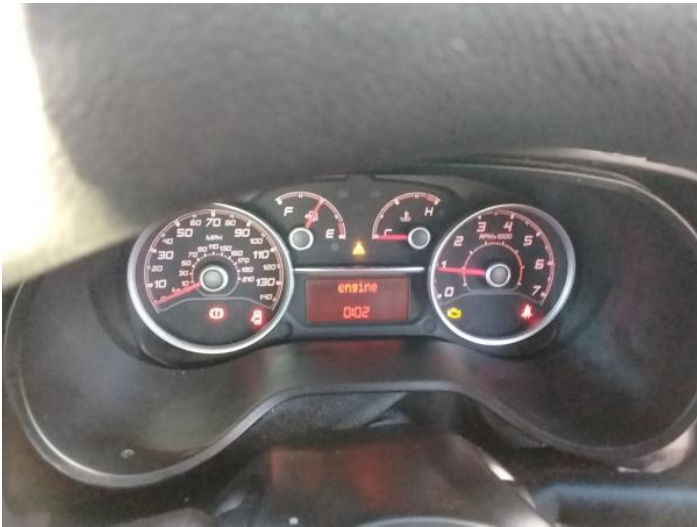
17: Dash Warning Lights  
Displayed  
No Action

| EML light illuminated | Fault | DPF light illuminated | OK |
