# VEHICLE INSPECTION REPORT

**PJ71NLK**

## Fiat Doblo II 1.6 MULTIJET 16V

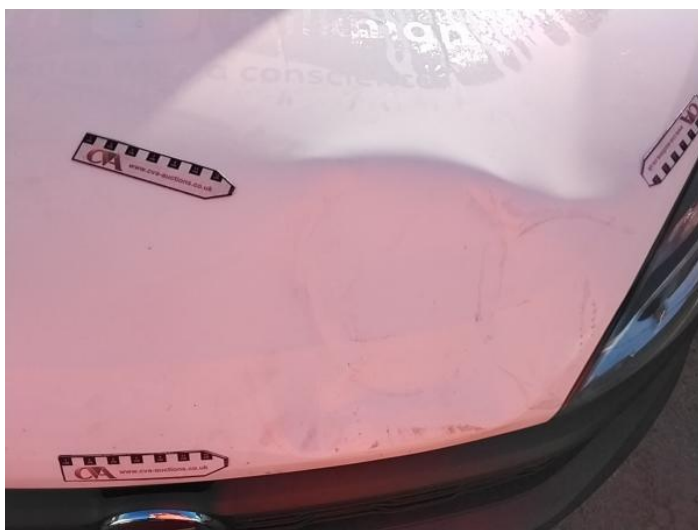
1: Bonnet  
Dented  
With Paint Damage

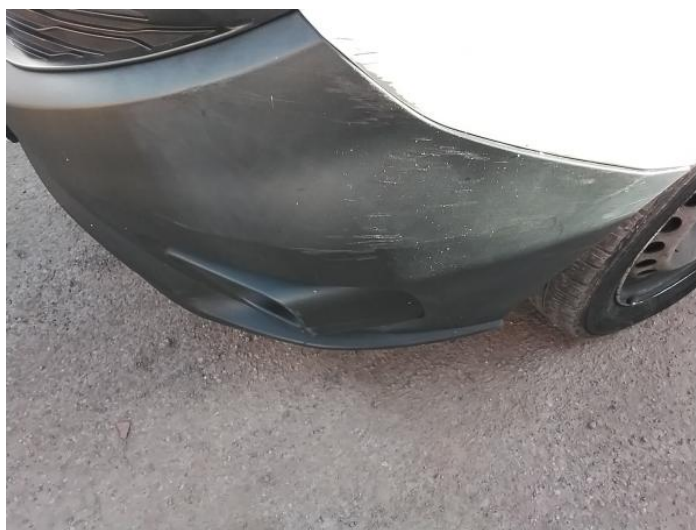
2: Bumper Front  
Scratched  
Over 100mm Thru Paint

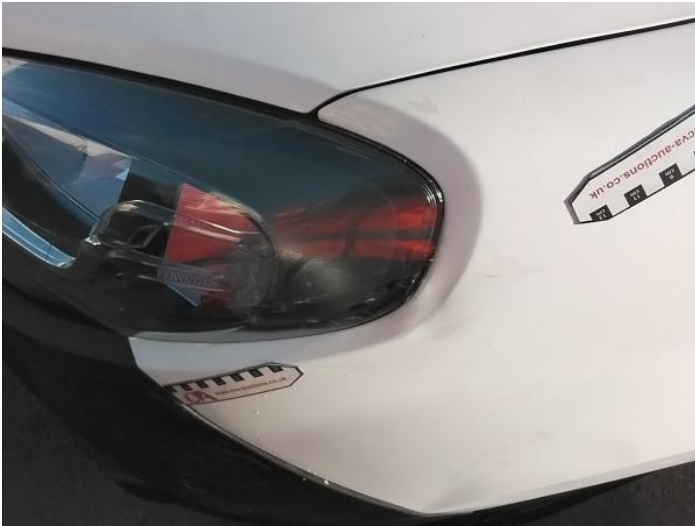
3: Wing nsf  
Dented  
With Paint Damage

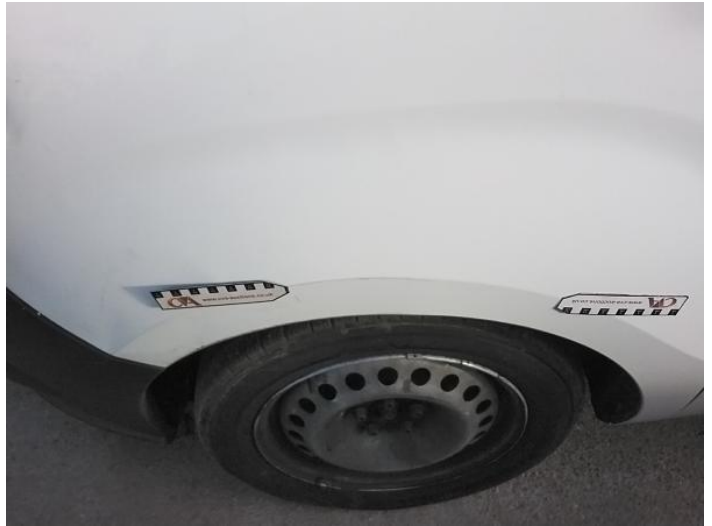
4: Wing nsf  
Scratched  
Over 25mm Thru Paint

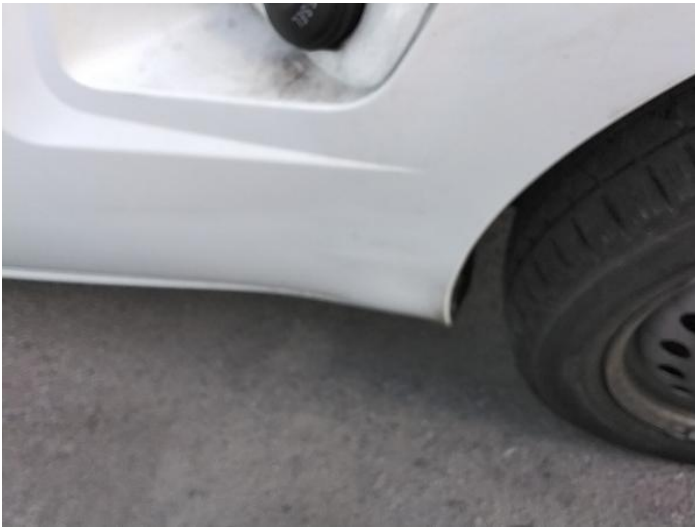
5: Qtr Panel nsr  
Dented  
Over 30mm

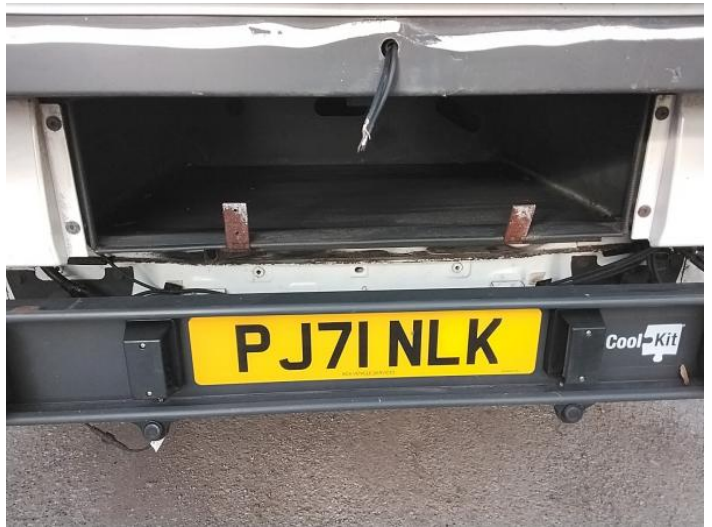
6: Panel Rear  
Missing  
Replace

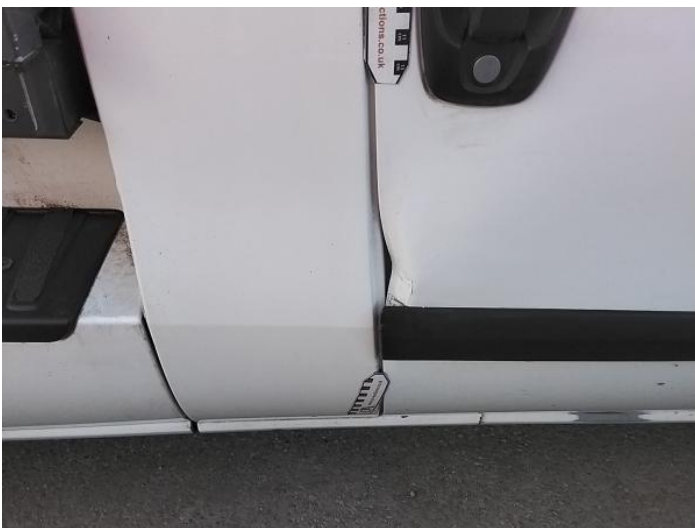
7: Door osf  
Dented  
With Paint Damage

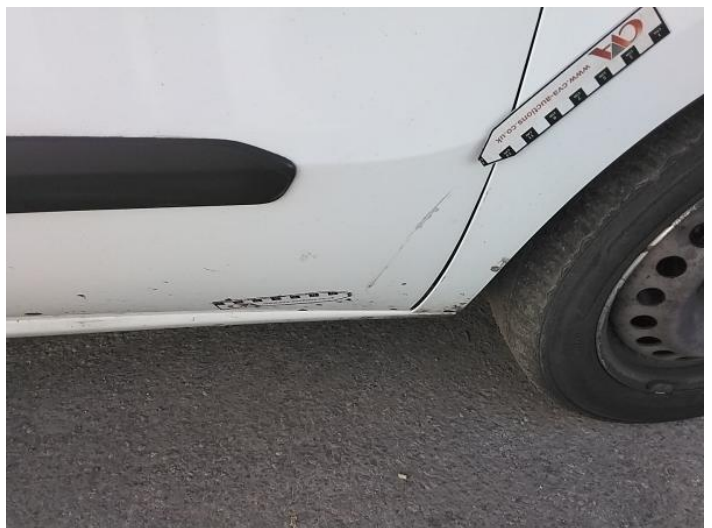
8: Door osf  
Scratched  
Over 25mm Thru Paint

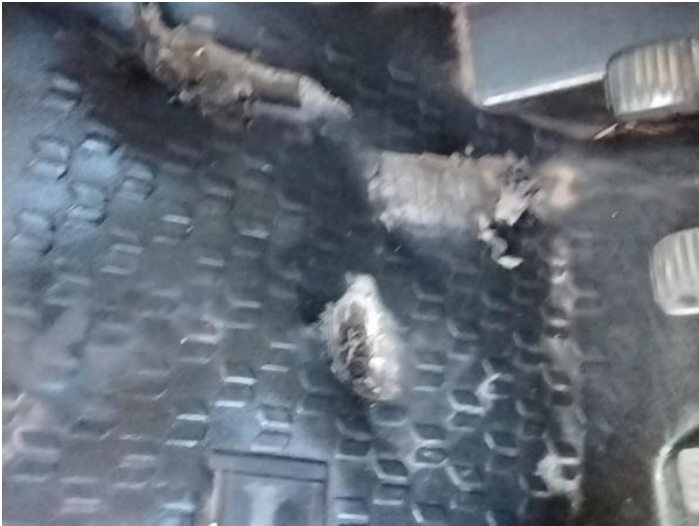
9: Carpets Front  
Holed  
Over 3mm

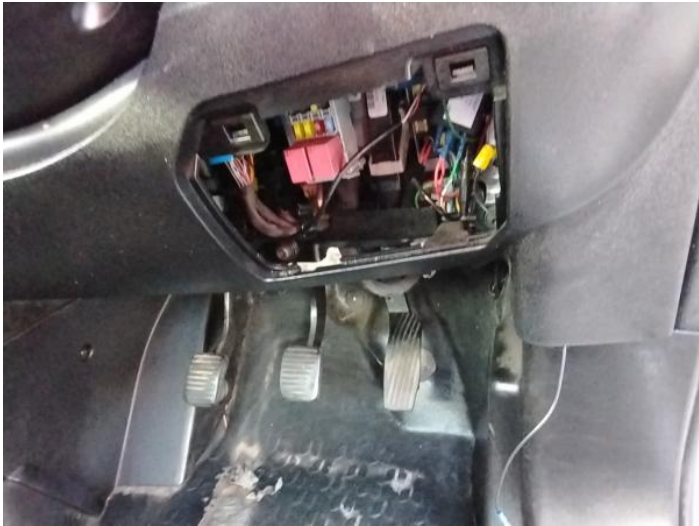
10: Fascia Panel  
Missing  
Replace

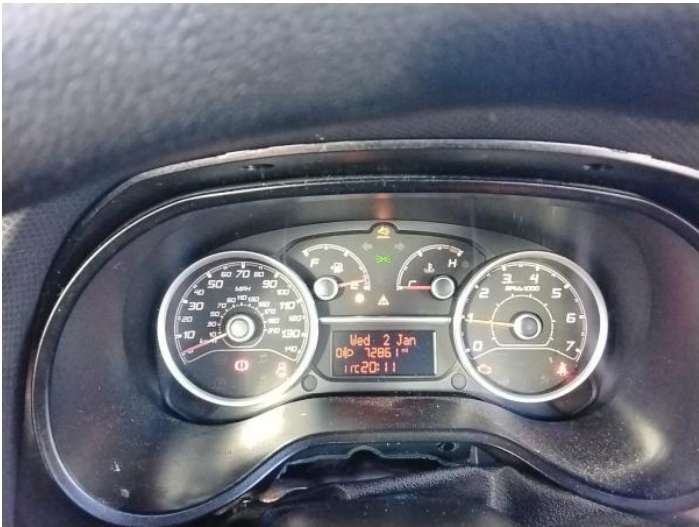
\*WARNING LIGHT ON DASH\* AD-BLUE

11: Dash Warning Lights  
Displayed  
No Action
