# VEHICLE INSPECTION REPORT

**BL68OVH**

## Iveco Eurocargo 180-250

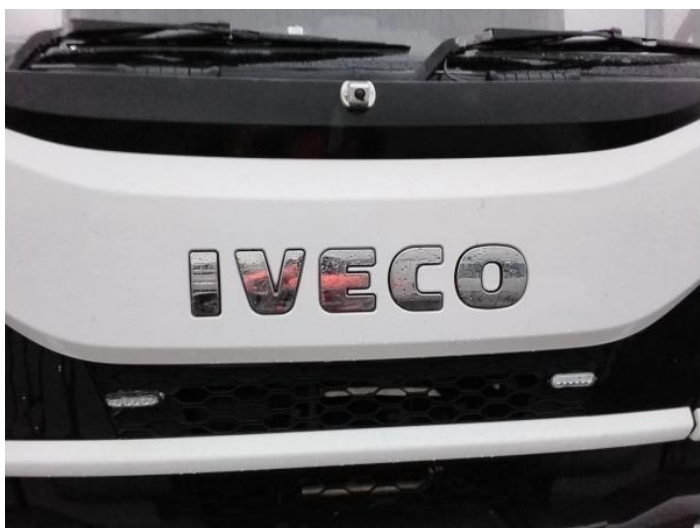
1: Bonnet  
Chipped  
Multiple Chips

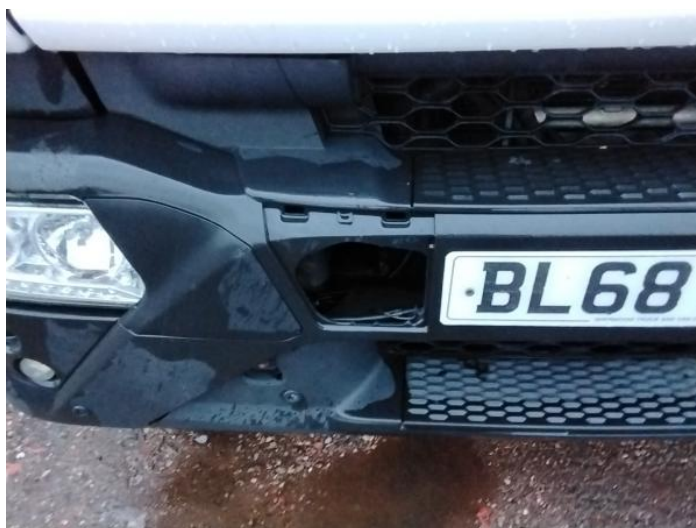
2: Bumper Front Moulding  
Missing  
Replace

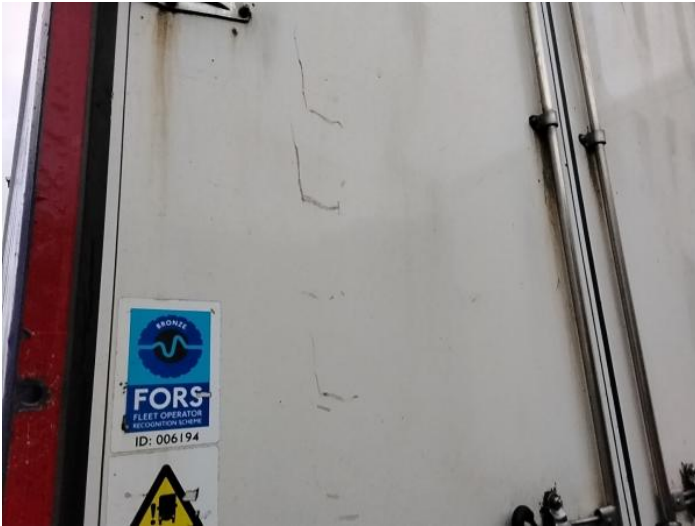
3: Door nsr  
Scratched  
Over 25mm Thru Paint

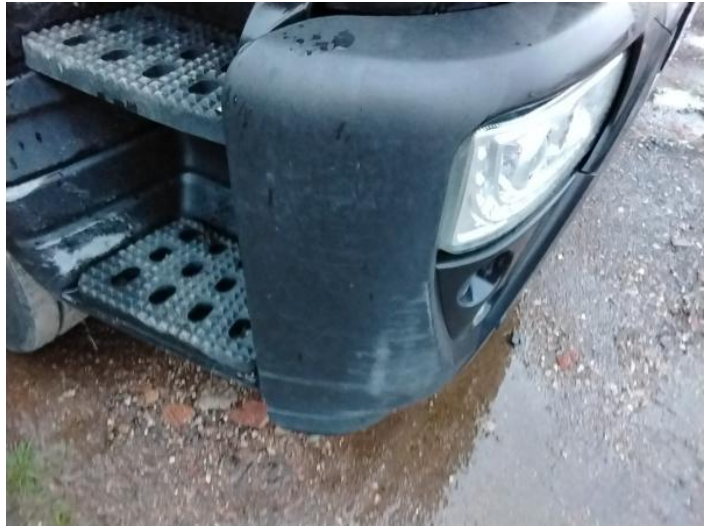
4: Bumper Front  
Scratched  
Over 100mm Thru Paint

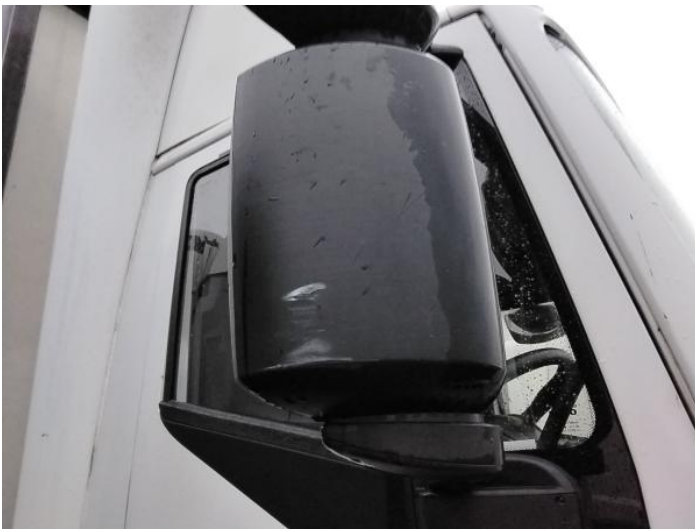
5: Door Mirror Assy osf  
Scuffed (Unpainted)  
UpTo 100mm

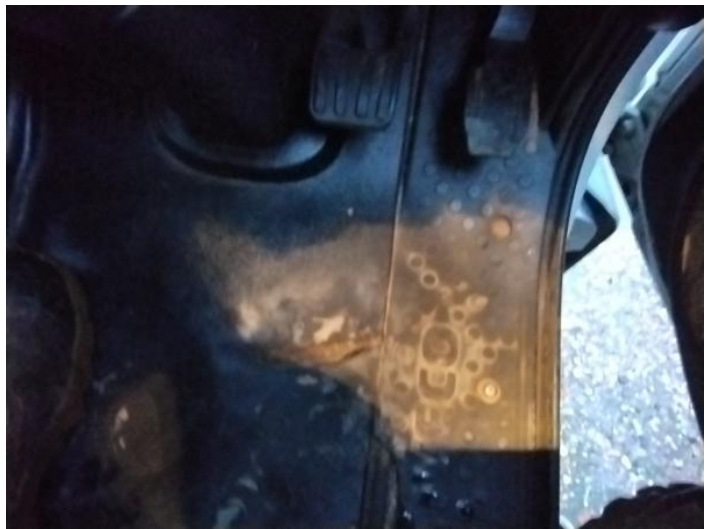
6: Carpets Front  
Torn  
Over 10mm

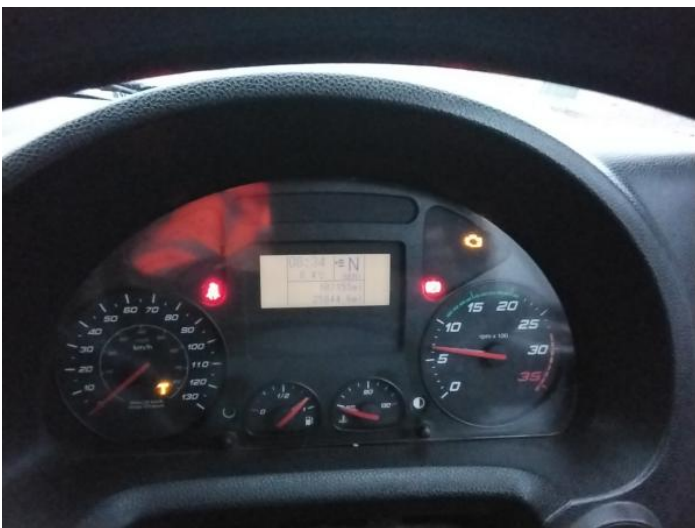
7: Dash Warning Lights  
Displayed  
No Action

| EML light illuminated | Fault | DPF light illuminated | OK |

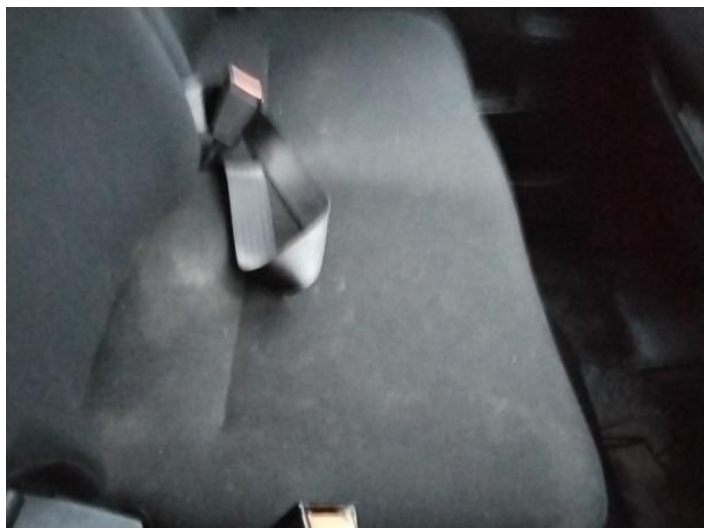
8: Seat Base Cover nsf  
Soiled  
Heavy
