# VEHICLE INSPECTION REPORT

**CX18SWZ**

## Fiat Doblo 1.6 MULTIJET 16V SX

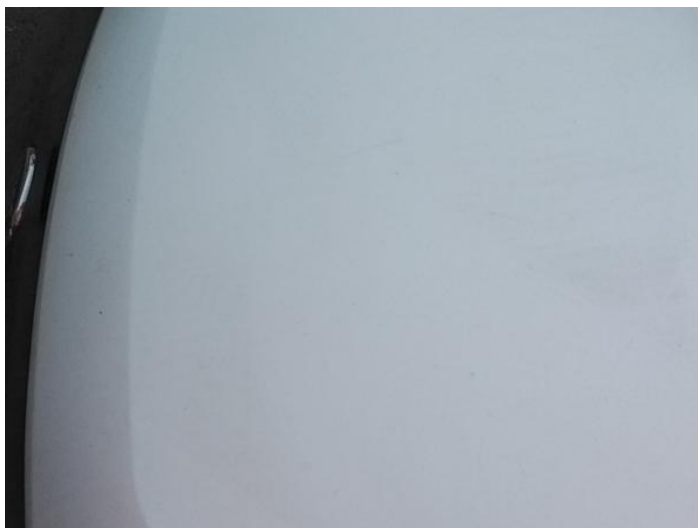
1: Bonnet  
Chipped  
Multiple Chips

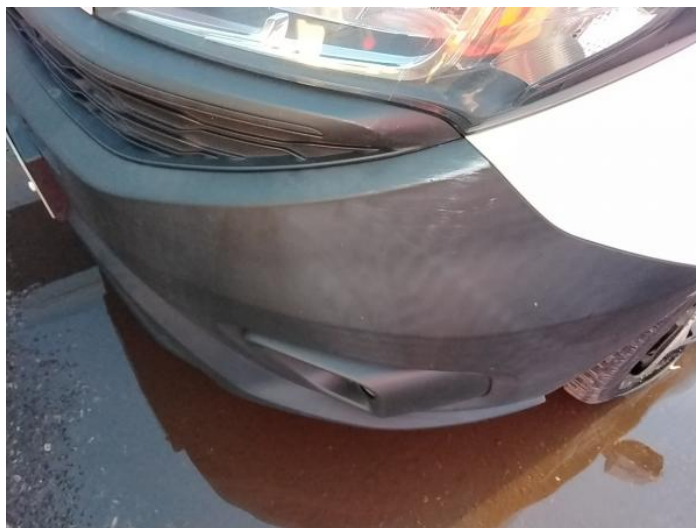
2: Bumper Front  
Scratched  
Over 100mm Thru Paint

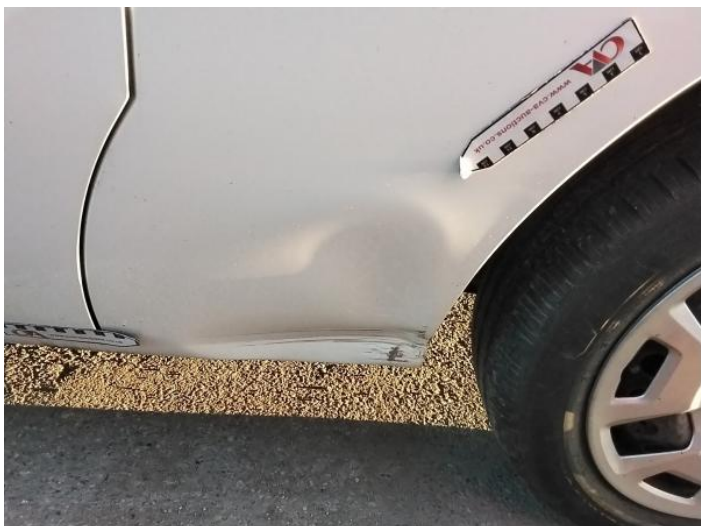
3: Qtr Panel nsr  
Dented  
With Paint Damage

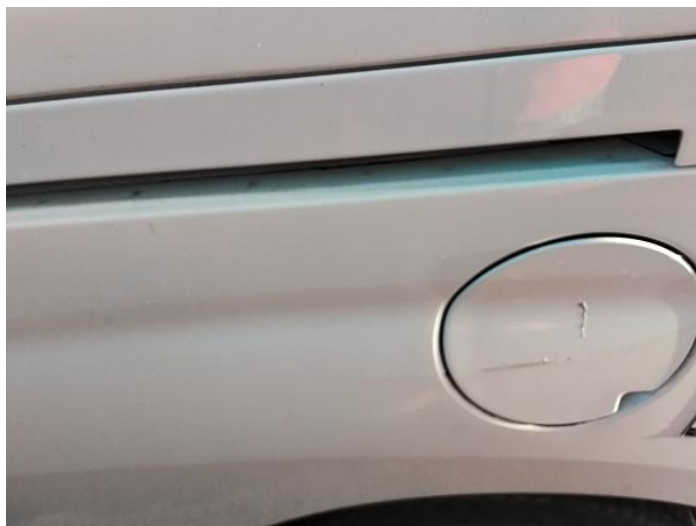
4: Fuel Flap  
Scratched  
Over 25mm Thru Paint

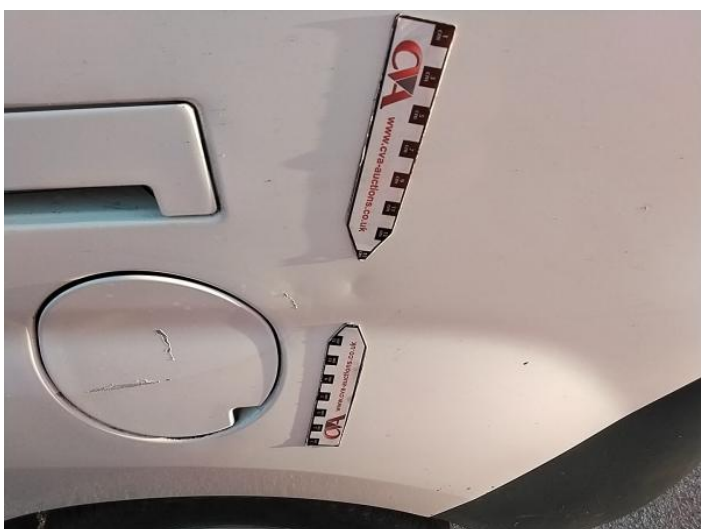
5: Qtr Panel nsr  
Dented  
Over 30mm

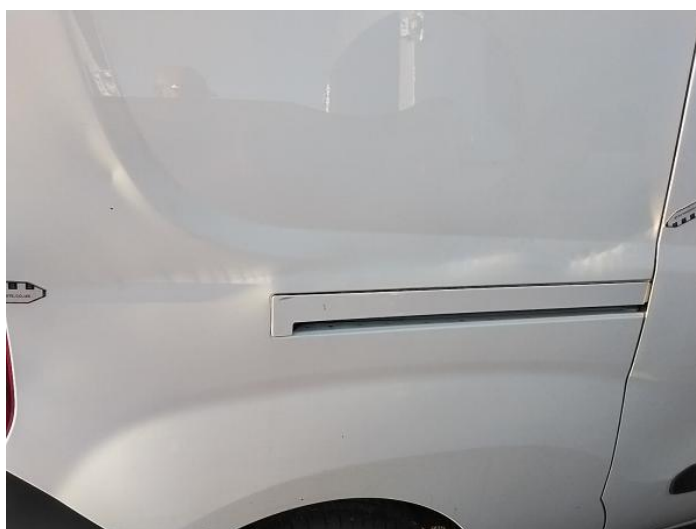
6: Qtr Panel osr  
Dented  
Over 30mm

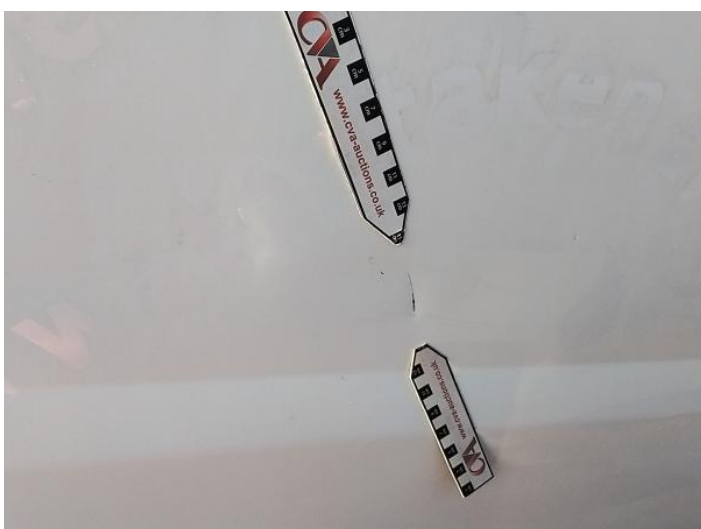
7: Qtr Panel osr  
Dented  
With Paint Damage

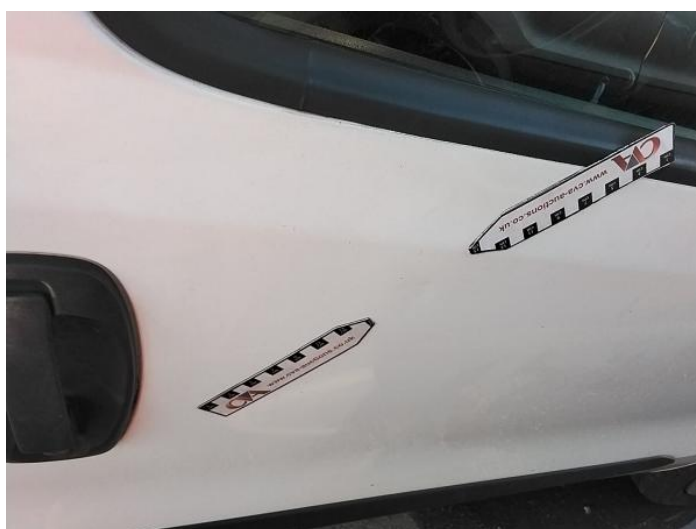
8: Door osf  
Dented  
Over 30mm

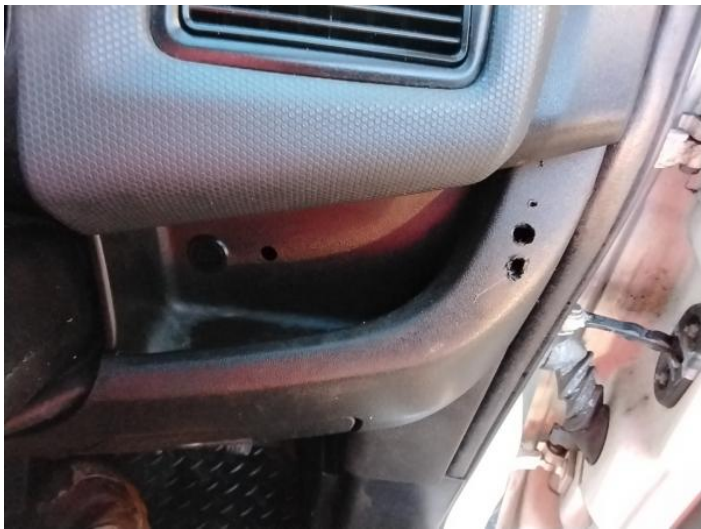
9: Fascia Panel  
Holed  
Over 3mm
