## **VEHICLE INSPECTION REPORT**

FP68AVD

### Vauxhall Vivaro 2700 1.6 CDTI 95PS

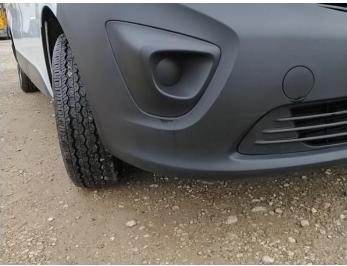
2: Bumper Front Moulding Scuffed (Unpainted) UpTo 100mm

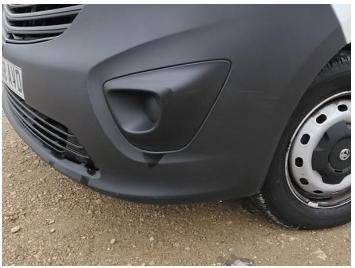
3: Bumper Front Moulding Scuffed (Unpainted) UpTo 100mm

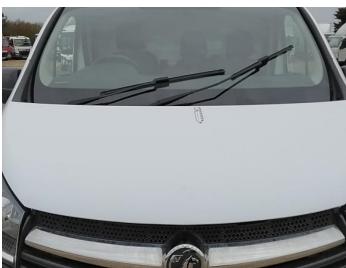
4: Bonnet Chipped Multiple Chips

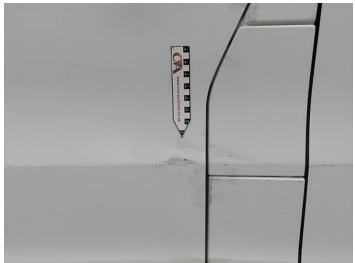
6: Door nsf Dented With Paint Damage

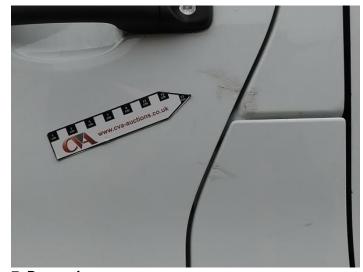
7: Door nsf Scratched Over 25mm Thru Paint

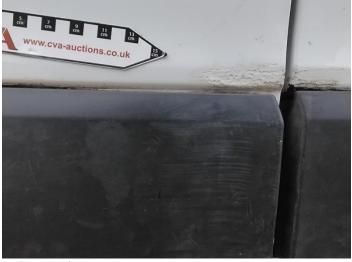
8: Door nsf Scratched UpTo 25mm Thru Paint

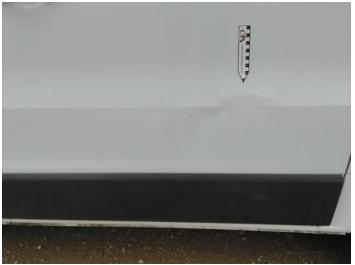
9: Door nsr Dented Between 10mm + 30mm

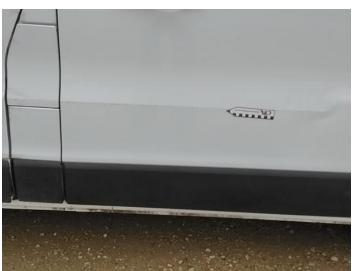
10: Door nsr Scratched Over 25mm Thru Paint

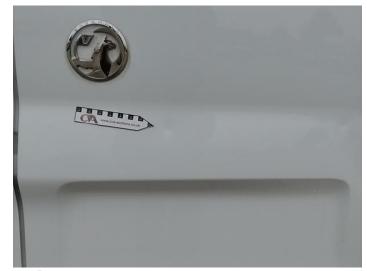
13: Door osr Dented Over 2 UpTo 10mm

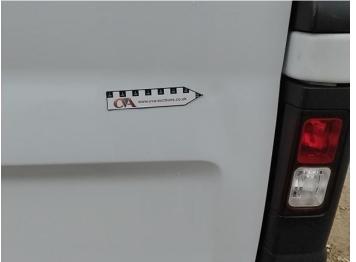
14: Door osr Dented Over 2 UpTo 10mm

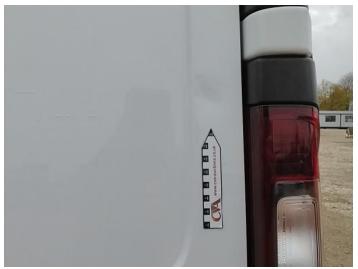
15: Door osr Dented Between 10mm + 30mm

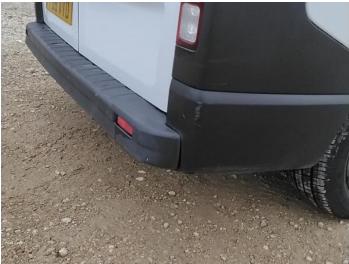
16: Bumper Rear Moulding Scuffed (Unpainted) UpTo 100mm

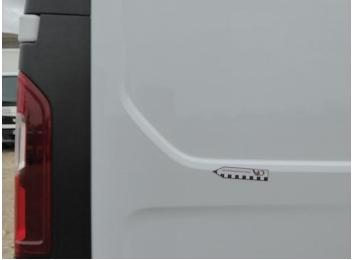
17: Qtr Panel osr Scratched Over 25mm Thru Paint

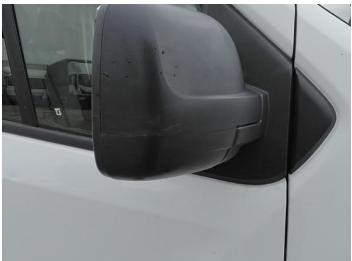
18: Door Mirror Assy osf Scuffed (Unpainted) UpTo 100mm
