# VEHICLE INSPECTION REPORT

**BJ18VZH**

## Nissan NV300 1.6 DCI 120PS

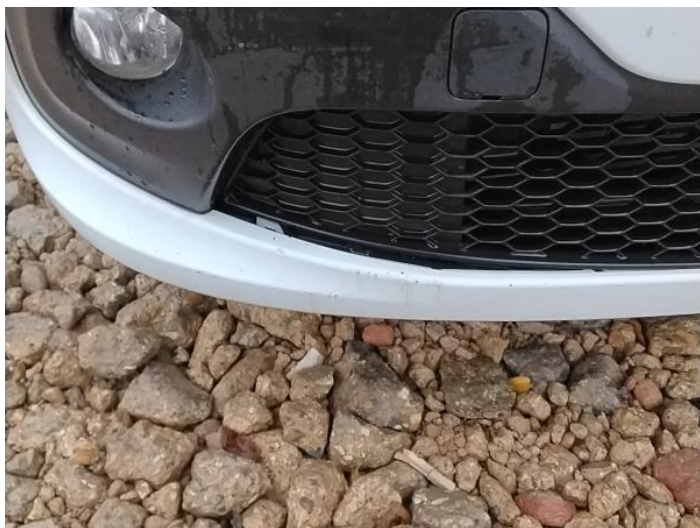
1: Grille Front  
Broken  
Replace

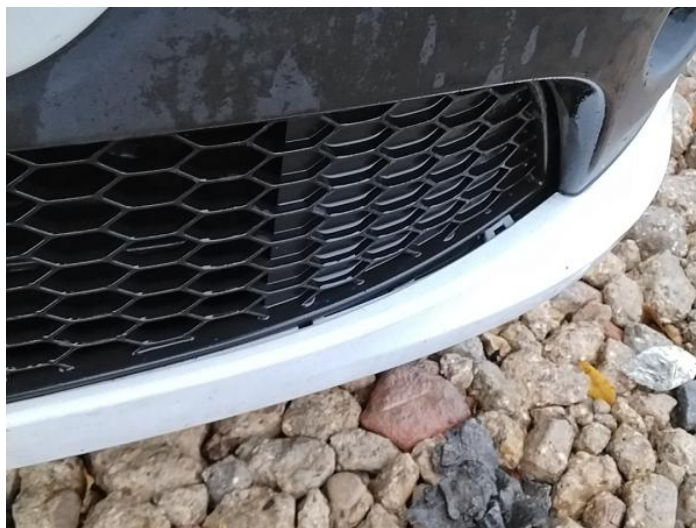
2: Grille Front  
Broken  
Replace

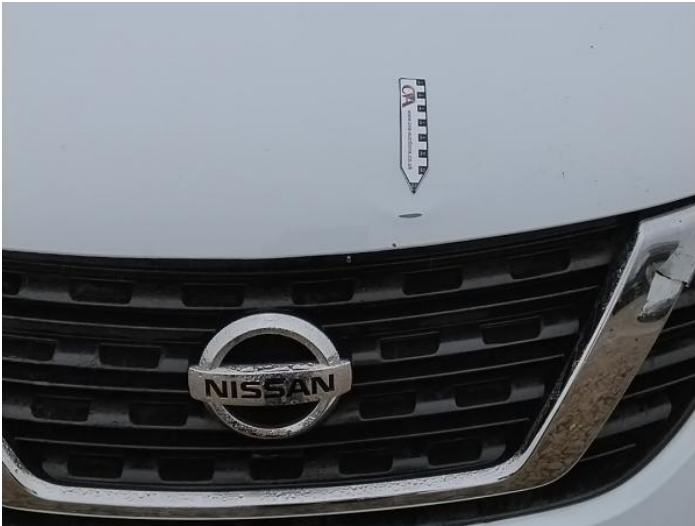
3: Bonnet  
Dented  
With Paint Damage

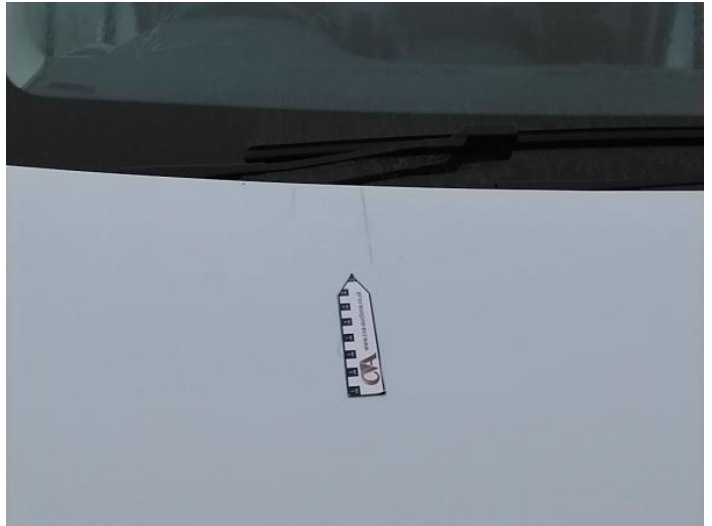
4: Bonnet  
Scratched  
Over 25mm Not Thru Paint

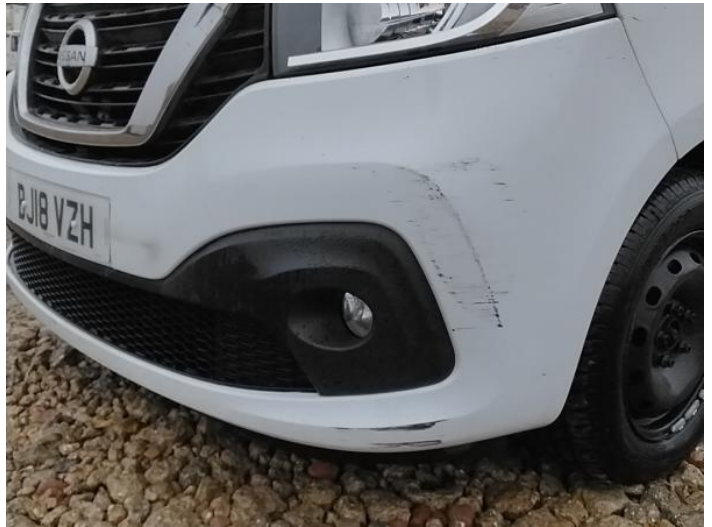
6: Bumper Front  
Scratched  
25 to 100mm Thru Paint

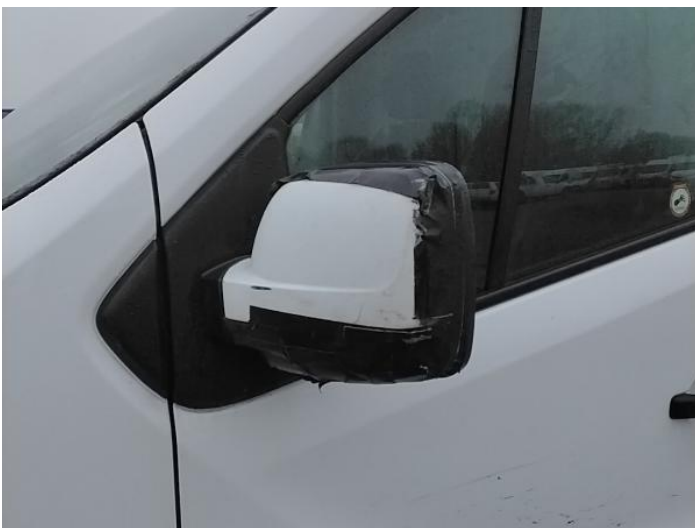
7: Door Mirror Assy nsf  
Broken  
Replace

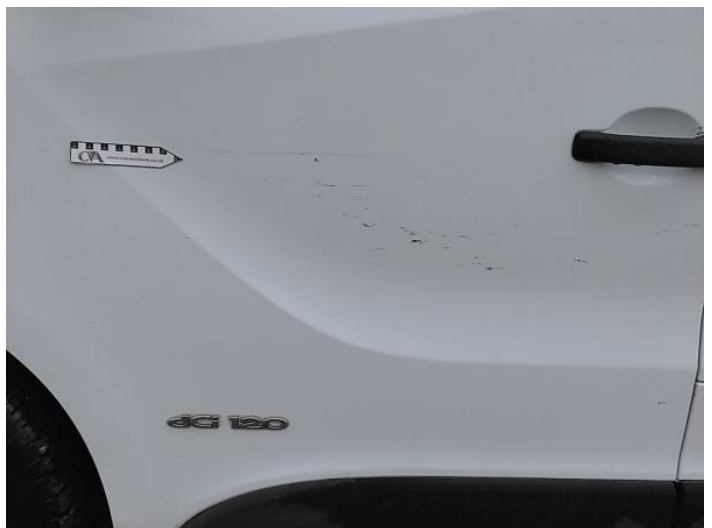
8: Door nsf  
Scratched  
Over 25mm Not Thru Paint

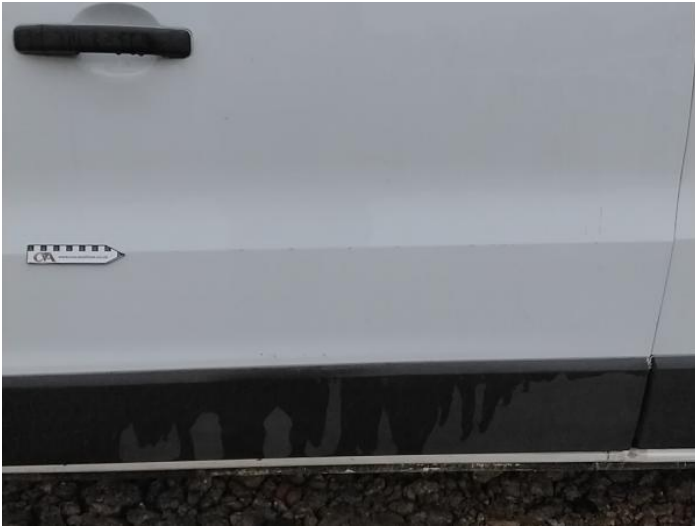
9: Door nsr  
Scratched  
Over 25mm Thru Paint

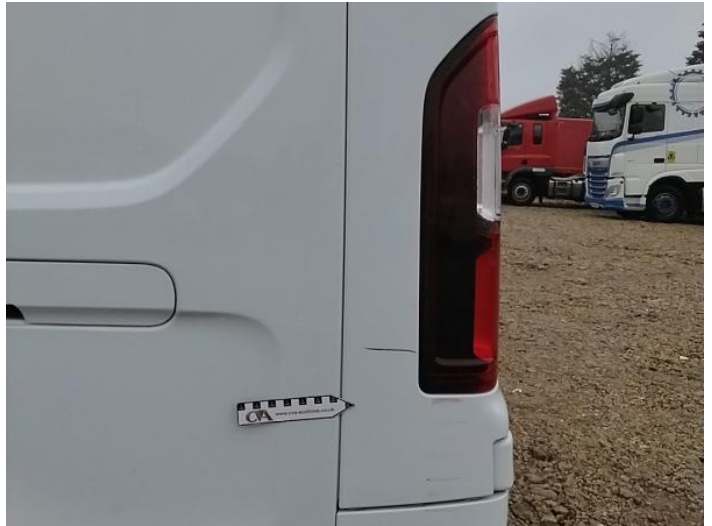
10: Qtr Panel nsr  
Scratched  
Over 25mm Not Thru Paint

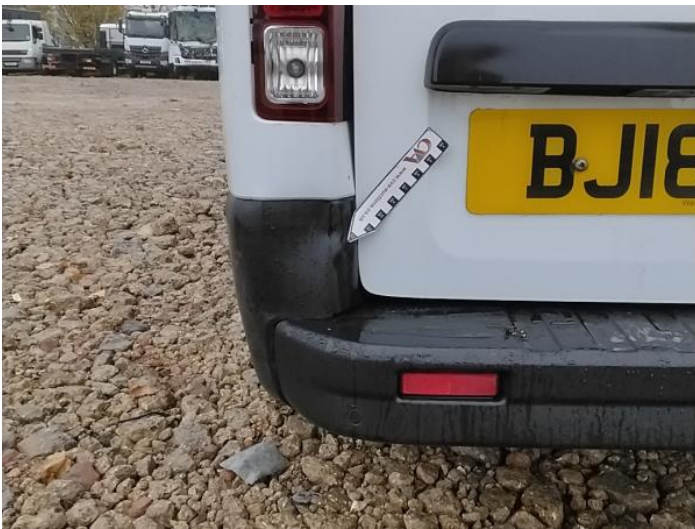
11: Bumper Rear  
Dented  
Between 10mm + 30mm

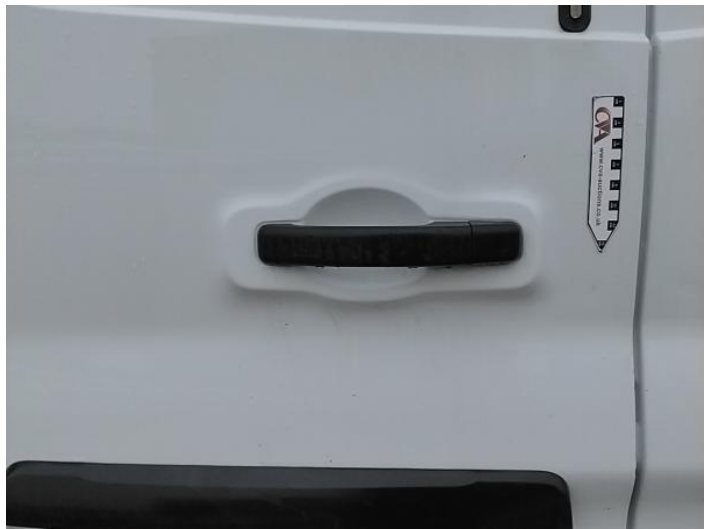
12: Door nsr  
Dented  
2 Or Less UpTo 10mm

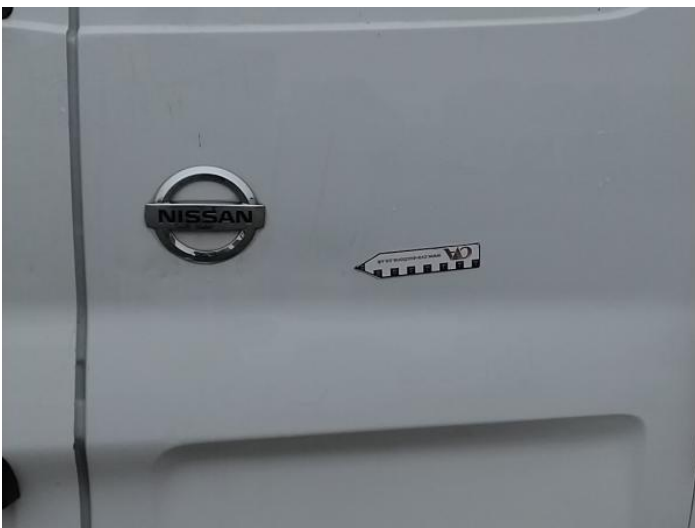
13: Door osr  
Dented  
Between 10mm + 30mm

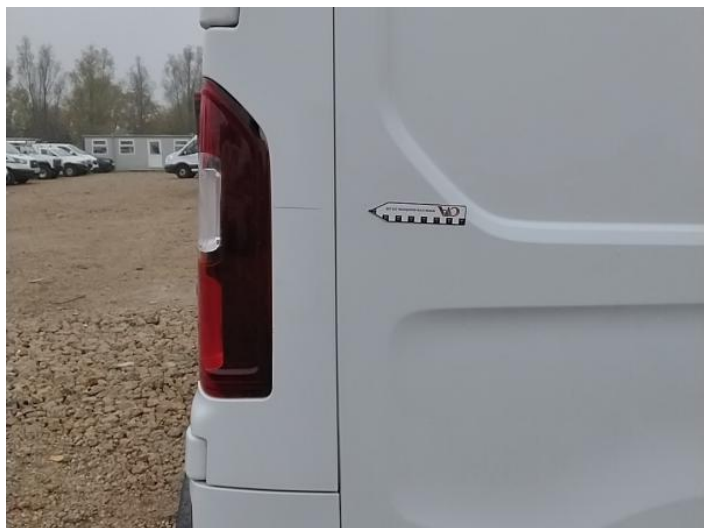
14: Qtr Panel osr  
Scratched  
UpTo 25mm Not Thru Paint

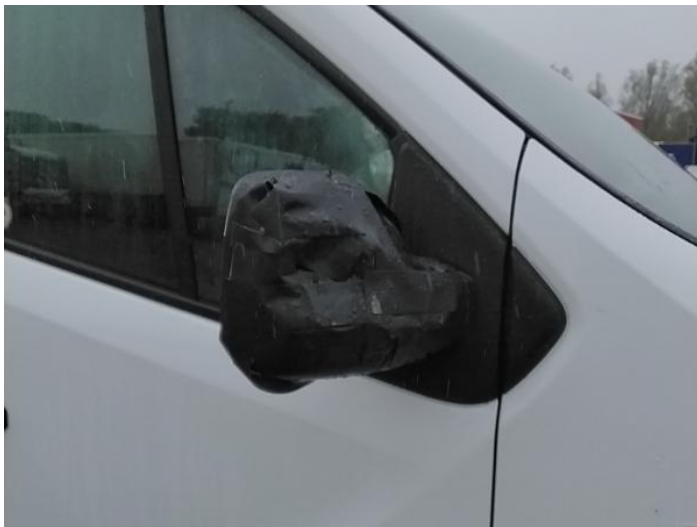
15: Door Mirror Assy osf  
Broken  
Replace

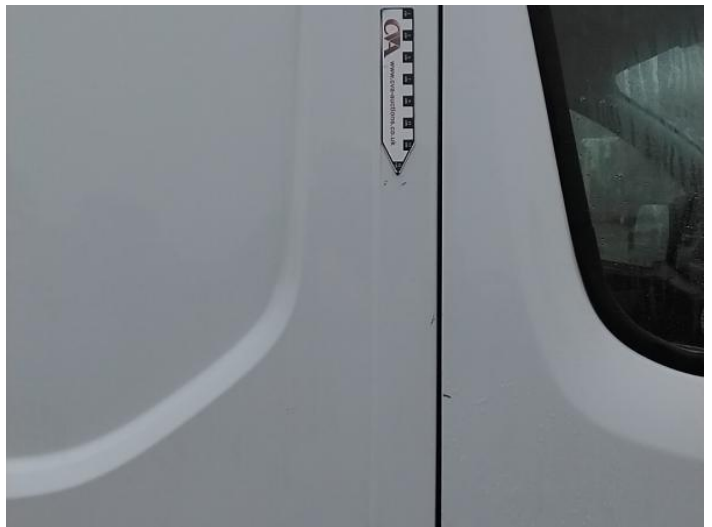
16: B Post os  
Scratched  
UpTo 25mm Thru Paint
