VEHICLE INSPECTION REPORT

WX17KFU

Isuzu D-Max 2.5TD

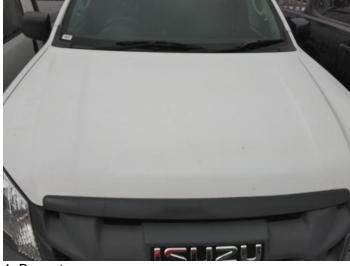
1: Bonnet Chipped Multiple Chips

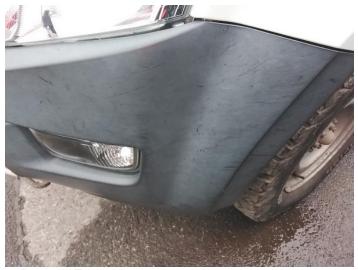
2: Bumper Front Scratched Over 100mm Thru Paint

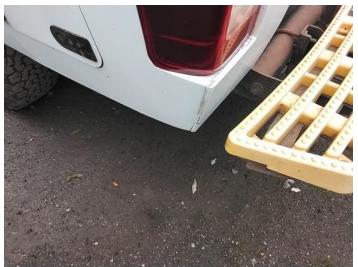
3: Qtr Panel nsr Cracked Replace

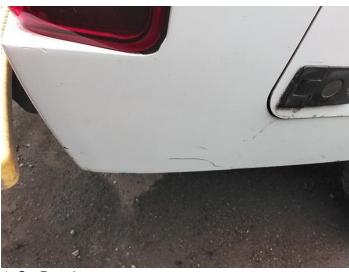
4: Qtr Panel osr Scratched Over 25mm Thru Paint

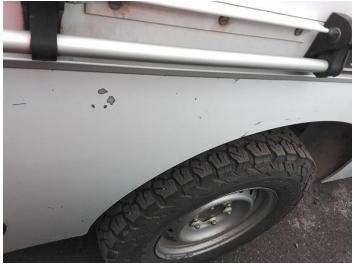
5: Qtr Panel osr Chipped Multiple Chips

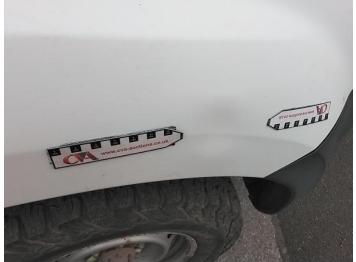
6: Wing osf Dented Over 30mm

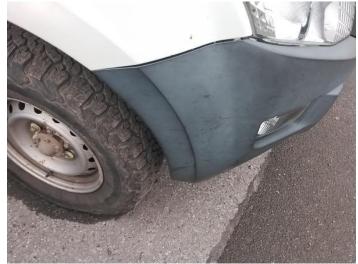
7: Bumper Front Scratched Over 100mm Thru Paint

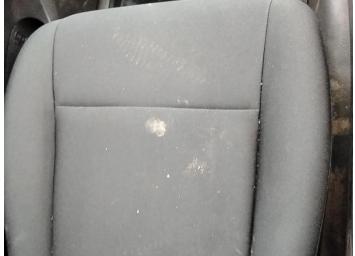
8: Seat Base Cover nsf Soiled Heavy

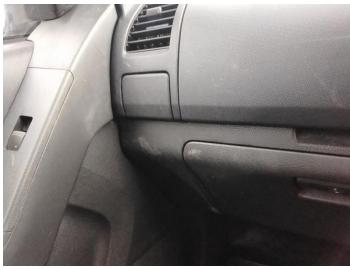
9: Fascia Panel Soiled Heavy
