# VEHICLE INSPECTION REPORT

**WX66HZD**

## Isuzu D-Max 2.5TD

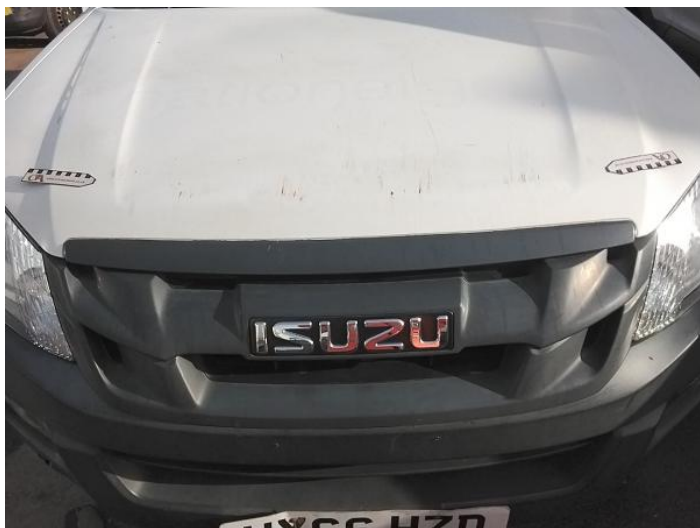
1: Bonnet  
Dented  
With Paint Damage

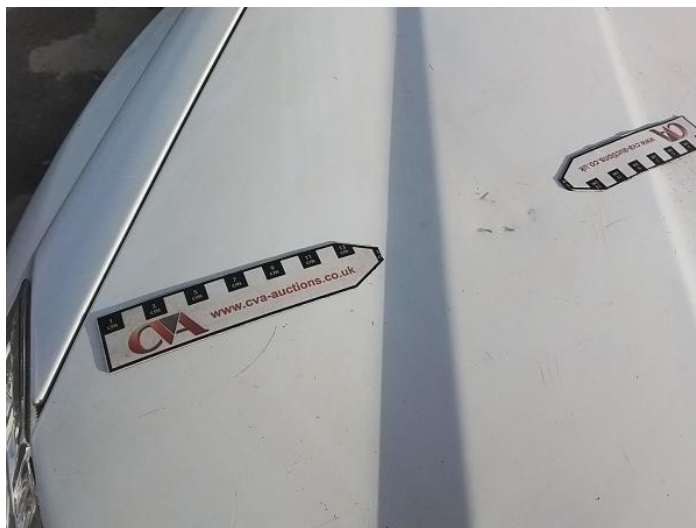
2: Bonnet  
Dented  
With Paint Damage

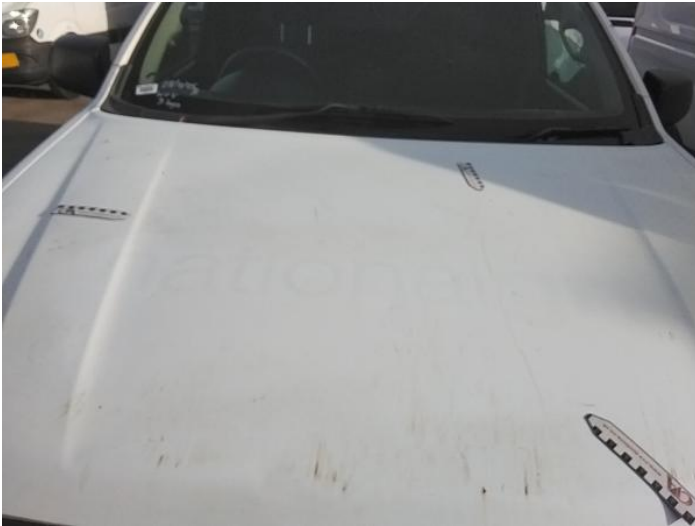
3: Bonnet  
Scratched  
Over 25mm Thru Paint

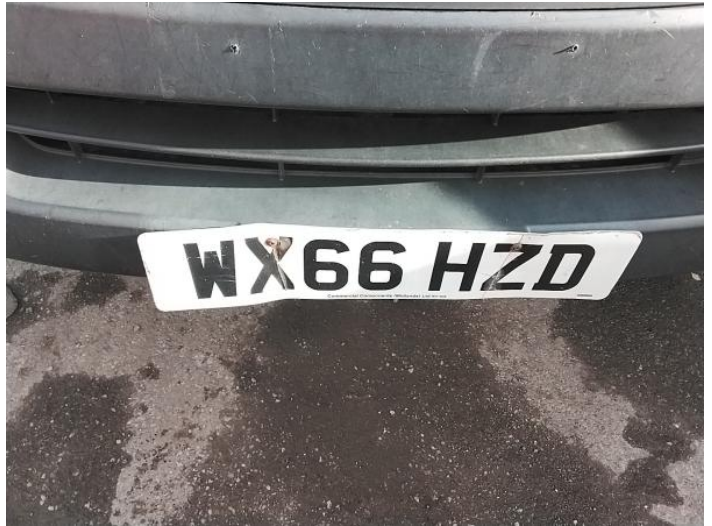
4: Number Plate Front  
Broken  
Replace

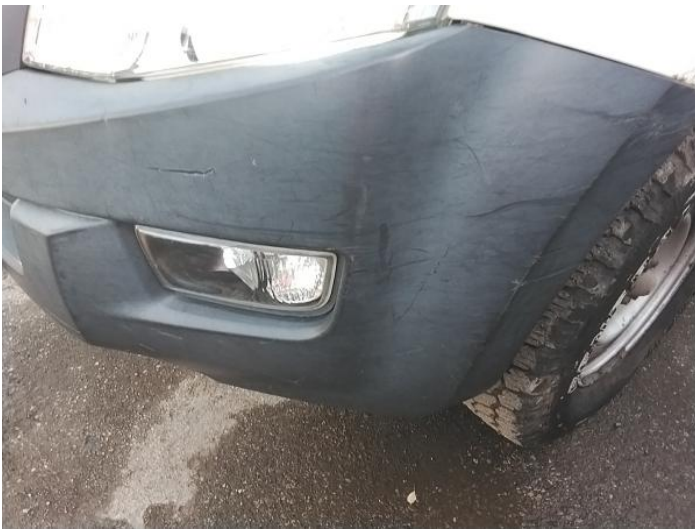
5: Bumper Front  
Scratched  
Over 100mm Thru Paint

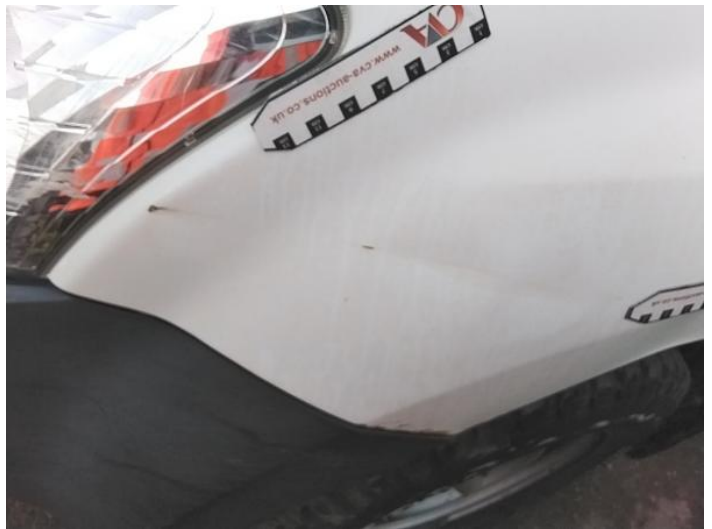
6: Wing nsf  
Dented  
With Paint Damage

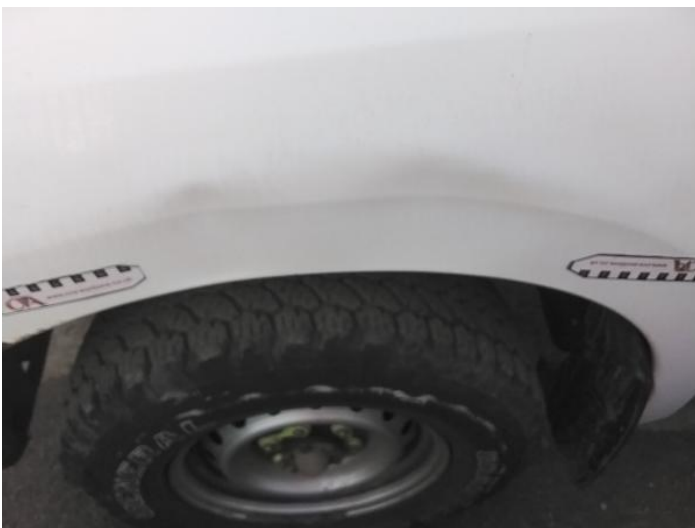
7: Wing nsf  
Dented  
Over 30mm

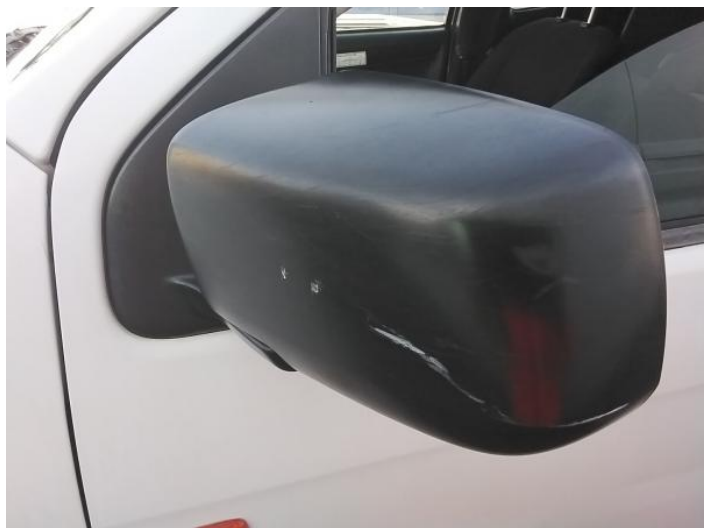
8: Door Mirror Assy nsf  
Scuffed (Unpainted)  
Over 100mm

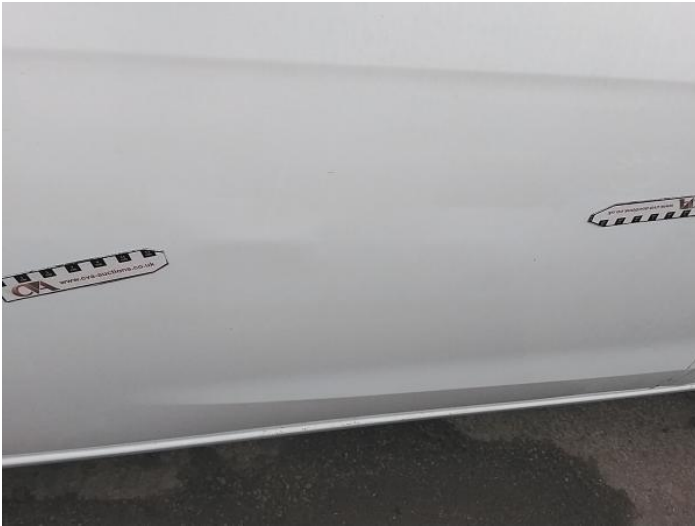
9: Door nsf  
Dented  
Over 30mm

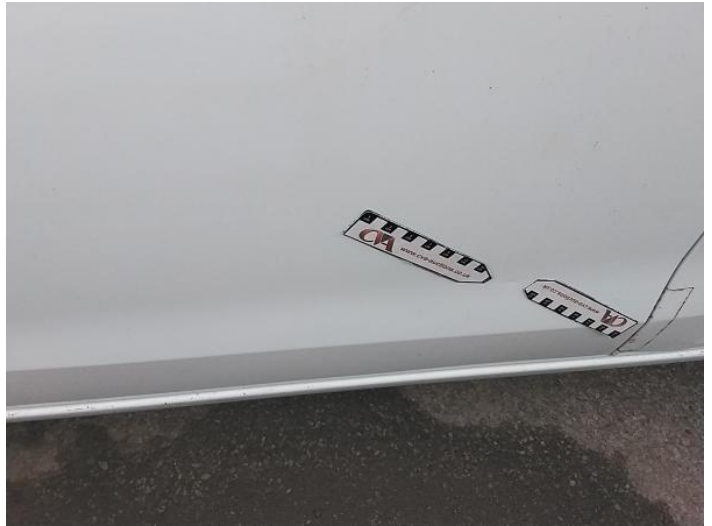
10: Door nsf  
Dented  
With Paint Damage

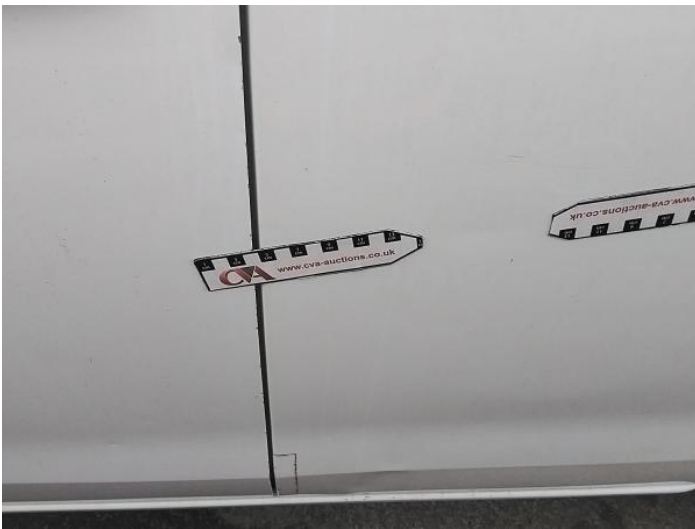
11: Qtr Panel nsr  
Dented  
Over 30mm

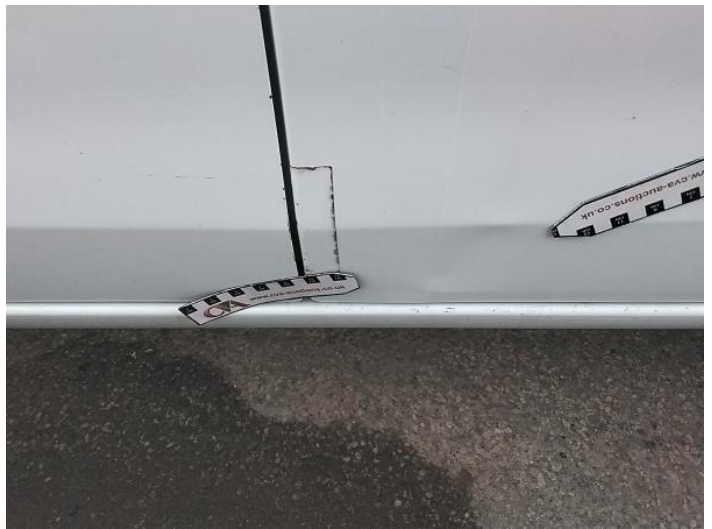
12: Qtr Panel nsr  
Dented  
With Paint Damage

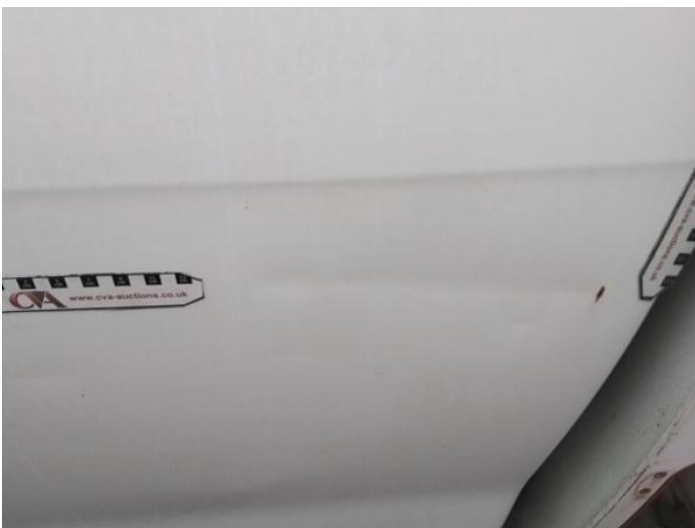
13: Qtr Panel nsr  
Dented  
With Paint Damage

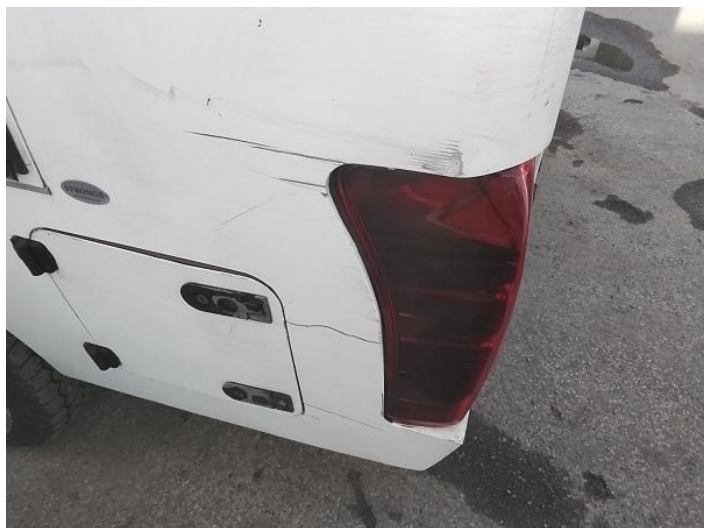
14: Qtr Panel nsr  
Scratched  
Over 25mm Thru Paint

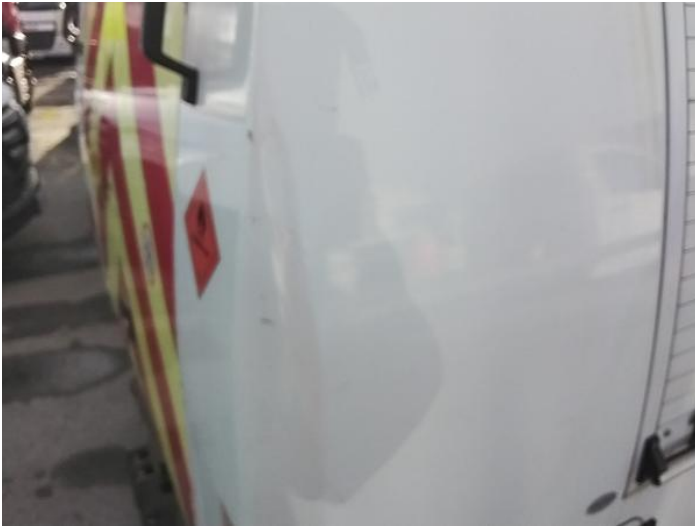
15: Qtr Panel osr  
Scratched  
Over 25mm Thru Paint

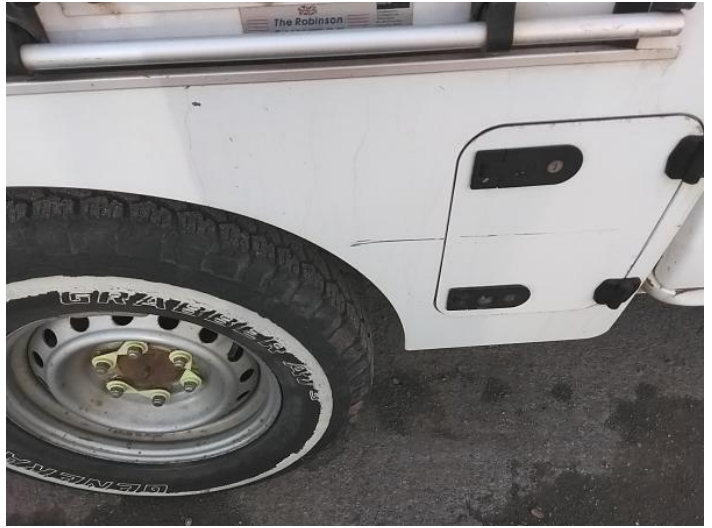
16: Qtr Panel osr  
Dented  
With Paint Damage

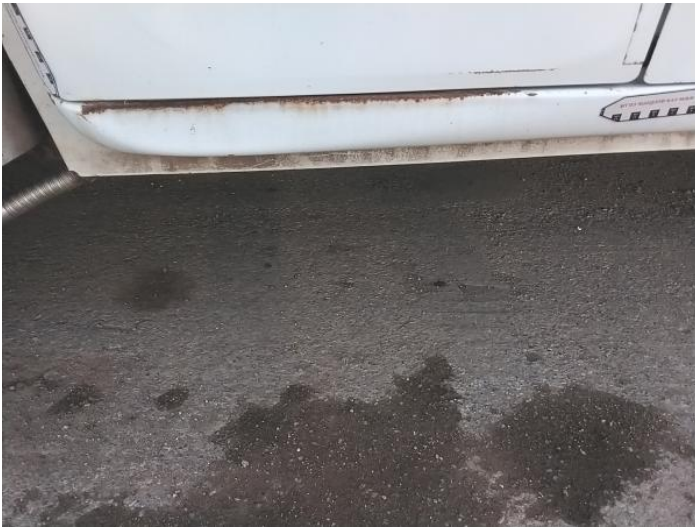
17: Sill os  
Dented  
With Paint Damage

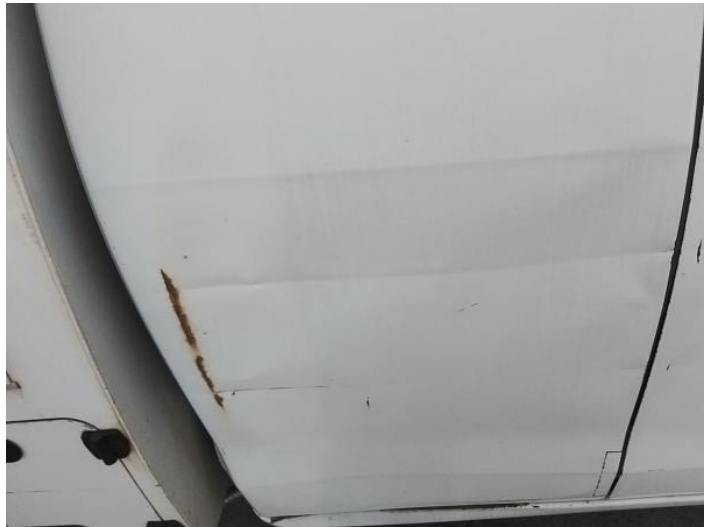
18: Qtr Panel osr  
Dented  
Over 30% Of Panel

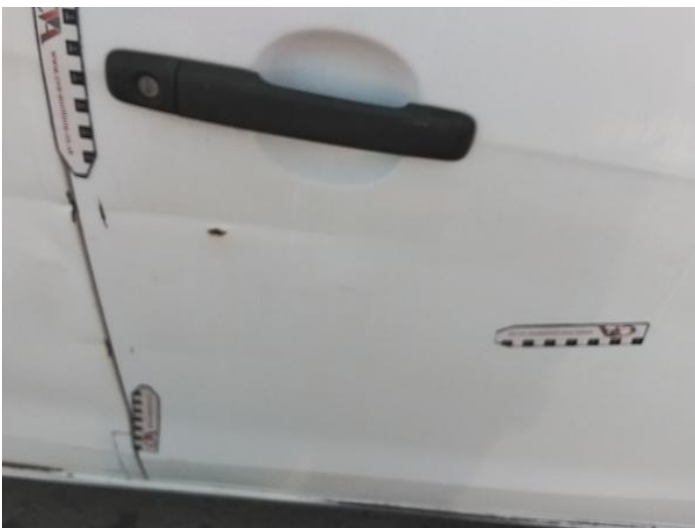
19: Door osf  
Dented  
With Paint Damage

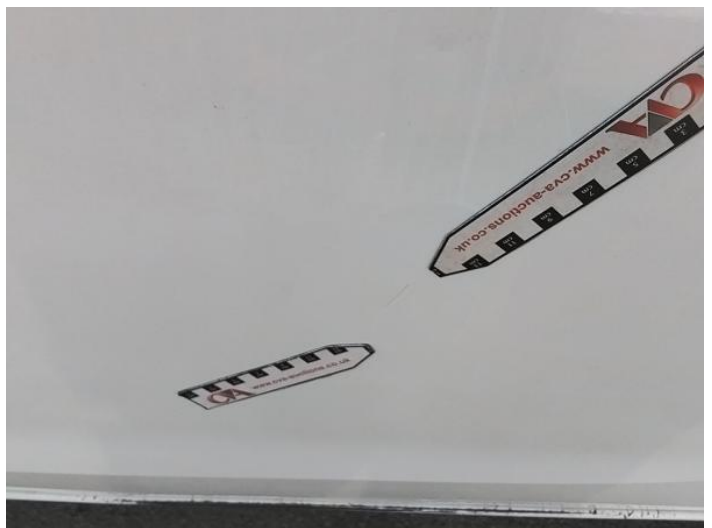
20: Door osf  
Dented  
With Paint Damage

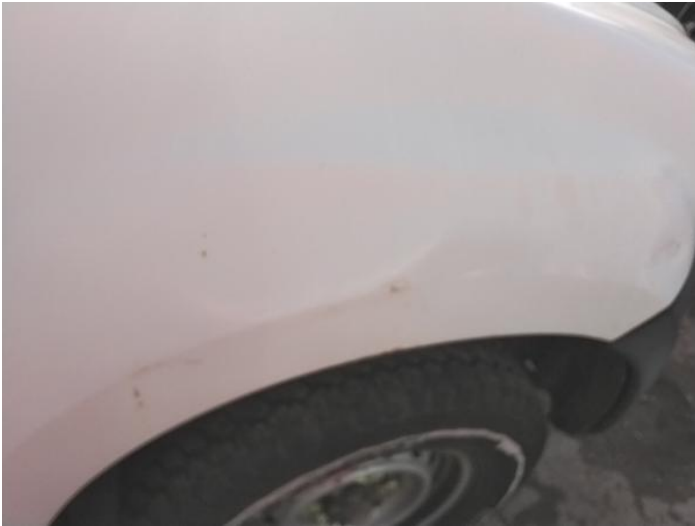
21: Wing osf  
Dented  
Over 30% Of Panel

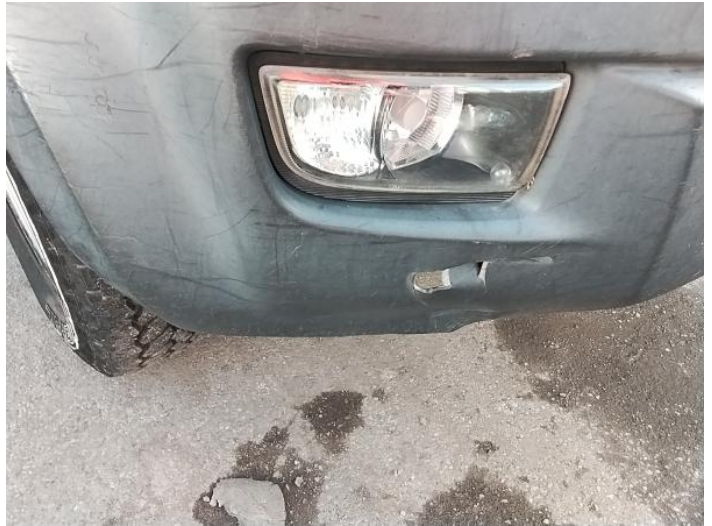
22: Bumper Front  
Hole  
Over 25mm

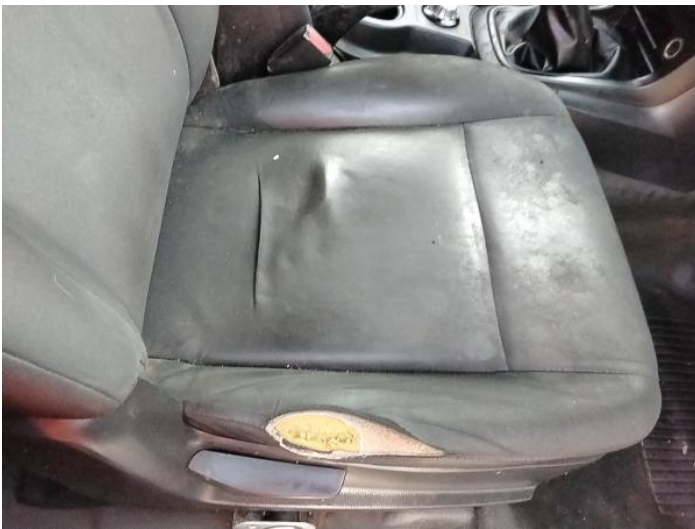
23: Seat Base Cover osf  
Holed  
Over 3mm

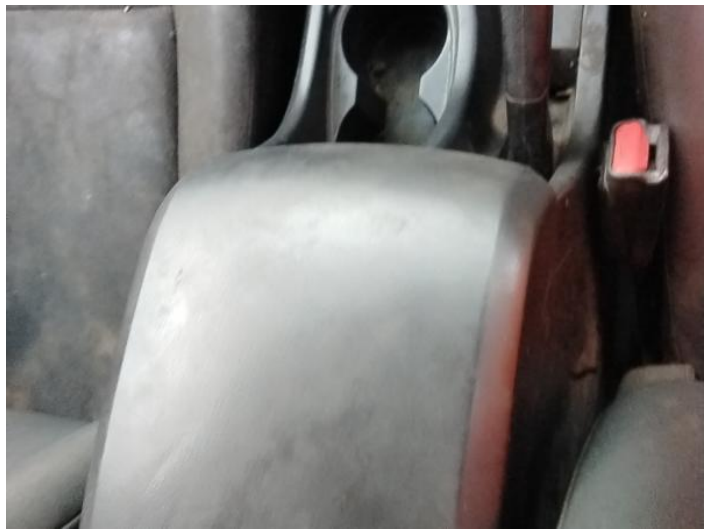
24: Fascia Panel  
Soiled  
Heavy

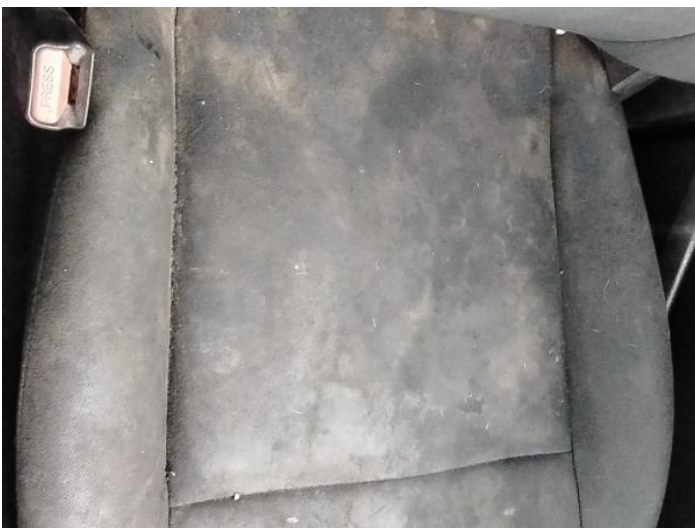
25: Seat Base Cover nsf  
Soiled  
Heavy

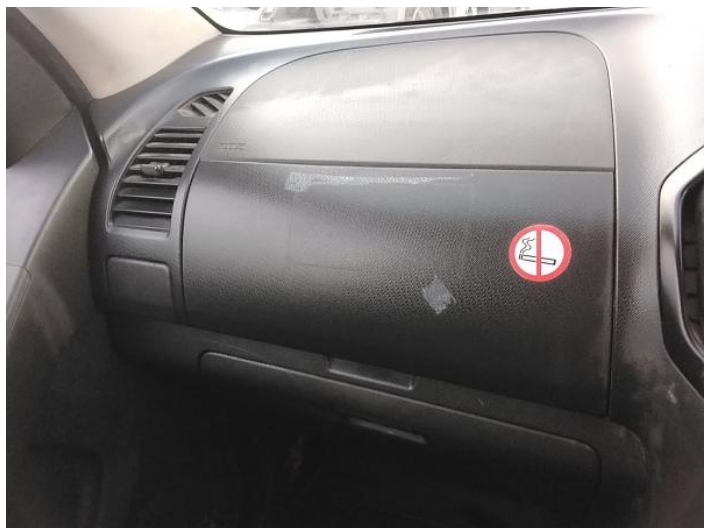
26: Fascia Panel  
Scuffed  
Over 25mm

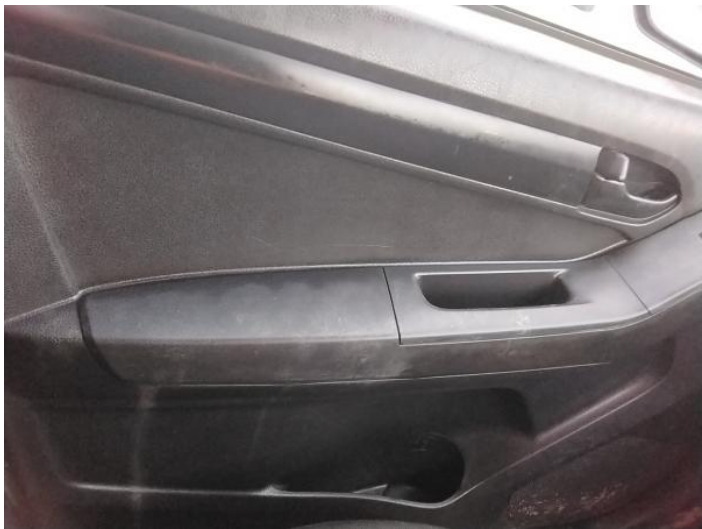
27: Door Pad nsf  
Soiled  
Heavy
