# VEHICLE INSPECTION REPORT

**BX59DFY**

## Daf LF 45.160

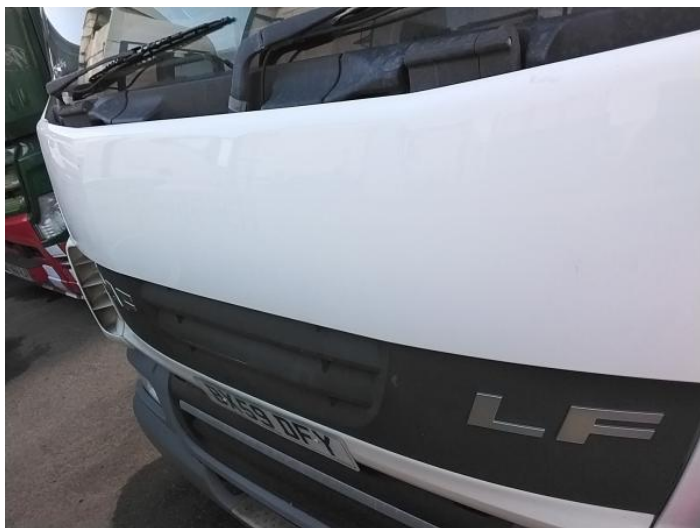
1: Bonnet  
Chipped  
Multiple Chips

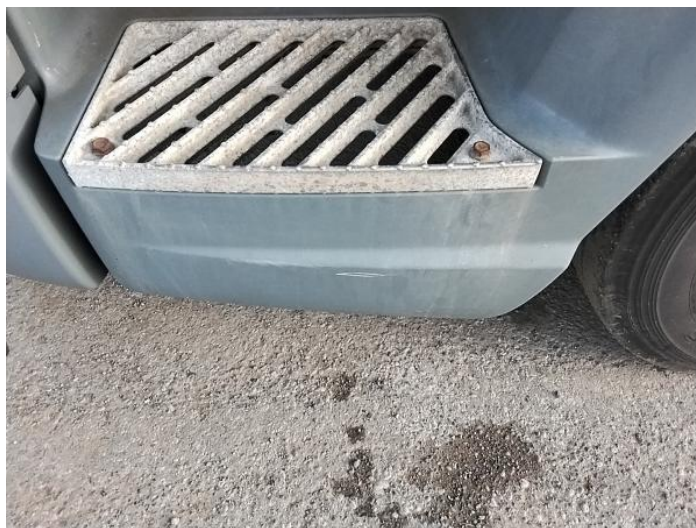
2: Bumper Front Moulding  
Scuffed (Unpainted)  
UpTo 100mm

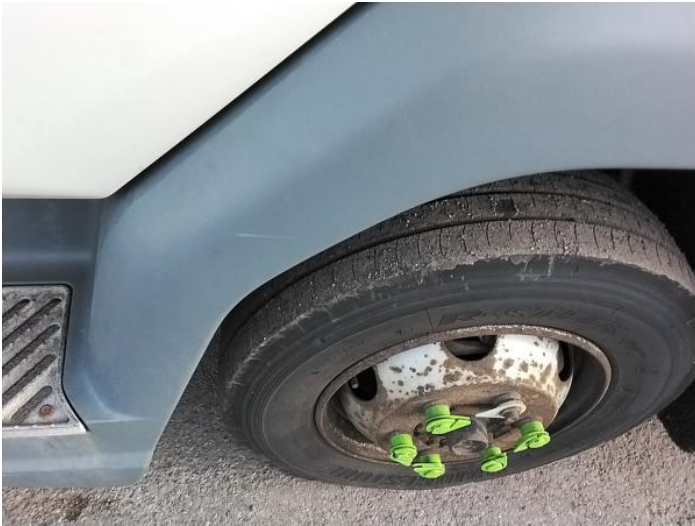
3: Wing nsf  
Scratched  
Over 25mm Thru Paint

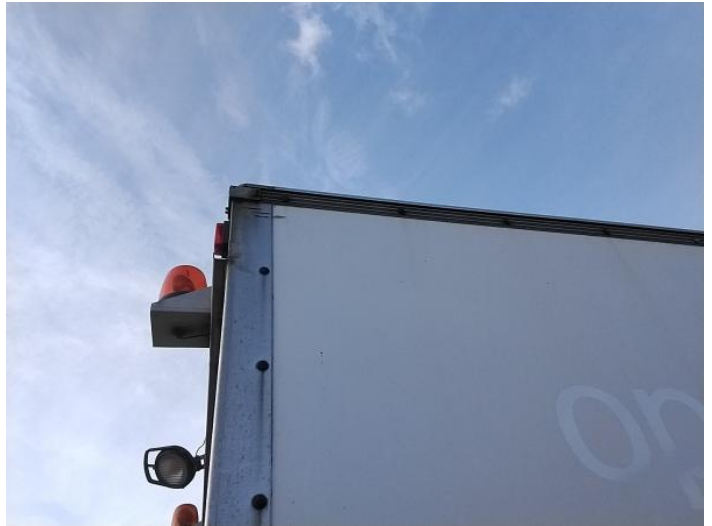
4: Qtr Panel osr  
Scratched  
Over 25mm Thru Paint

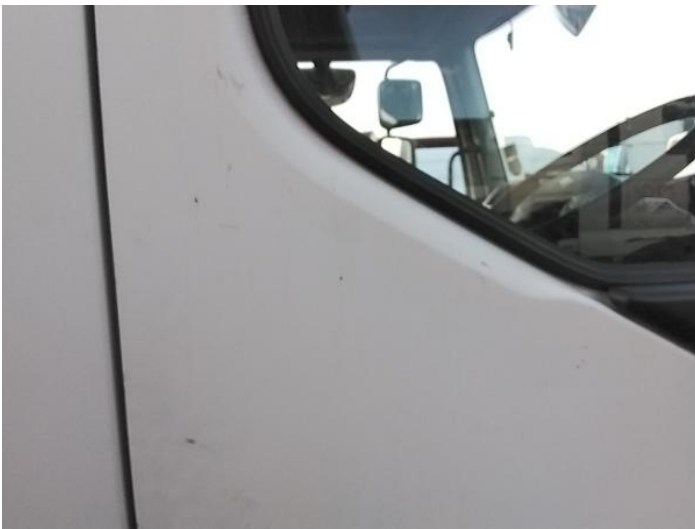
5: Door osf  
Chipped  
Multiple Chips

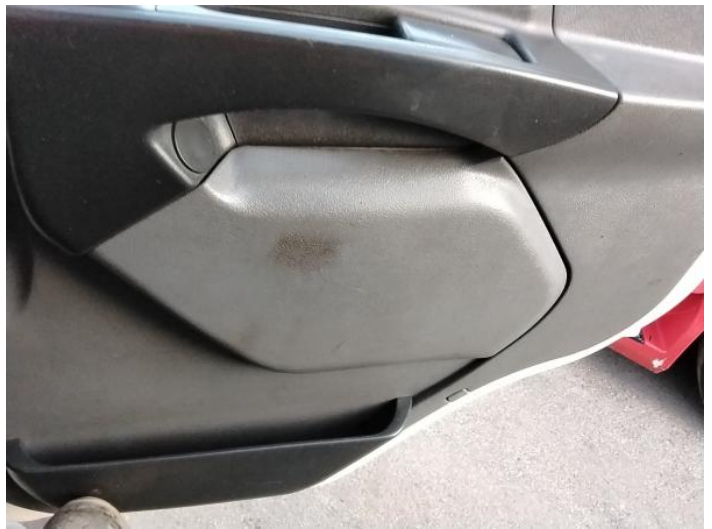
6: Door Pad osf  
Soiled  
Heavy

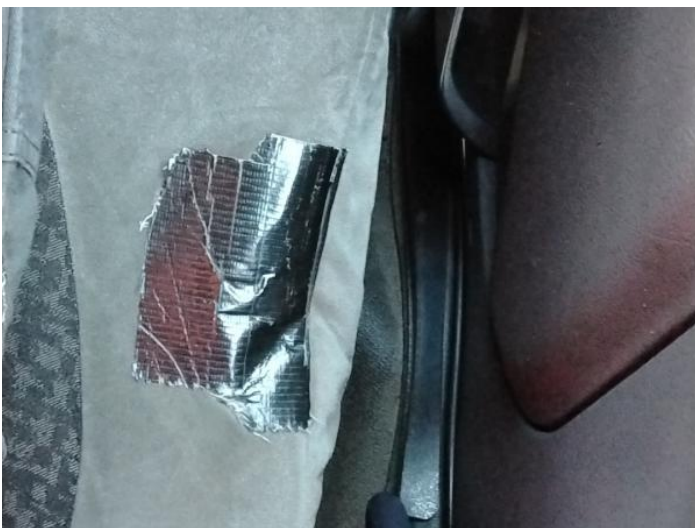
7: Seat Base Cover osf  
Holed  
Over 3mm

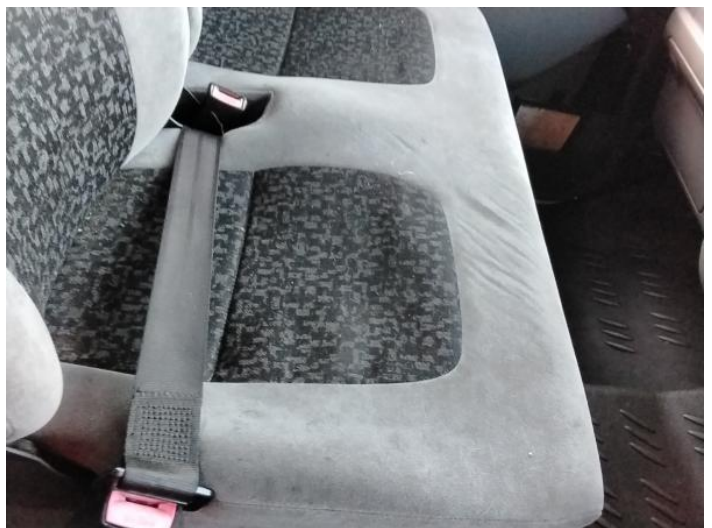
8: Seat Base Cover nsf  
Soiled  
Heavy
