# VEHICLE INSPECTION REPORT

**FP69ZCK**

## Vauxhall Vivaro 2900 1.5D 100PS

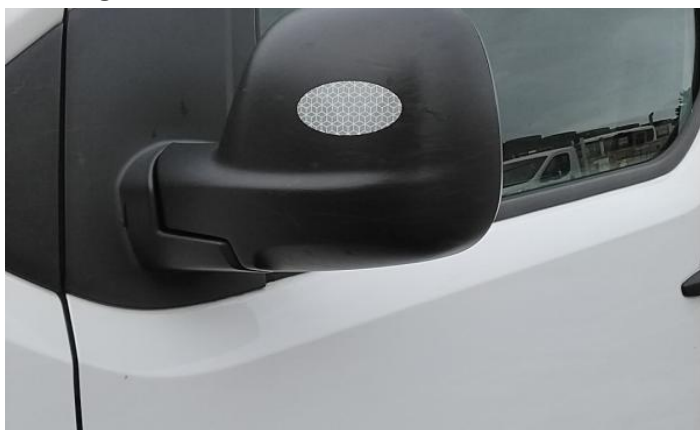
1: Door Moulding nsf  
Scuffed (Unpainted)  
UpTo 100mm

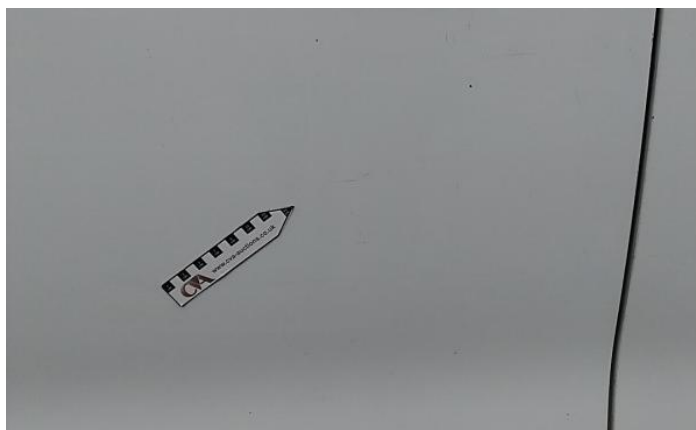
2: Door nsf  
Scratched  
Over 25mm Thru Paint

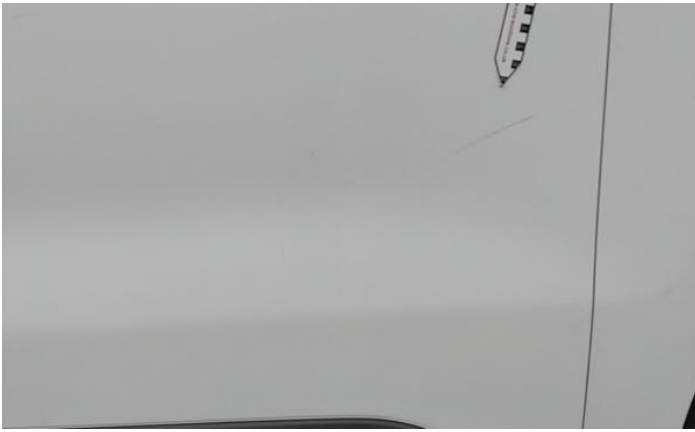
3: Door nsr  
Scratched  
Over 25mm Not Thru Paint

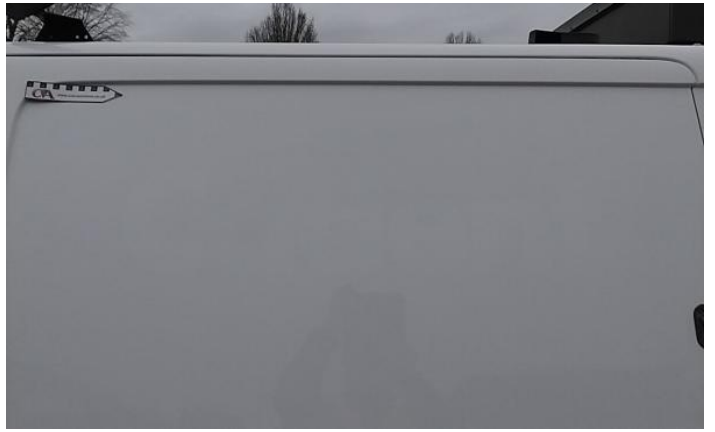
4: Door nsr  
Scratched  
Over 25mm Not Thru Paint

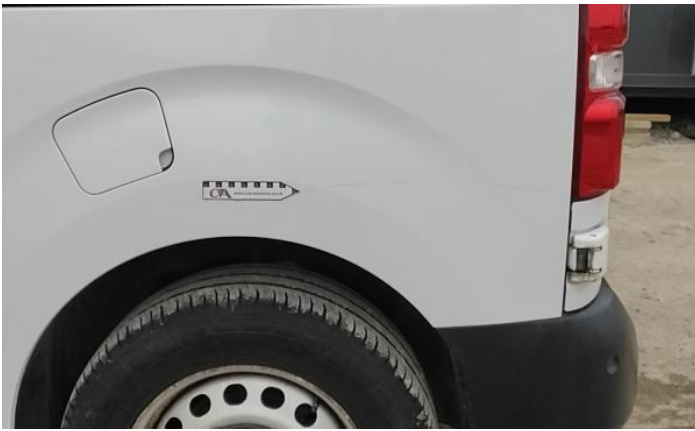
5: Qtr Panel nsr  
Scratched  
Over 25mm Not Thru Paint

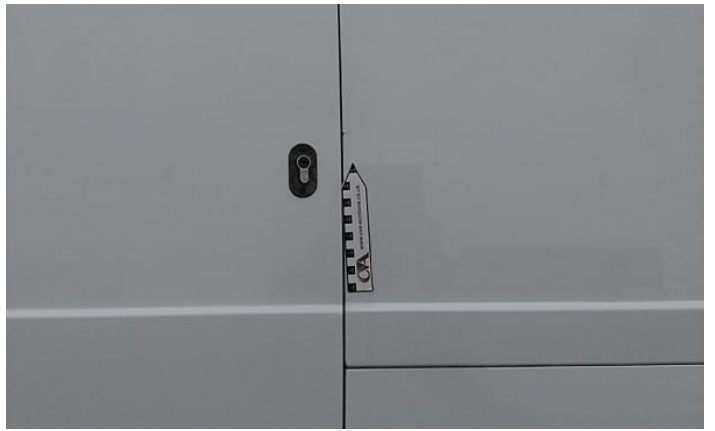
6: Qtr Panel nsr  
Dented  
With Paint Damage

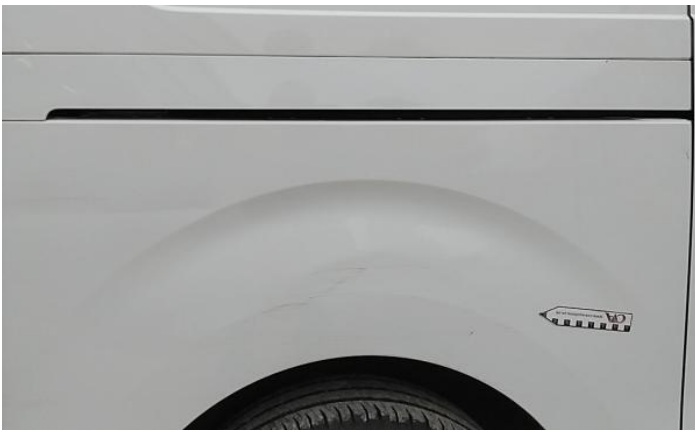
7: Qtr Panel osr  
Scratched  
Over 25mm Thru Paint

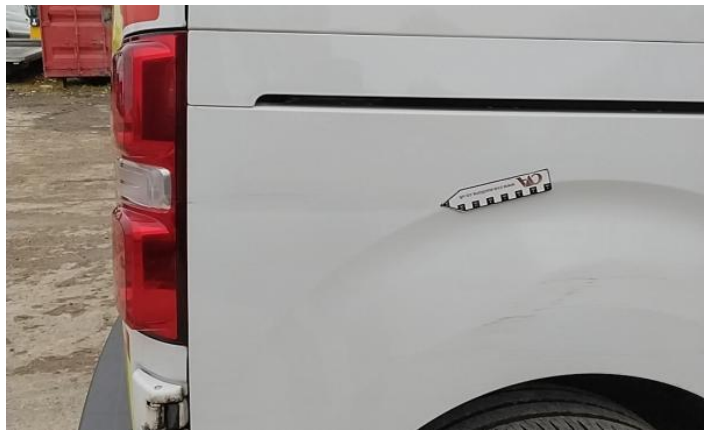
8: Qtr Panel osr  
Dented  
Over 30mm

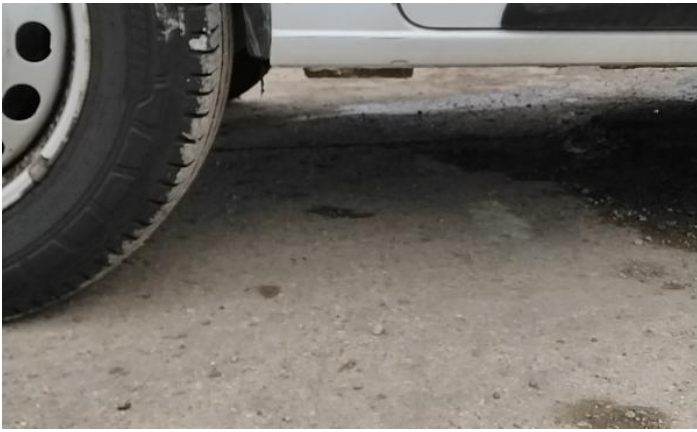
9: Qtr Panel osr  
Dented  
With Paint Damage

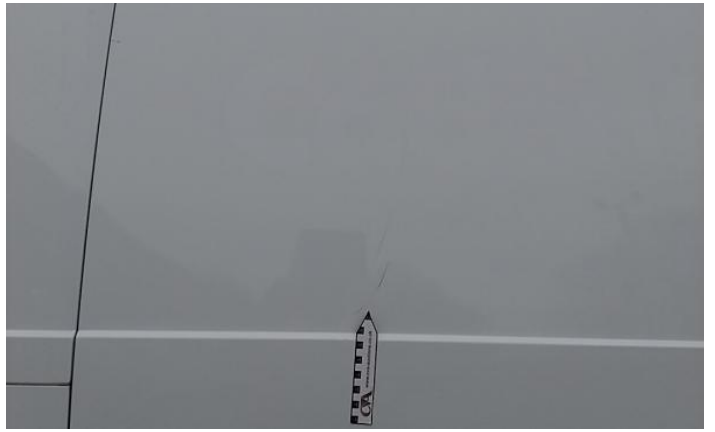
10: Qtr Panel osr  
Scratched  
Over 25mm Not Thru Paint

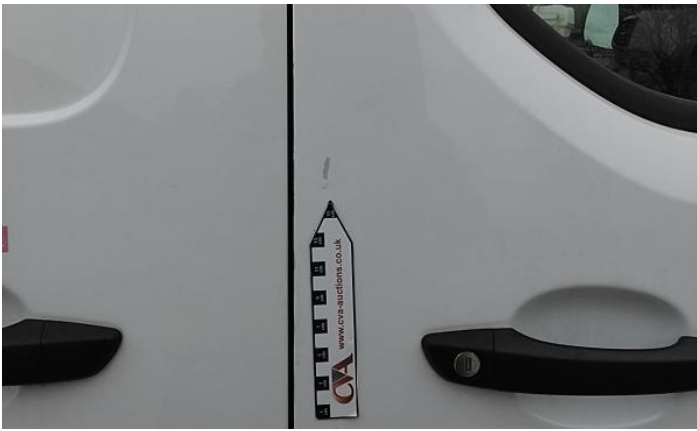
11: Door osf  
Dented  
With Paint Damage

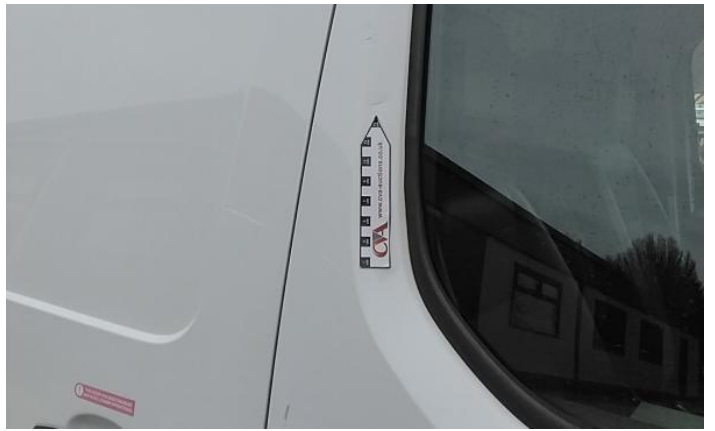
12: Door osf  
Dented  
Over 2 UpTo 10mm

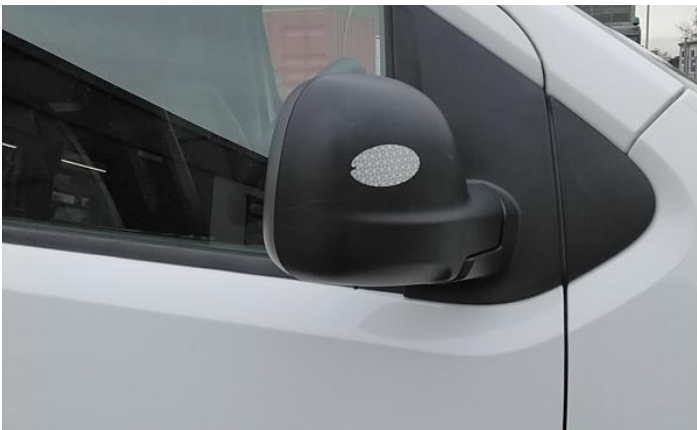
13: Door Mirror Assy osf  
Scuffed (Unpainted)  
UpTo 100mm
