## VEHICLE INSPECTION REPORT

**PO70ZFY**

### Mitsubishi L200 DI-D 2.3 Barbarian X 150PS

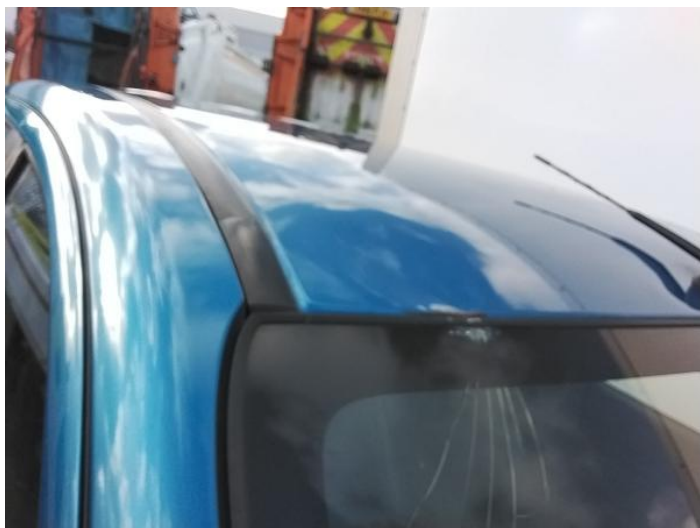
1: Roof  
Dented  
With Paint Damage

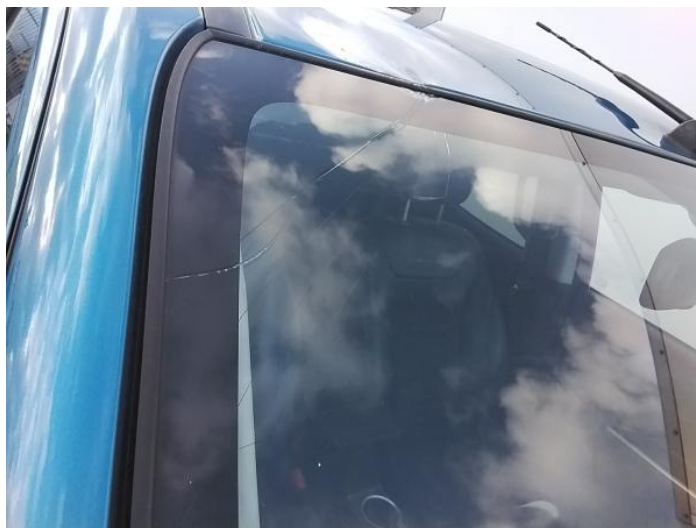
\*CRACK IN WINDSCREEN, WARNING LIGHT ON DASH\* AD-BLUE, TWIN SIDE LOAD DOOR, E/ MORRORS, HEATED SEATS

2: Screen Front  
Cracked  
Replace

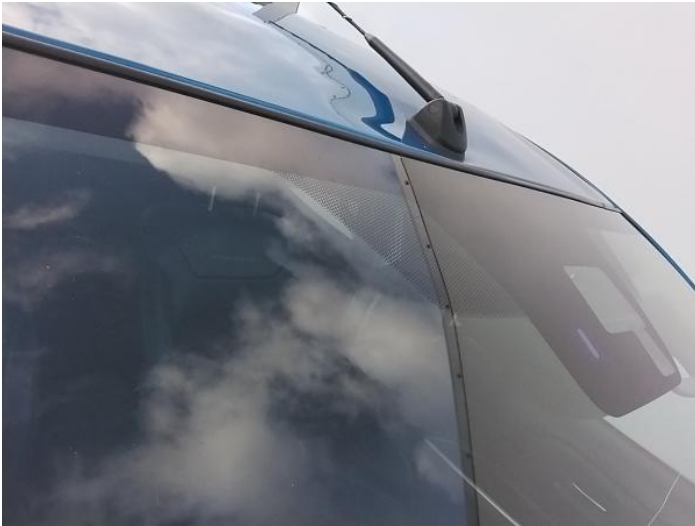
3: Roof  
Dented  
Over 30mm

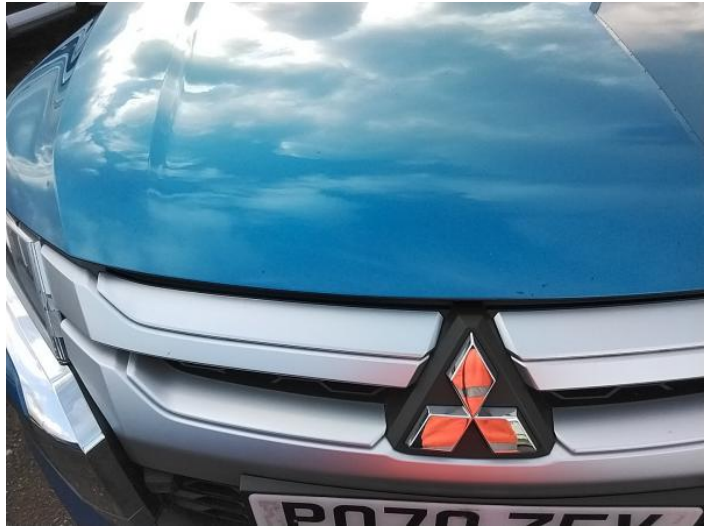
4: Bonnet  
Poor Previous Repair  
Poor Colour

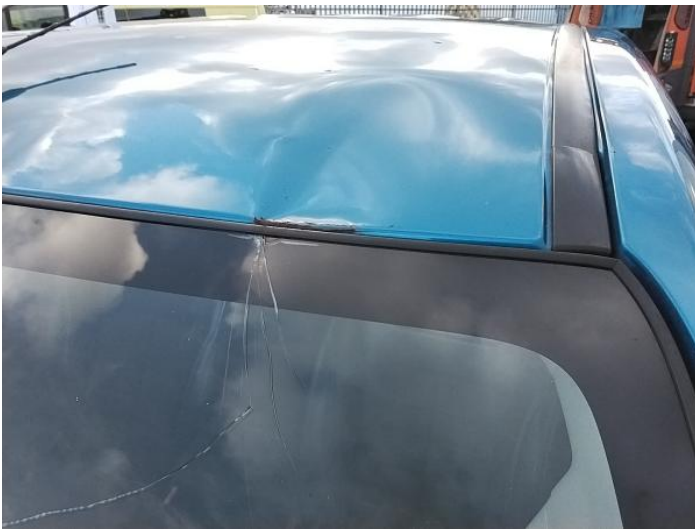
5: Roof  
Dented  
With Paint Damage

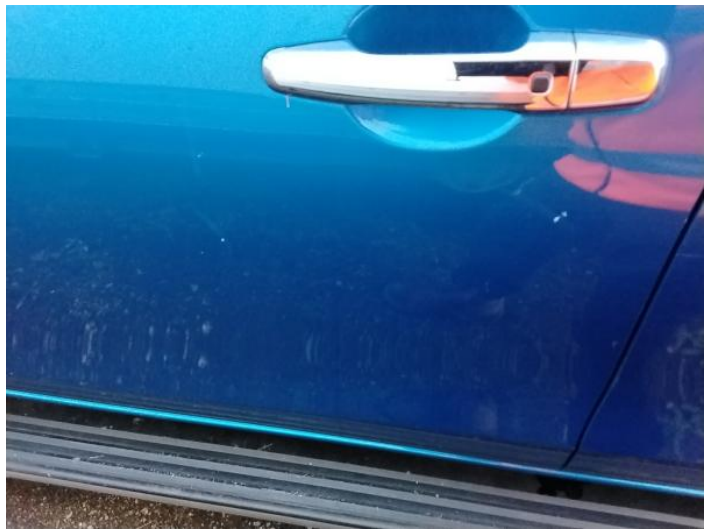
6: Door nsf  
Chipped  
Multiple Chips

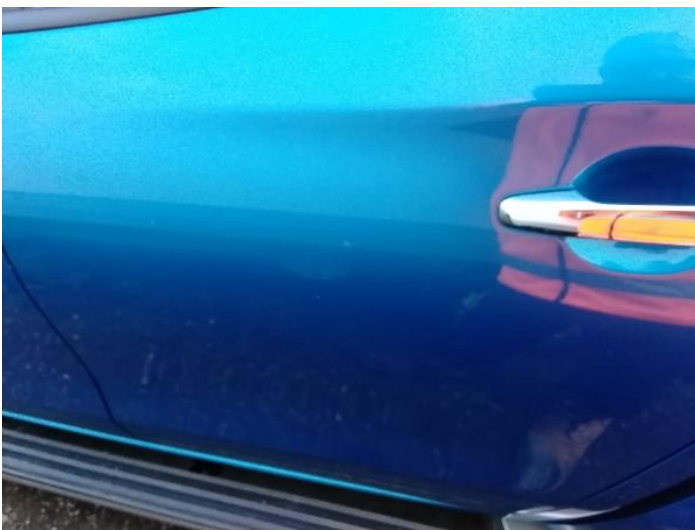
7: Door nsr  
Chipped  
Multiple Chips

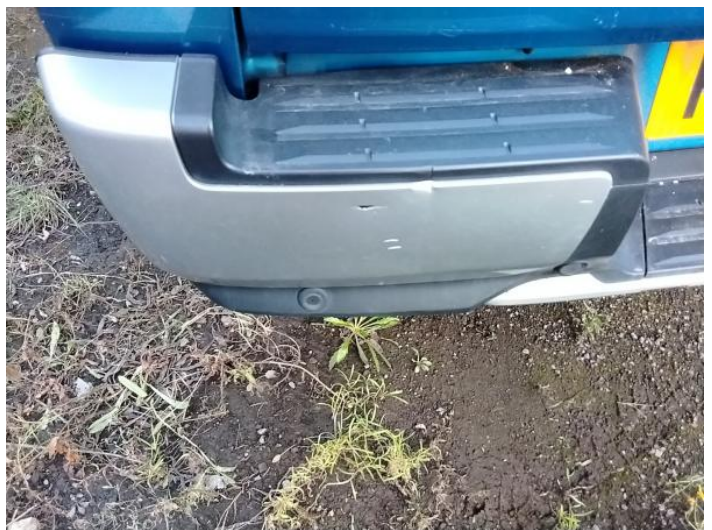
8: Bumper Rear Moulding  
Broken  
Replace

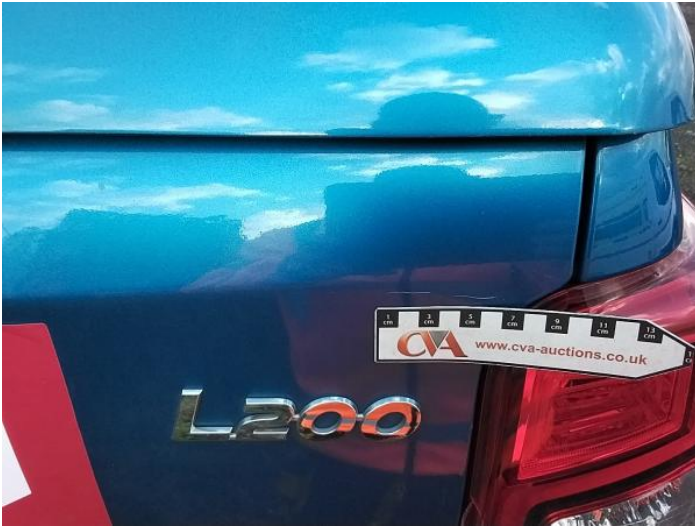
9: Tailgate  
 Scratched  
 Over 25mm Thru Paint

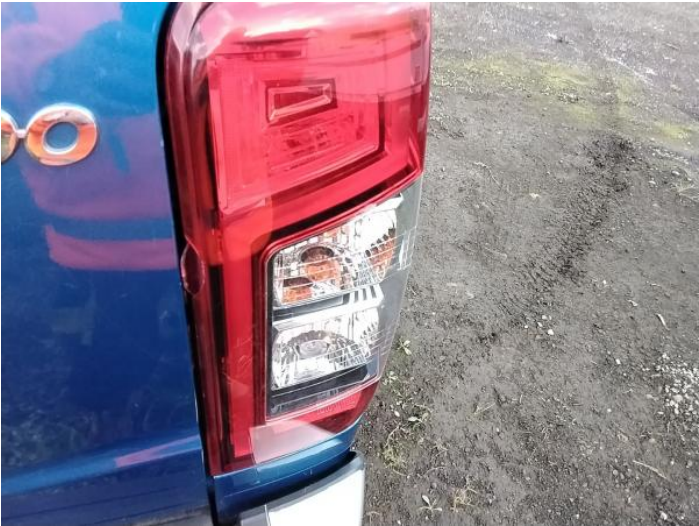
10: Lamp osr  
 Broken  
 Replace

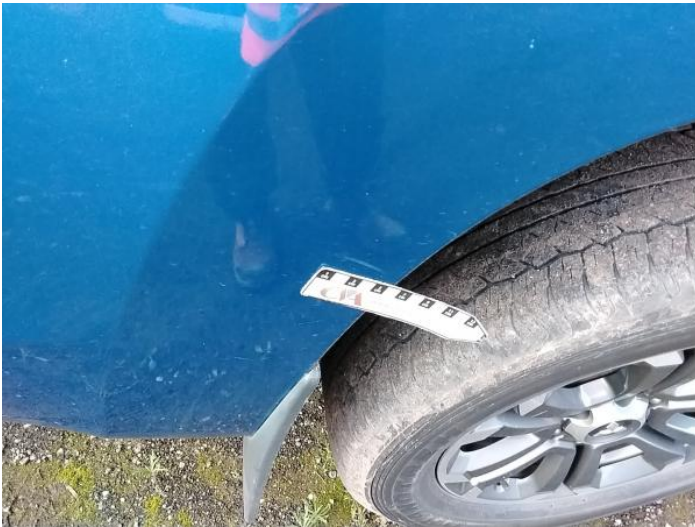
11: Qtr Panel osr  
 Scratched  
 Over 25mm Thru Paint

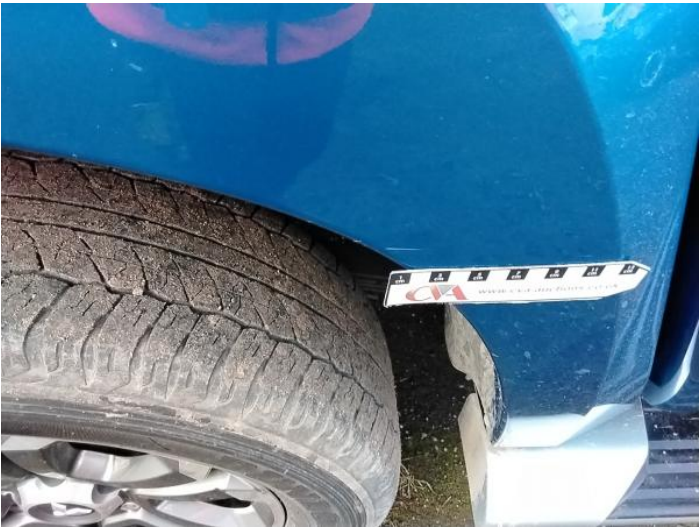
12: Qtr Panel osr  
 Scratched  
 Over 25mm Thru Paint

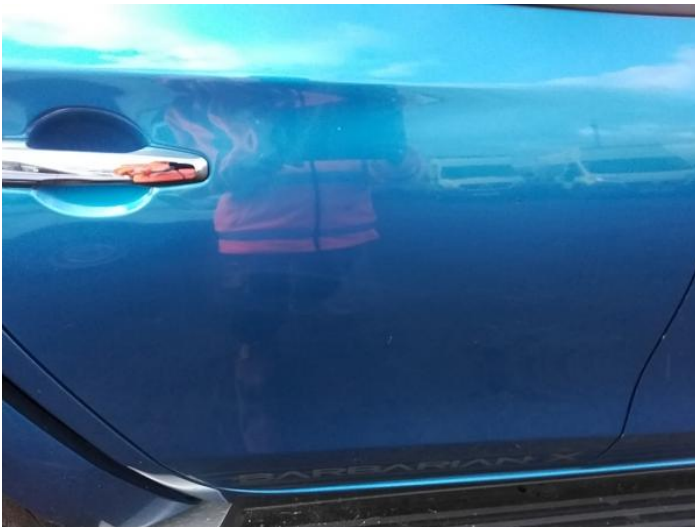
13: Door osr  
 Chipped  
 Multiple Chips

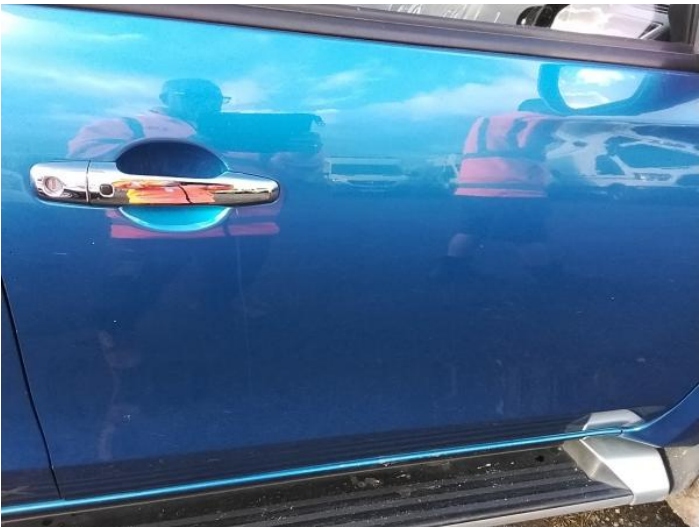
14: Door osf  
 Chipped  
 Multiple Chips

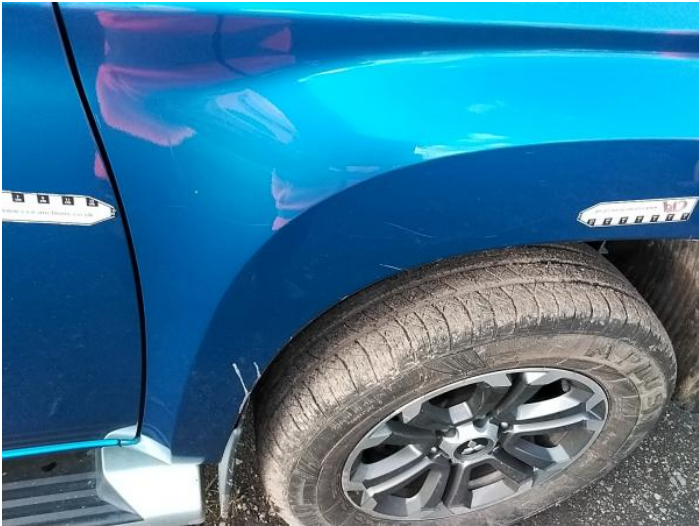
15: Wing osf  
Dented  
With Paint Damage

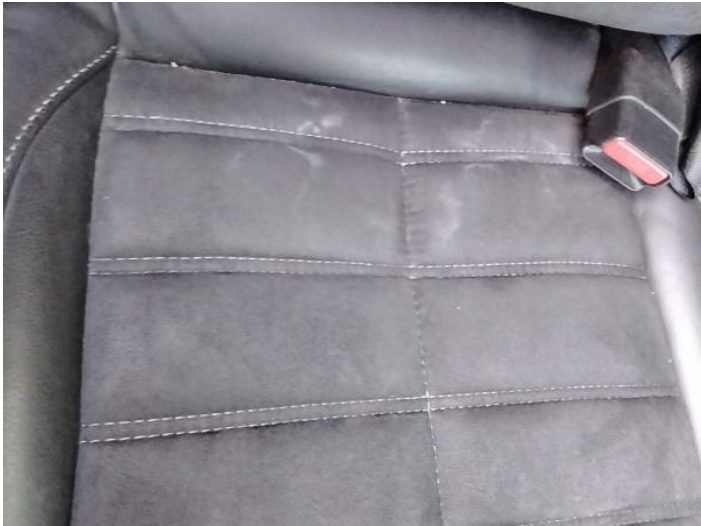
16: Seat Back Cover osr  
Soiled  
Heavy

| <b>Seat Condition</b> | Poor | <b>Odour</b> | No |

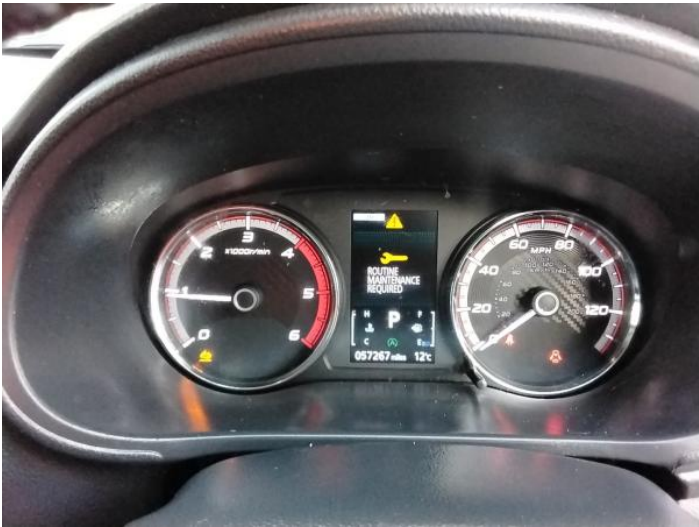
17: Dash Warning Lights  
Displayed  
No Action

| EML light illuminated | OK | DPF light illuminated | Fault |
| ABS light illuminated | OK | Service indicator light illuminated | Fault |
