# VEHICLE INSPECTION REPORT

**KV71XJZ**

## Mercedes-Benz Sprinter 315

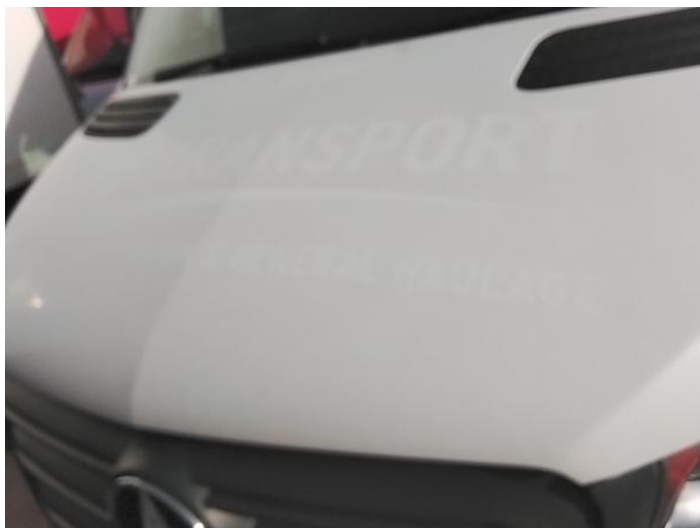
1: Bonnet  
Chipped  
Multiple Chips

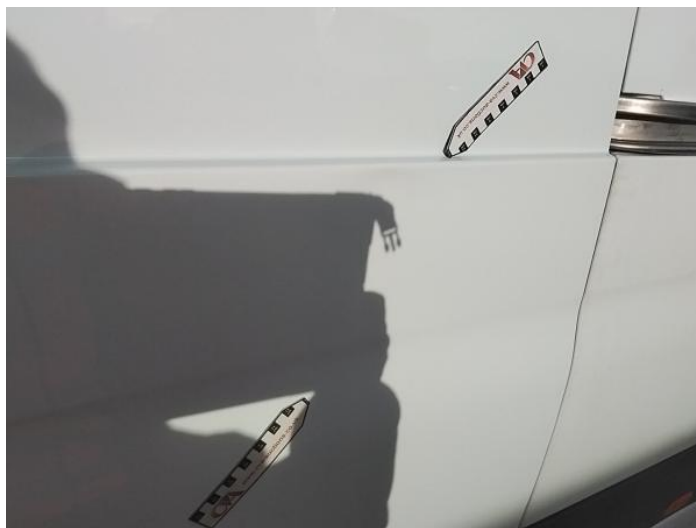
2: Qtr Panel nsr  
Dented  
Over 30mm

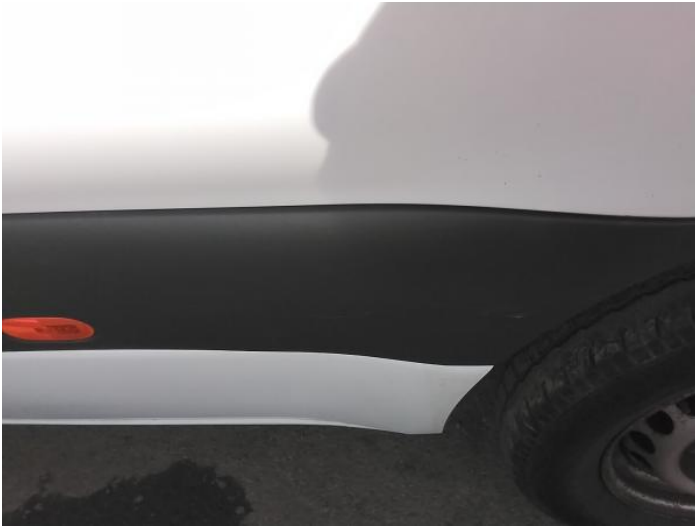
3: Qtr Panel Moulding ns  
Scuffed (Unpainted)  
Over 100mm

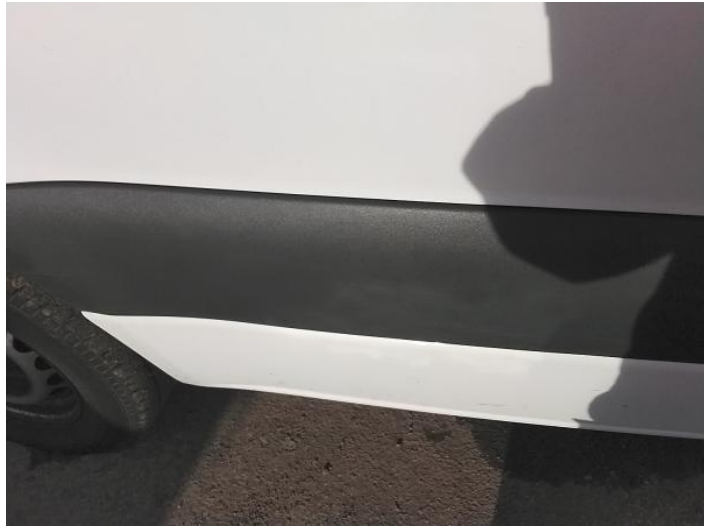
4: Qtr Panel Moulding ns  
Scuffed (Unpainted)  
Over 100mm

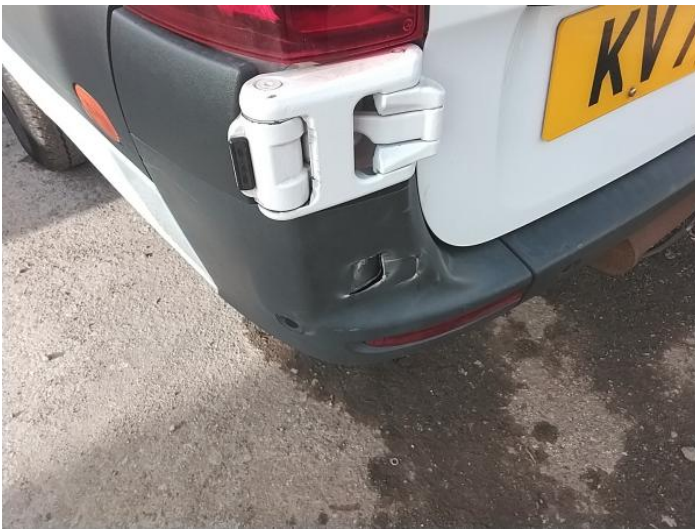
5: Bumper Rear Moulding  
Broken  
Replace

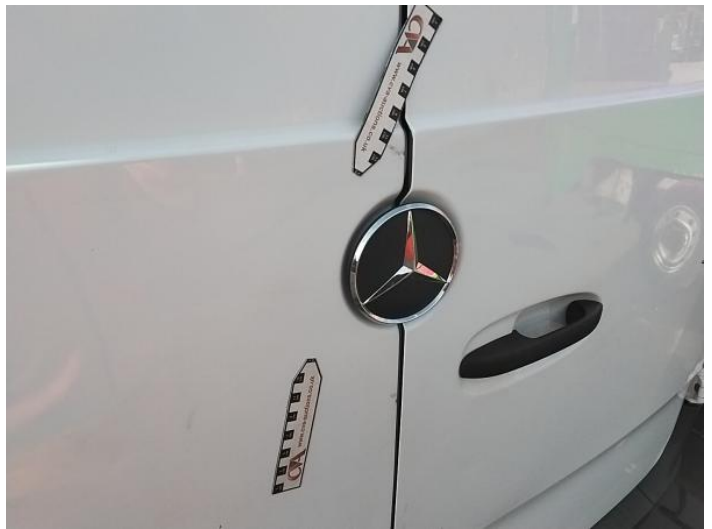
6: Door nsr  
Dented  
Over 30mm

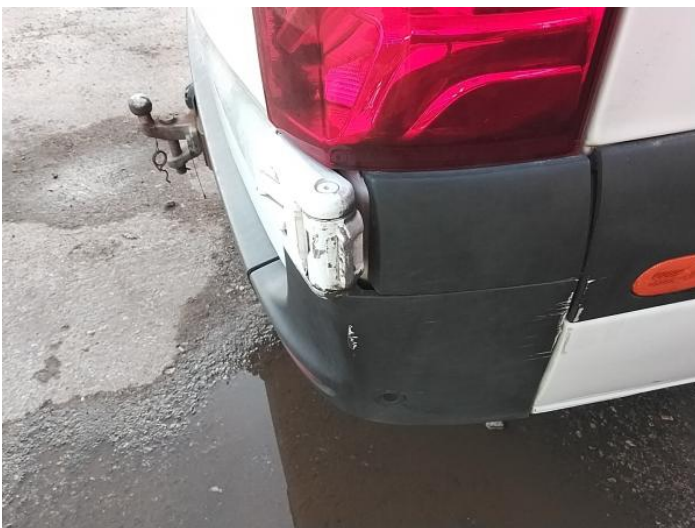
7: Bumper Rear Moulding  
Scuffed (Unpainted)  
Over 100mm
