# VEHICLE INSPECTION REPORT

**NK17UFB**

## Scania P 250

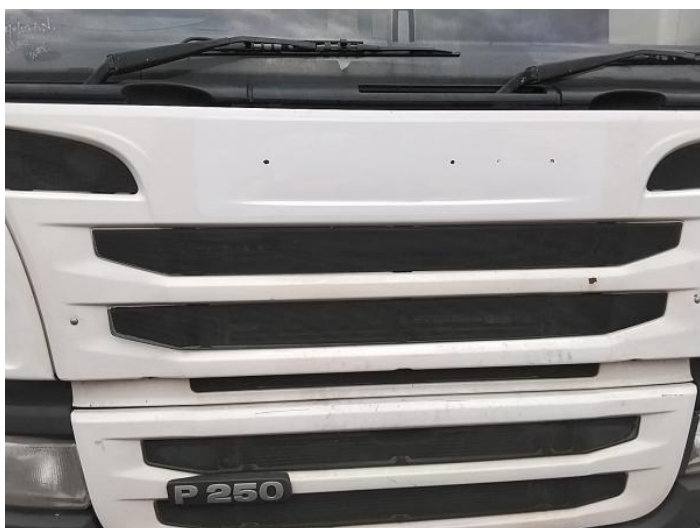
1: Bonnet  
Chipped  
Multiple Chips

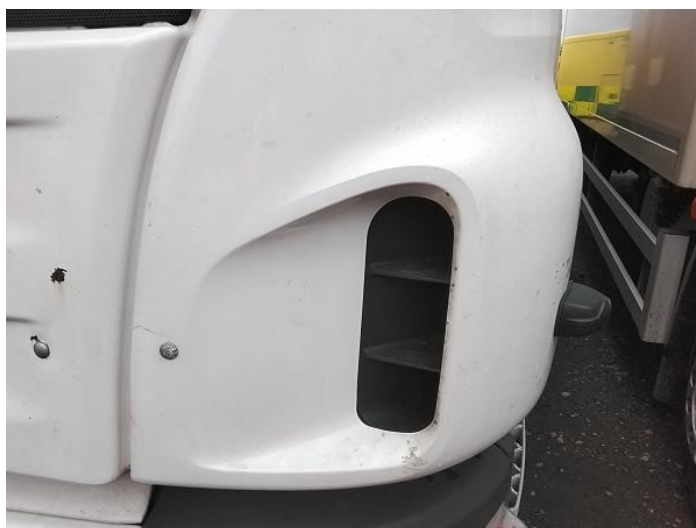
2: Panel Front  
Cracked  
Replace

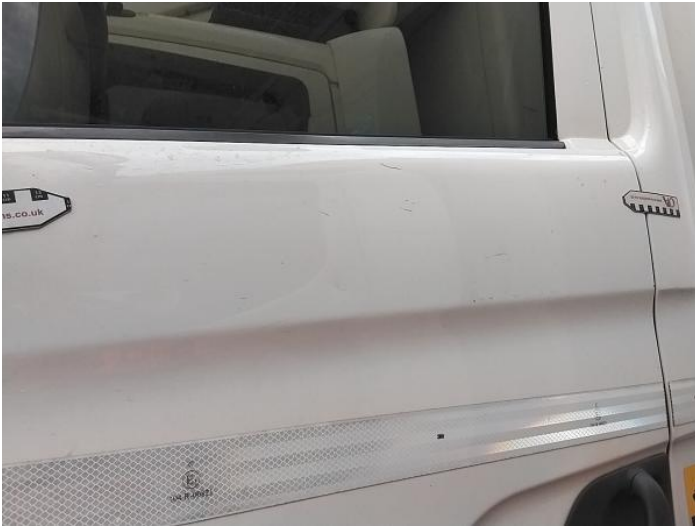
3: Door nsf  
Scratched  
Over 25mm Thru Paint

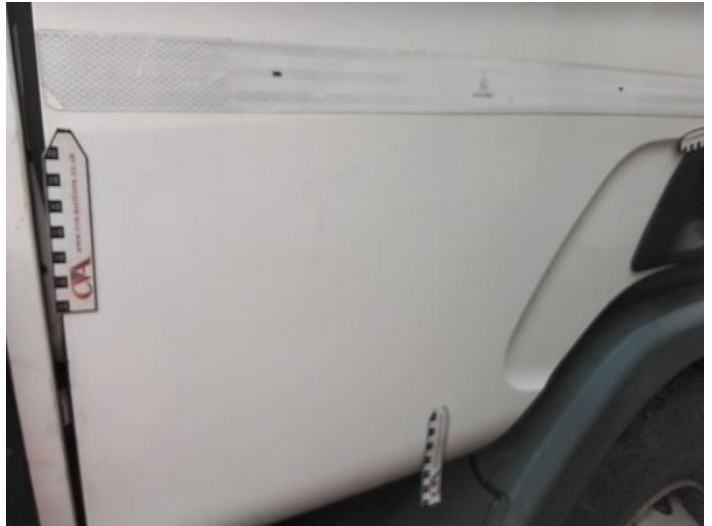
4: Door nsf  
Scratched  
Over 25mm Thru Paint

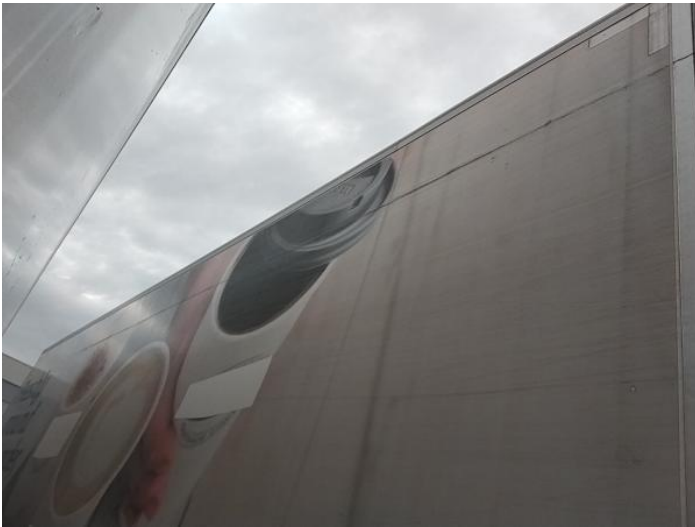
5: Qtr Panel nsr  
Scratched  
Over 25mm Thru Paint

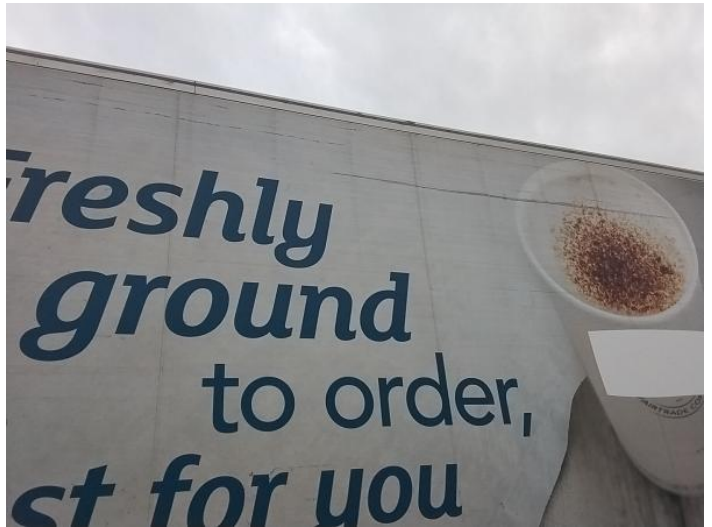
6: Qtr Panel osr  
Scratched  
Over 25mm Thru Paint

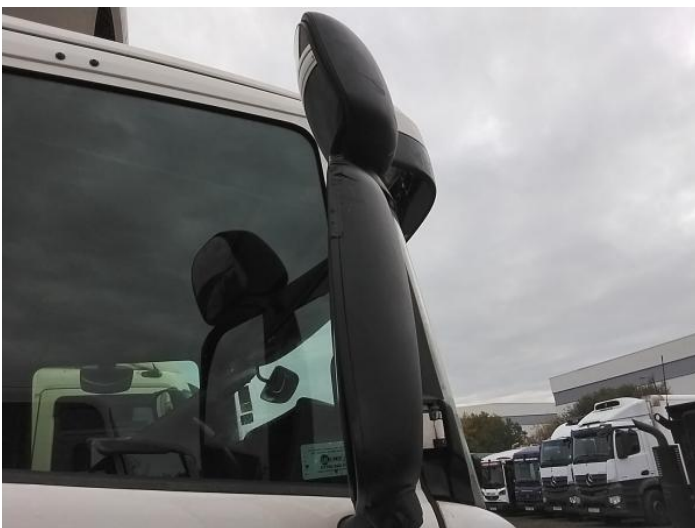
7: Door Mirror Assy osf  
Broken  
Replace

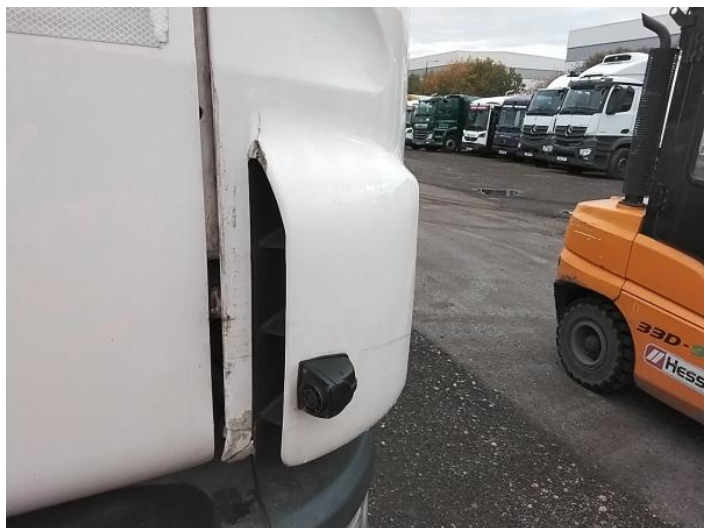
8: Panel Front  
Cracked  
Replace

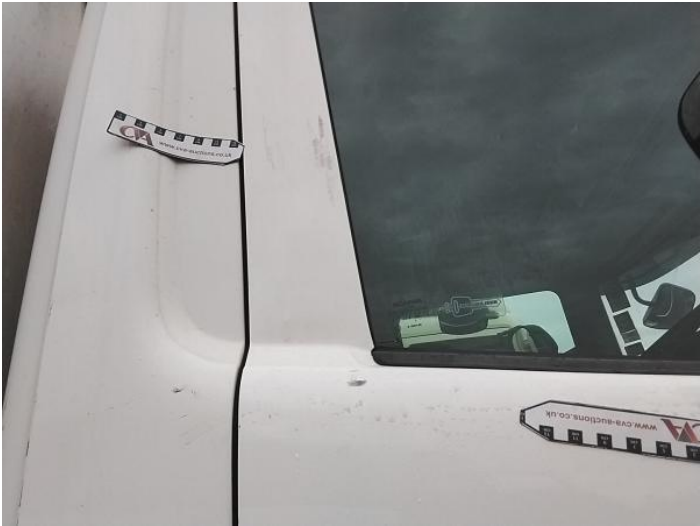
9: Door osf  
Scratched  
Over 25mm Thru Paint

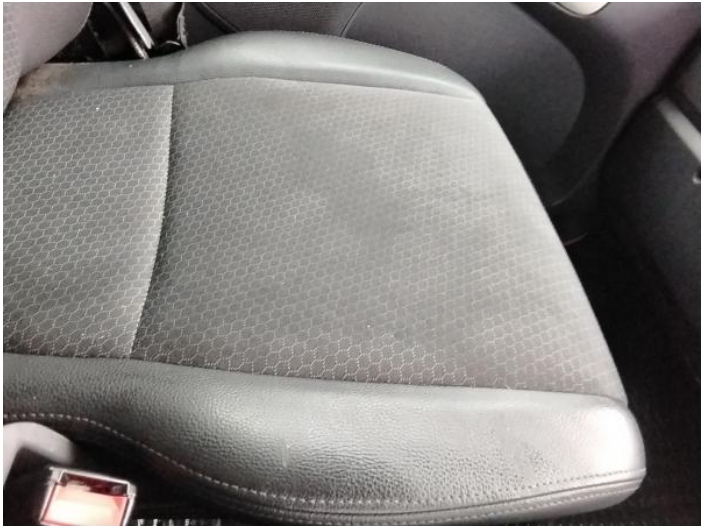
10: Seat Base Cover nsf  
Soiled  
Heavy

| Seat Condition | | Poor | Odour | | - |
