# VEHICLE INSPECTION REPORT

**SJ19NZZ**

## Volvo FMX 420

### Inspection

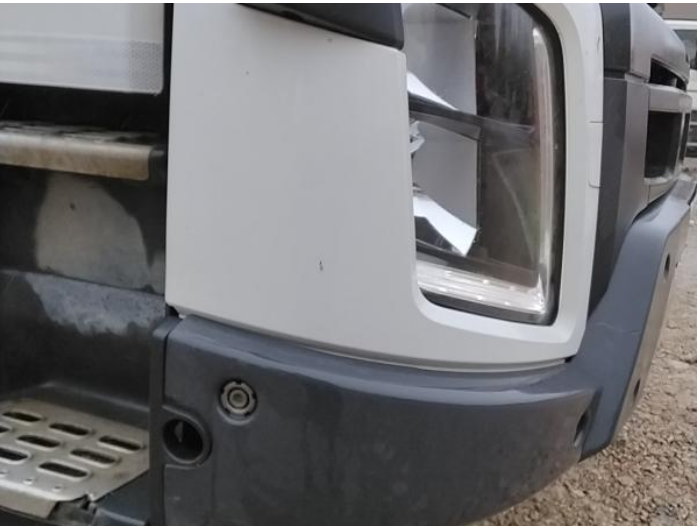
1: Fog Lamp Surround os  
Scratched (Painted)  
UpTo 25mm Thru Paint

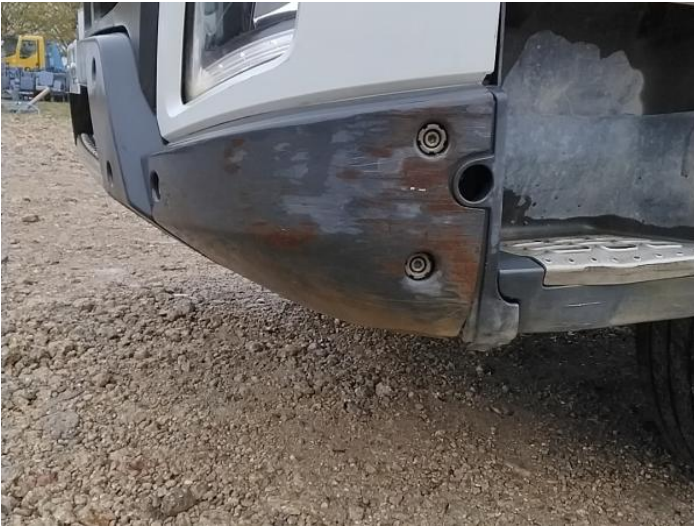
3: Bumper Front Moulding  
Scratched (Painted)  
Over 25mm Thru Paint

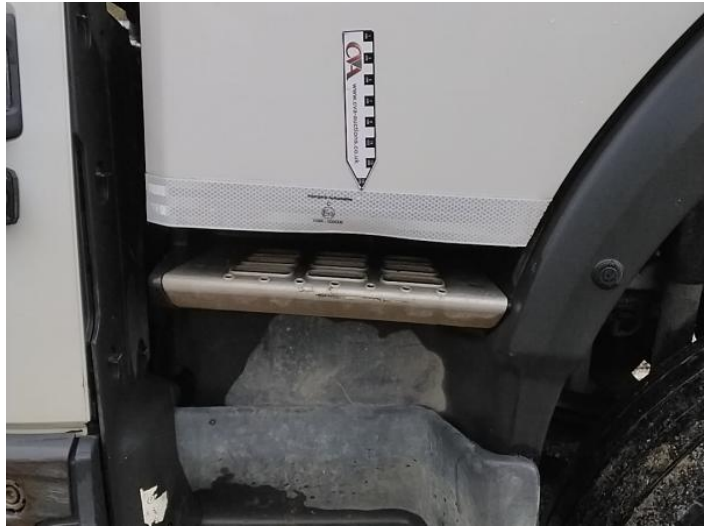
4: Door nsf  
Dented  
Between 10mm + 30mm

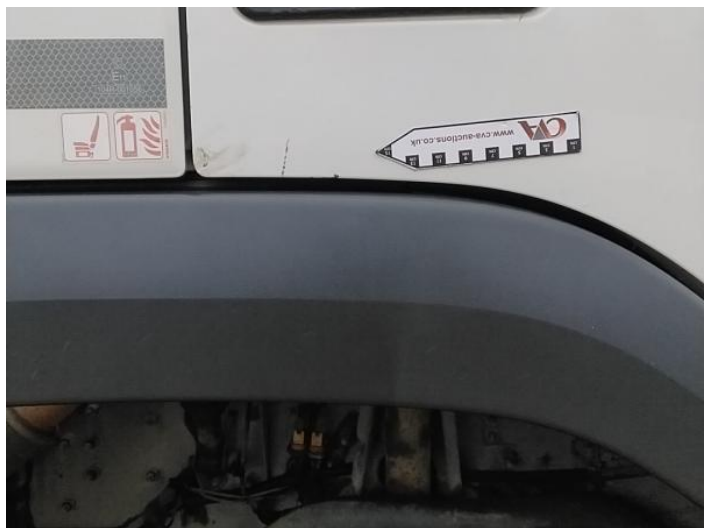
8: Door osf  
Scratched  
UpTo 25mm Thru Paint

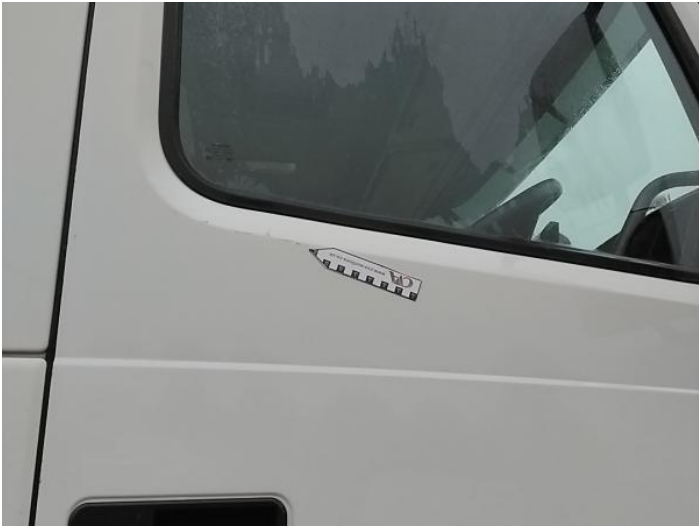
9: Door osf  
 Scratched  
 UpTo 25mm Thru Paint

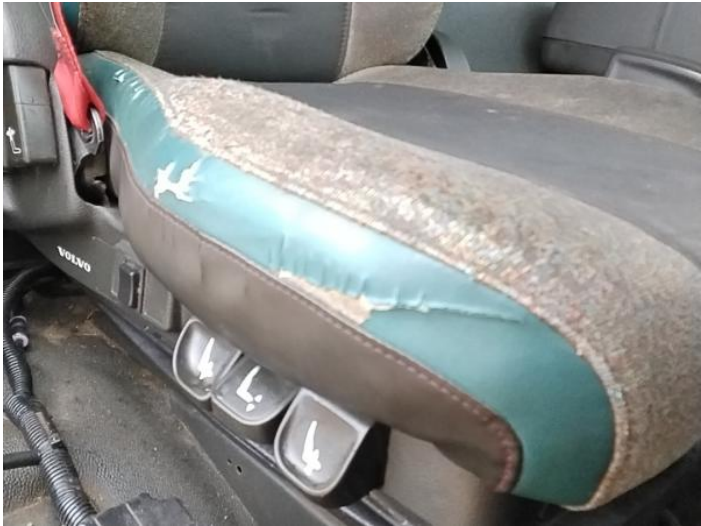
10: Seat Base Cover osf  
 Torn  
 Over 3mm
