VEHICLE INSPECTION REPORT

PE15HJC

Daf LF 150

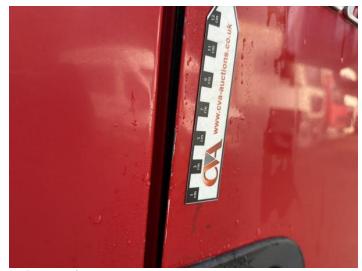
1: Door osf Chipped Edge Chip

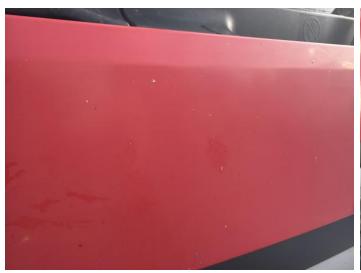
3: Bonnet Chipped Multiple Chips

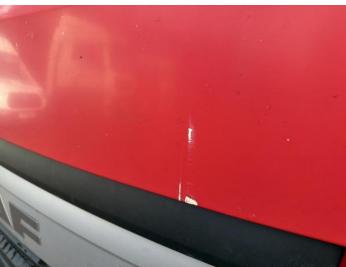
4: Bonnet Dented With Paint Damage

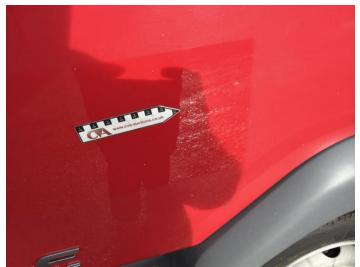
5: Door nsf Chipped Multiple Chips

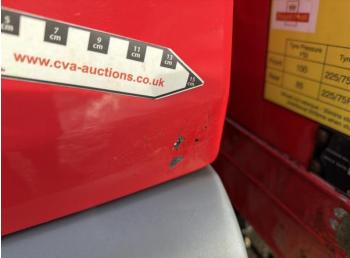
6: B Post ns Rusted Over 5mm

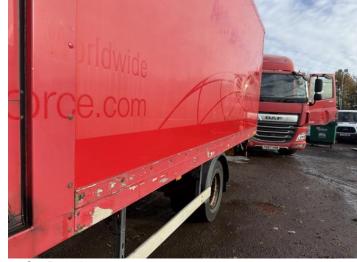
7: Qtr Panel nsr Chipped Multiple Chips

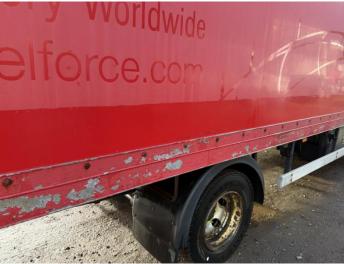
8: Qtr Panel osr Chipped Multiple Chips
