# VEHICLE INSPECTION REPORT

**YR69FZO**

## Ford Ranger XL 2.0 EcoBlue 170PS

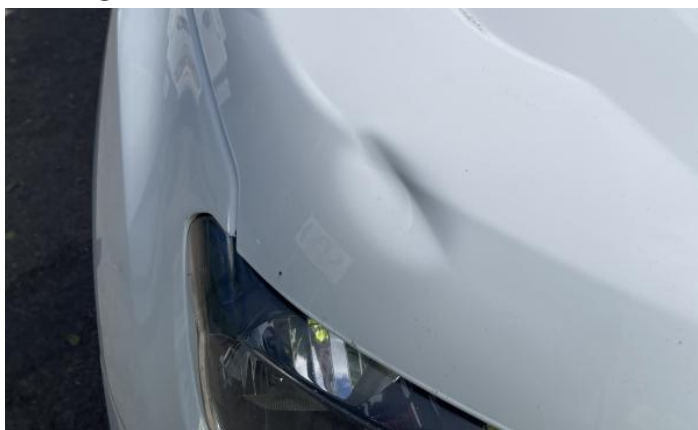
1: Bonnet  
Dented  
Over 30mm

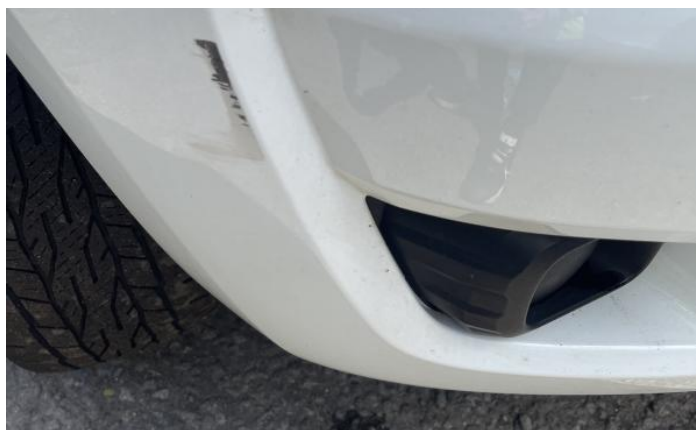
2: Bumper Front  
Scratched  
25 to 100mm Thru Paint

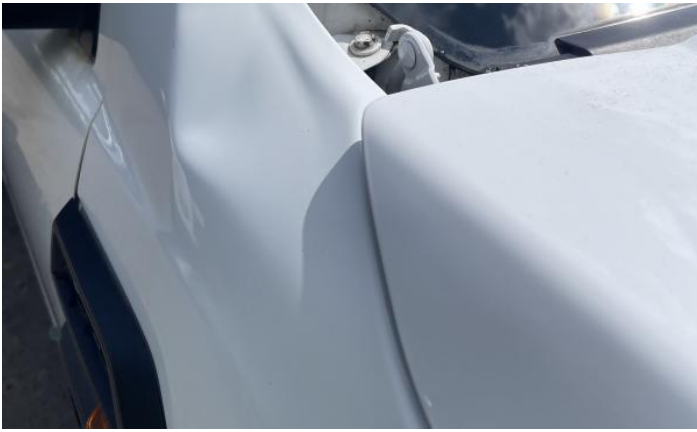
3: Wing osf  
Dented  
Over 30mm

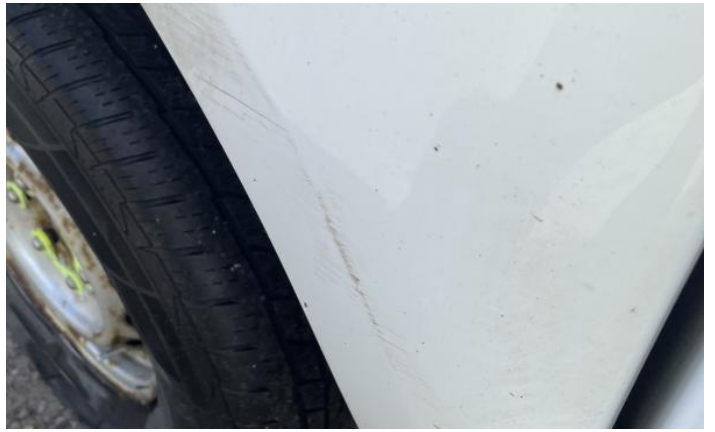
4: Qtr Panel osr  
Scratched  
Over 25mm Not Thru Paint

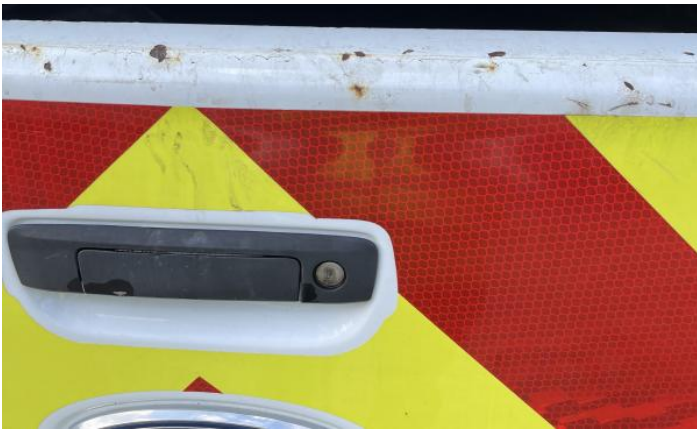
5: Tailgate  
Dented  
With Paint Damage

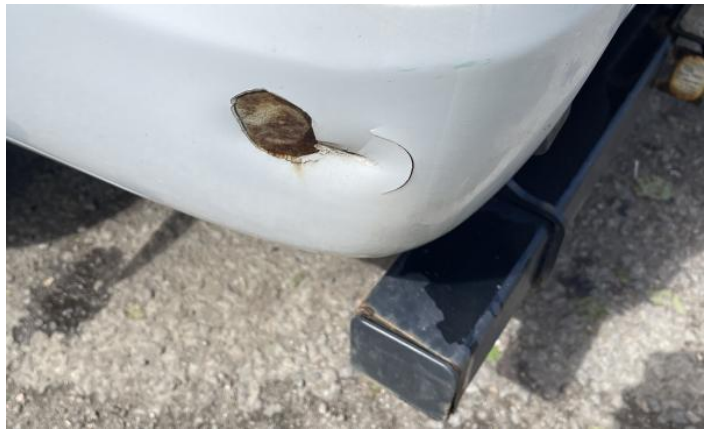
6: Qtr Panel nsr  
Dented  
With Paint Damage

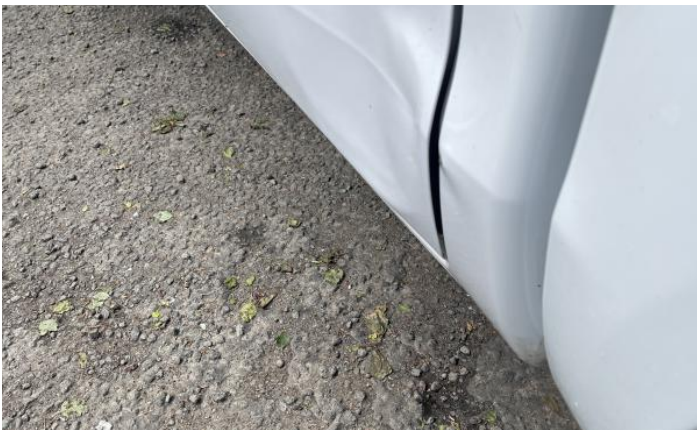
7: Door nsr  
Dented  
With Paint Damage

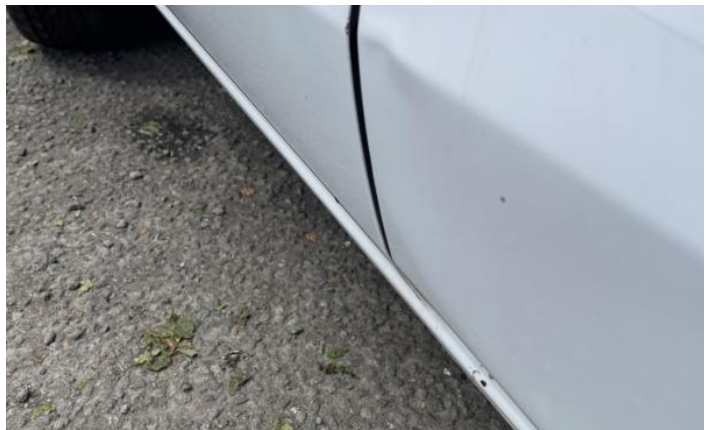
8: Door nsf  
Dented  
Over 30mm

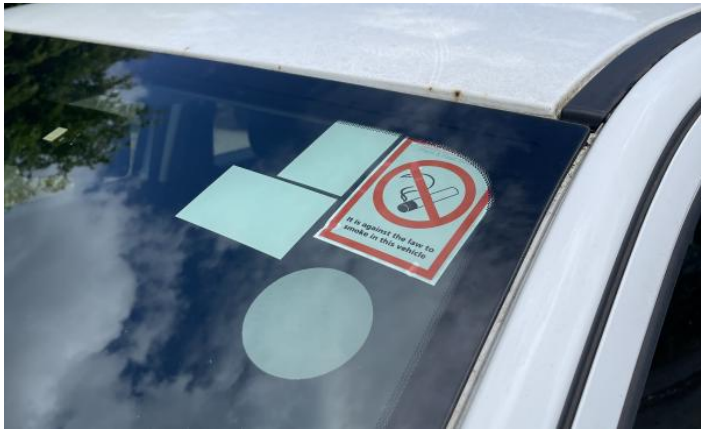
9: Roof  
 Rusted  
 Over 5mm
