# VEHICLE INSPECTION REPORT

**2625586**

## Iveco Eurocargo 110E21

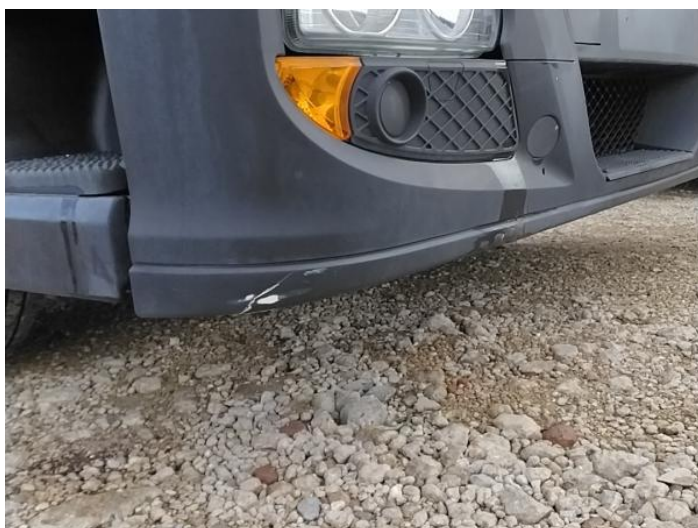
1: Bumper Front Moulding  
Scuffed (Unpainted)  
UpTo 100mm

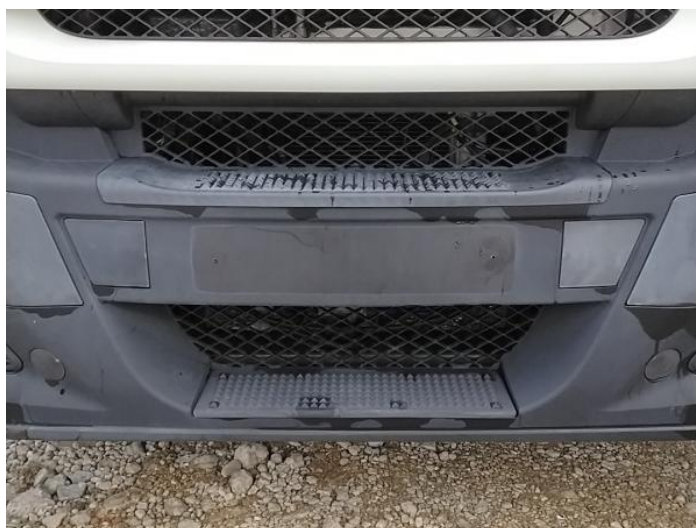
2: Number Plate Front  
Missing  
Replace

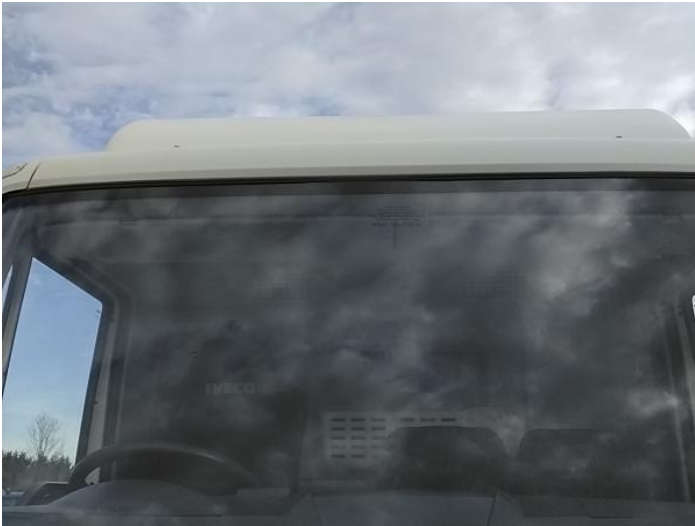
3: Screen Front  
Chipped  
Over 10mm

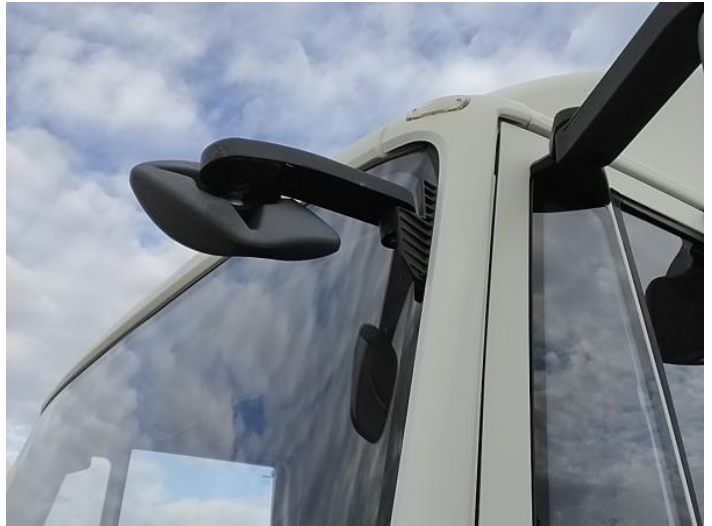
4: Door Mirror Assy nsf  
Missing  
Replace

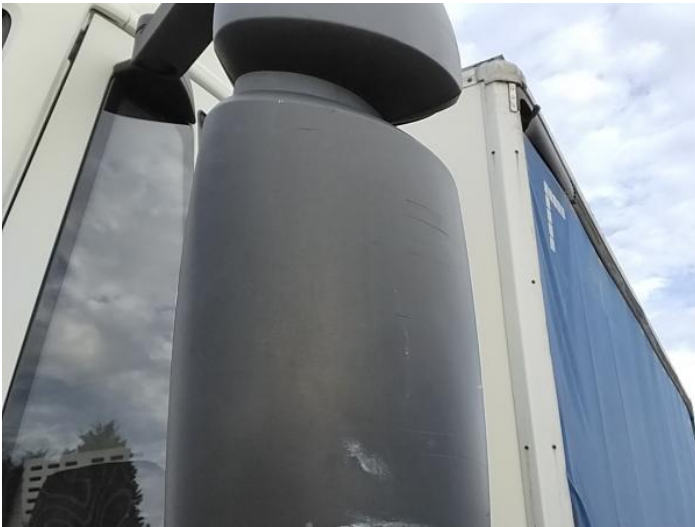
5: Door Mirror Assy nsf  
Scuffed (Unpainted)  
UpTo 100mm

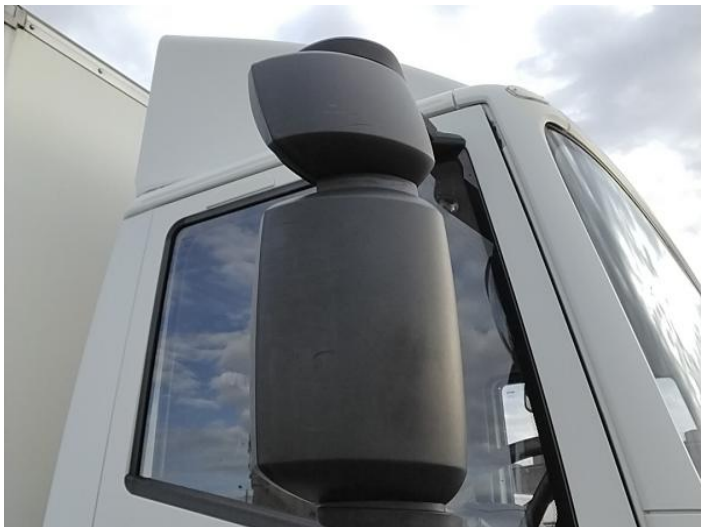
9: Door Mirror Assy osf  
 Scuffed (Unpainted)  
 UpTo 100mm
