# VEHICLE INSPECTION REPORT

**2625577**

## Iveco Eurocargo 180E25

### Inspection

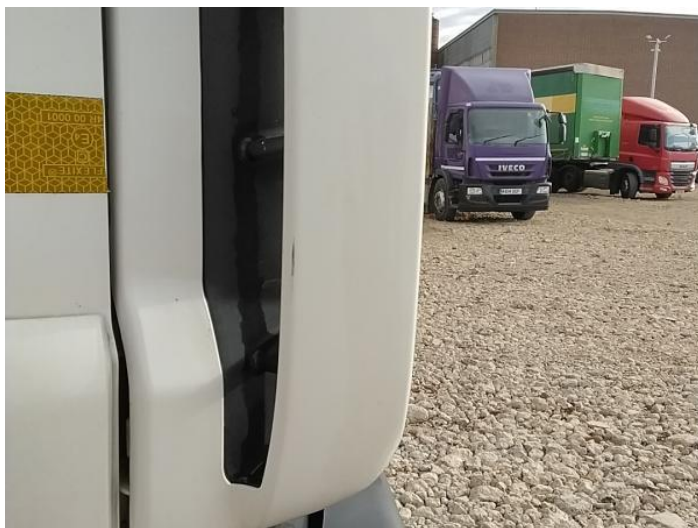
1: Wing osf  
Scratched  
UpTo 25mm Thru Paint

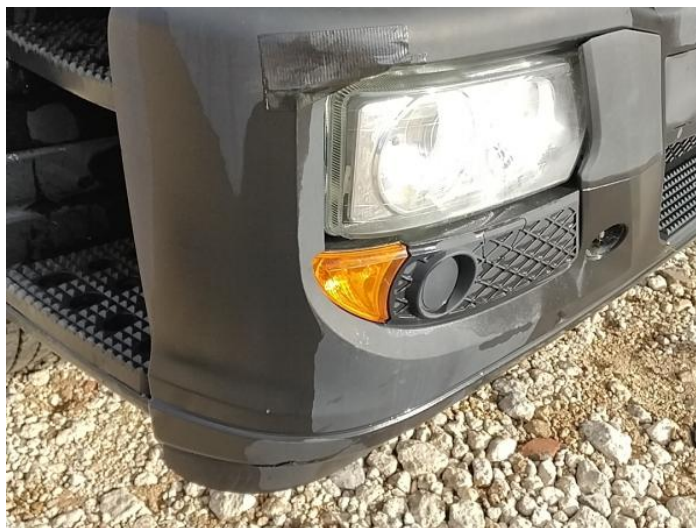
2: Fog Lamp Surround os  
Broken  
Replace

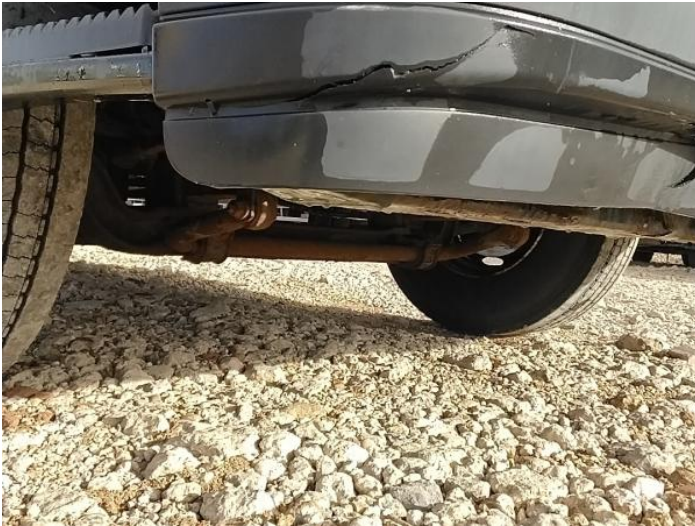
3: Bumper Front Moulding  
Broken  
Replace

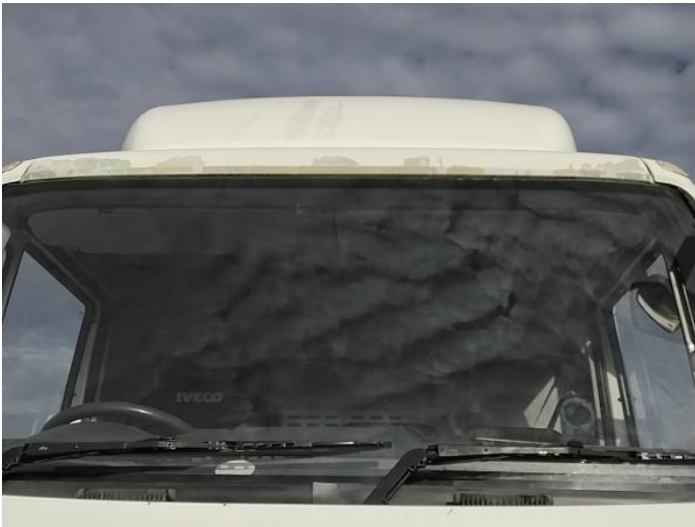
5: Screen Front  
Chipped  
UpTo 10mm

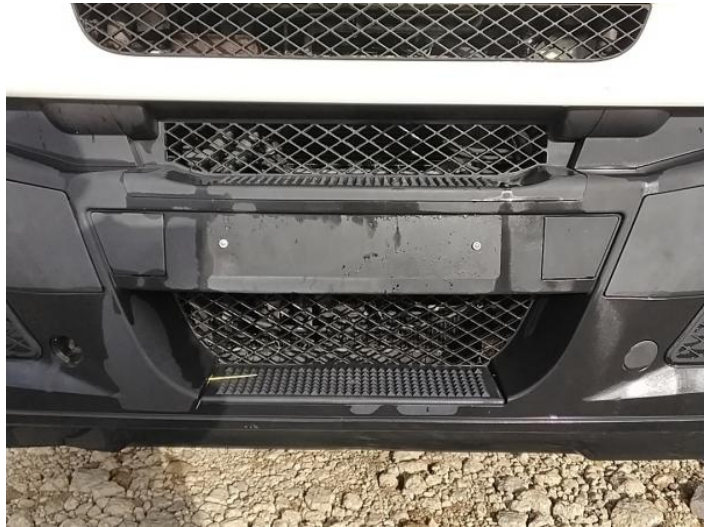
6: Number Plate Front  
Missing  
Replace

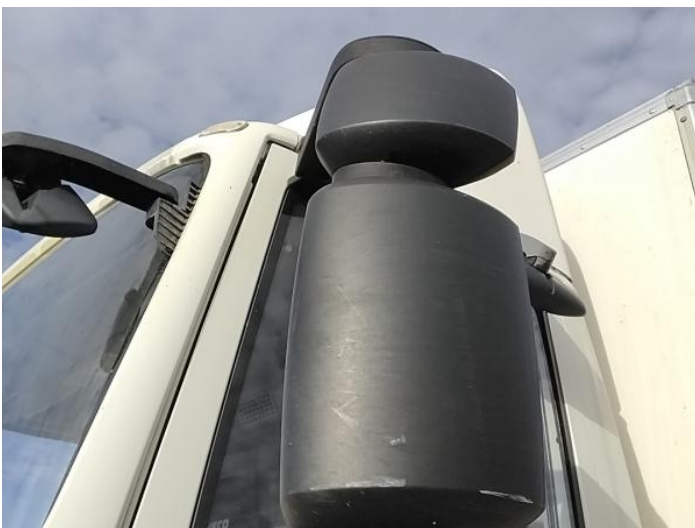
7: Door Mirror Assy nsf  
Scuffed (Unpainted)  
UpTo 100mm

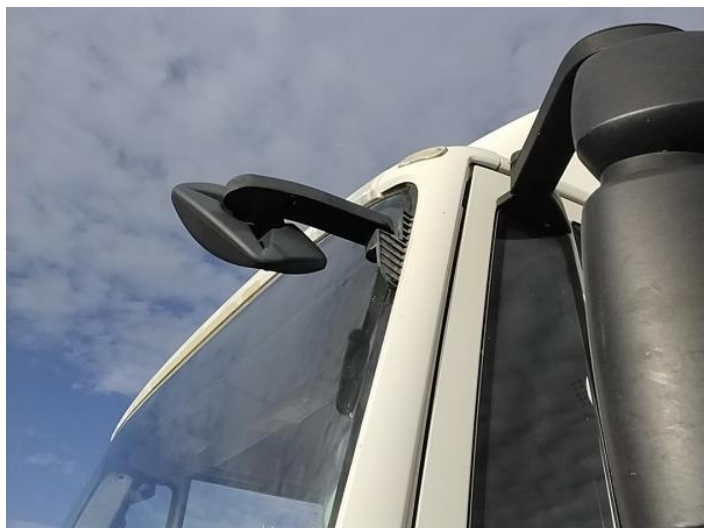
8: Door Mirror Assy nsf  
Missing  
Replace

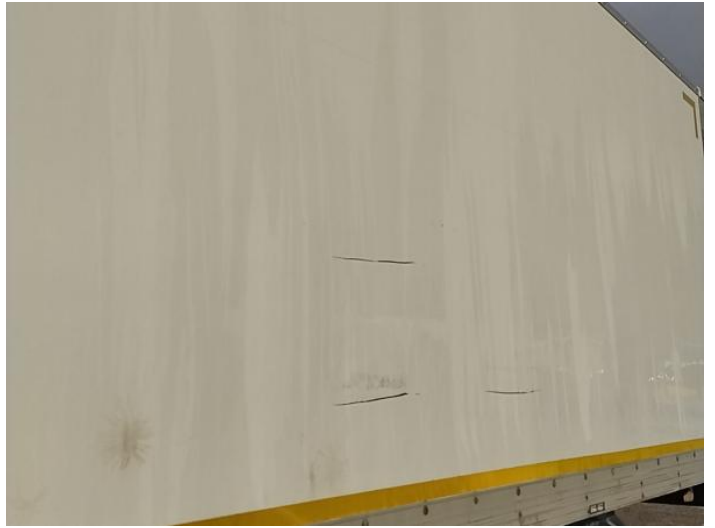
10: Qtr Panel nsr  
Scratched  
Over 25mm Not Thru Paint

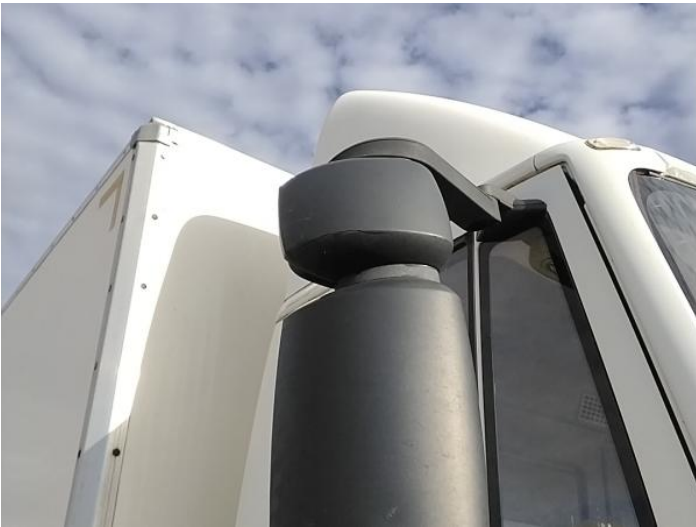
11: Door Mirror Assy osf  
Broken  
Replace
