# VEHICLE INSPECTION REPORT

**SF21ULN**

## Fiat Doblo Work Up 1.6 MULTIJET 16V II

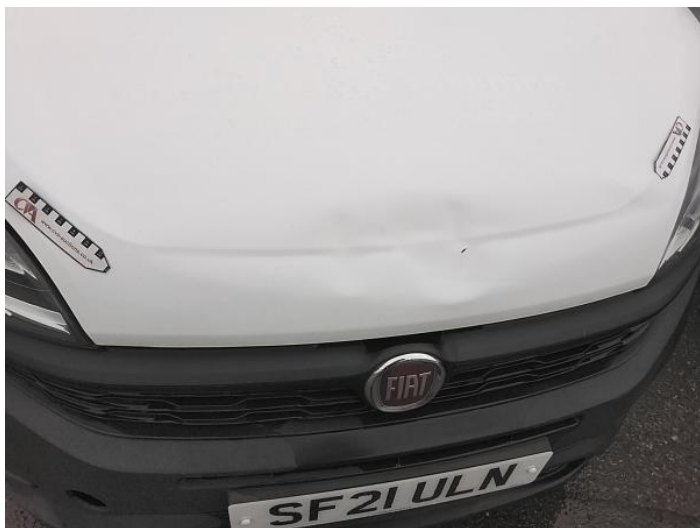
1: Bonnet  
Dented  
Over 30mm

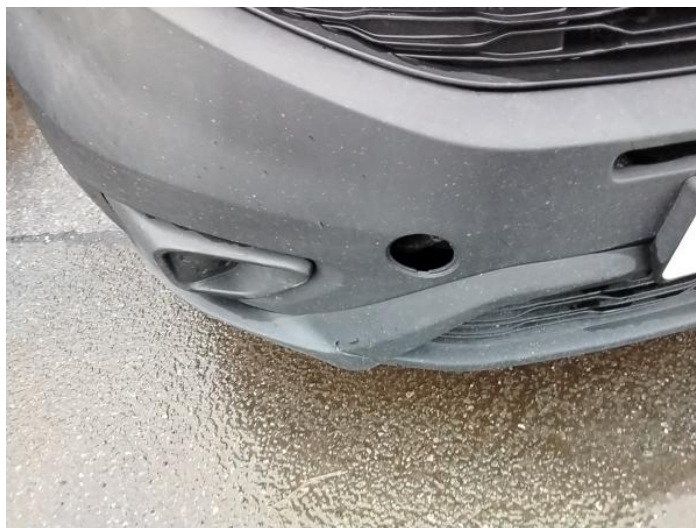
2: Bumper Front Moulding  
Missing  
Replace

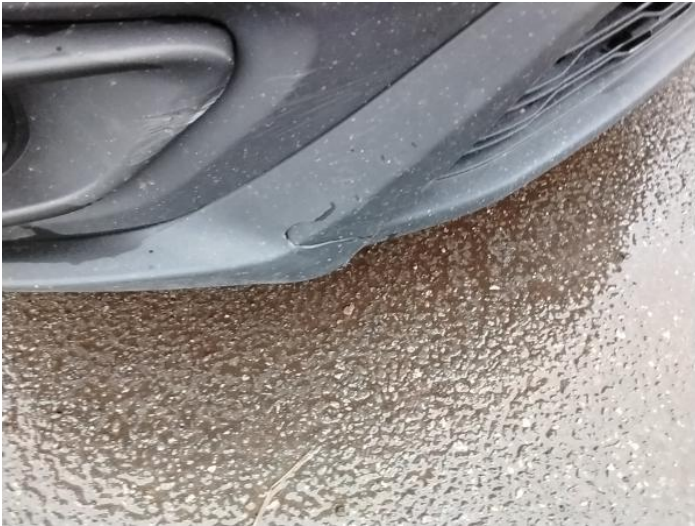
3: Bumper Front  
Cracked  
Over 25mm

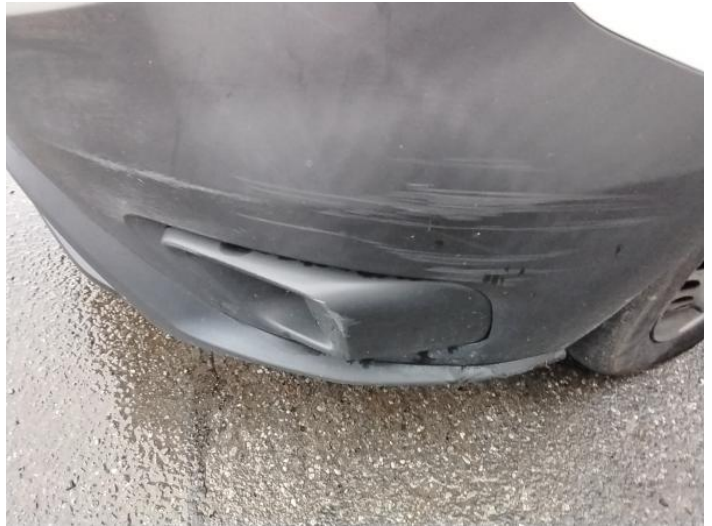
4: Bumper Front  
Scratched  
Over 100mm Thru Paint

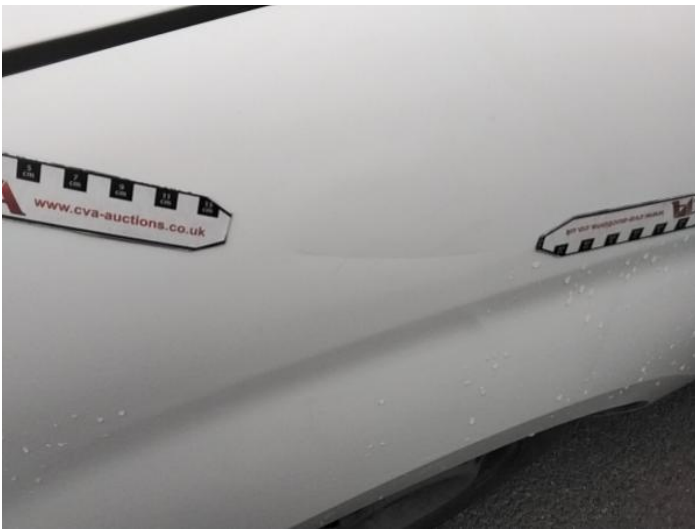
5: Wing nsf  
Dented  
With Paint Damage

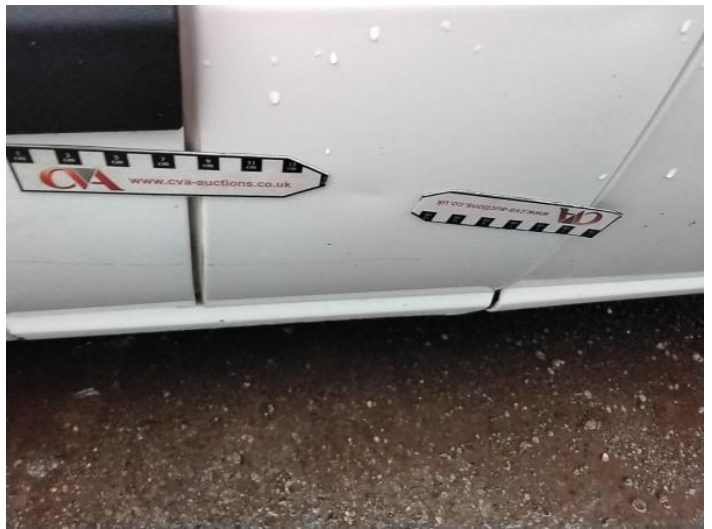
6: B Post ns  
Dented  
Over 30mm

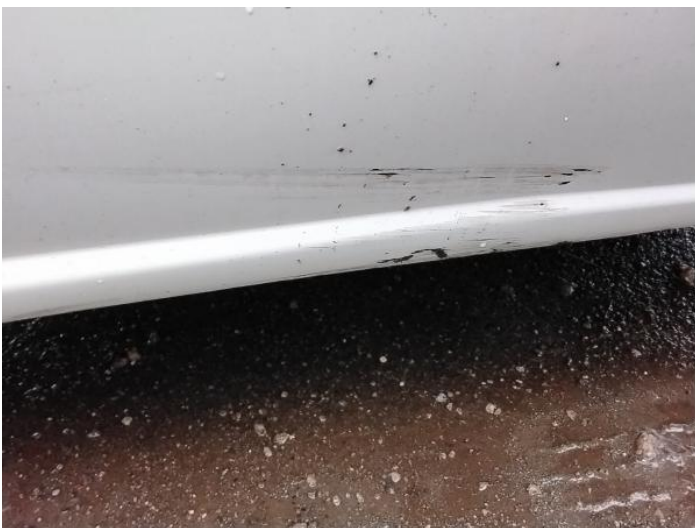
7: Qtr Panel nsr  
Dented  
With Paint Damage

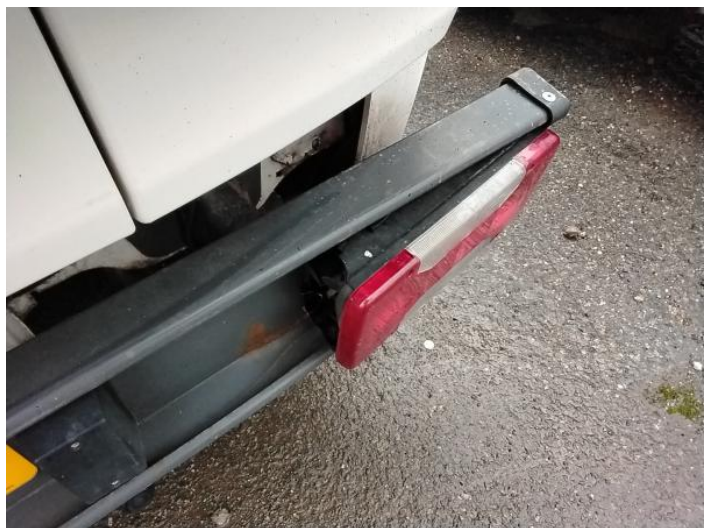
8: Lamp osr  
Broken  
Replace

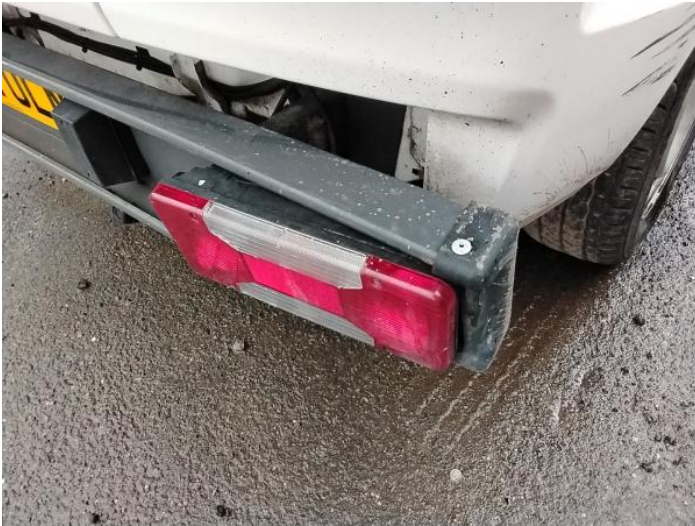
9: Bumper Rear  
Dented  
Over 30mm

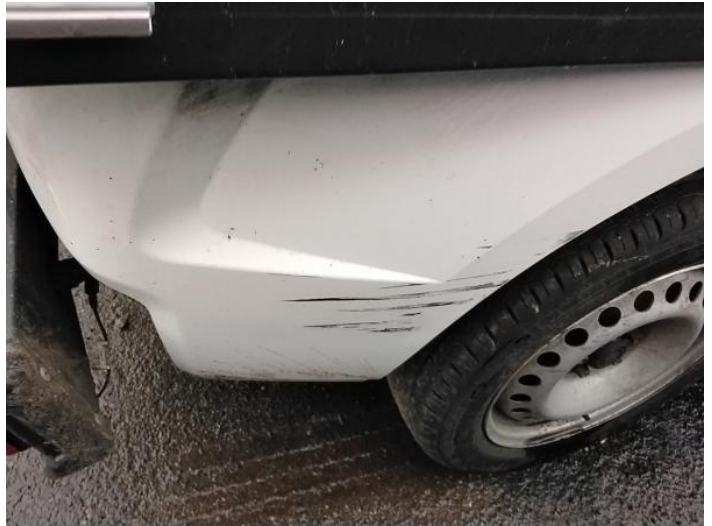
10: Qtr Panel osr  
Scratched  
Over 25mm Thru Paint

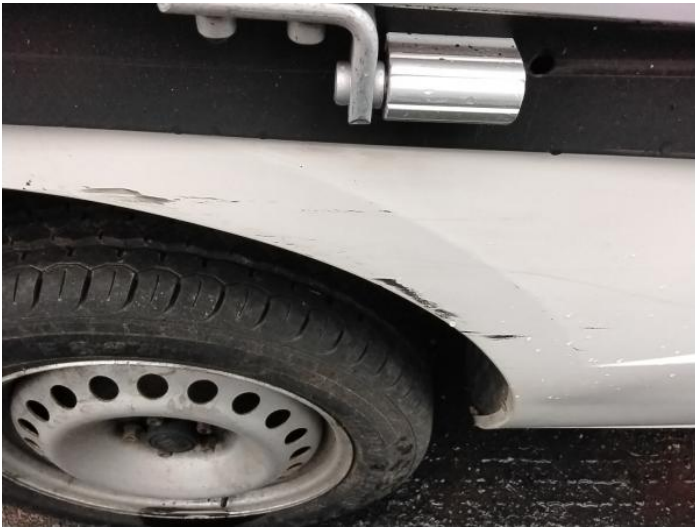
11: Qtr Panel osr  
Scratched  
Over 25mm Thru Paint

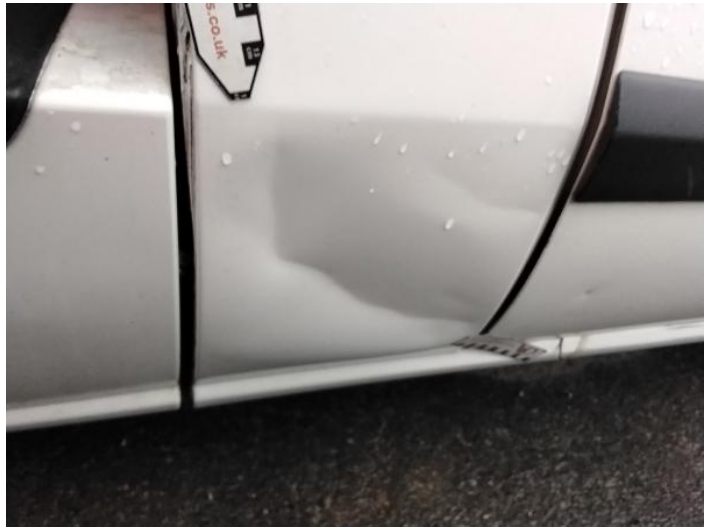
12: B Post os  
Dented  
Over 30mm

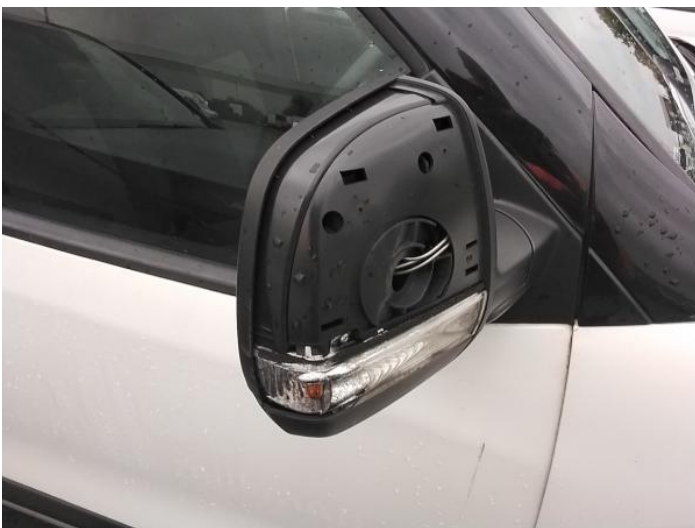
13: Door Mirror Assy osf  
Broken  
Replace

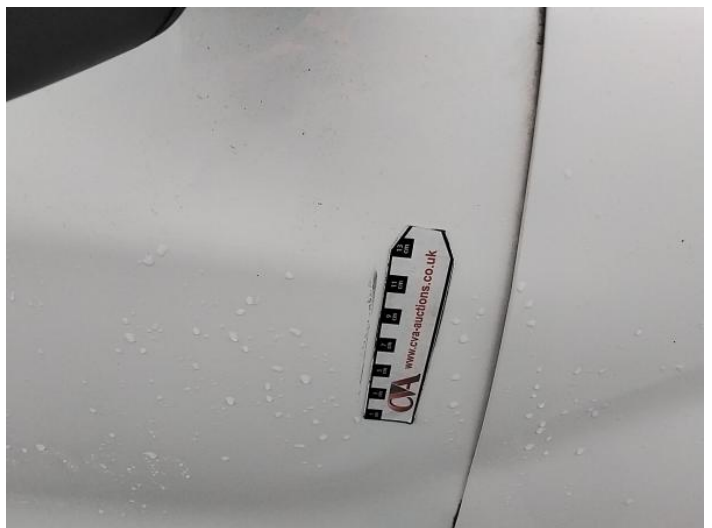
14: Door osf  
Scratched  
Over 25mm Thru Paint

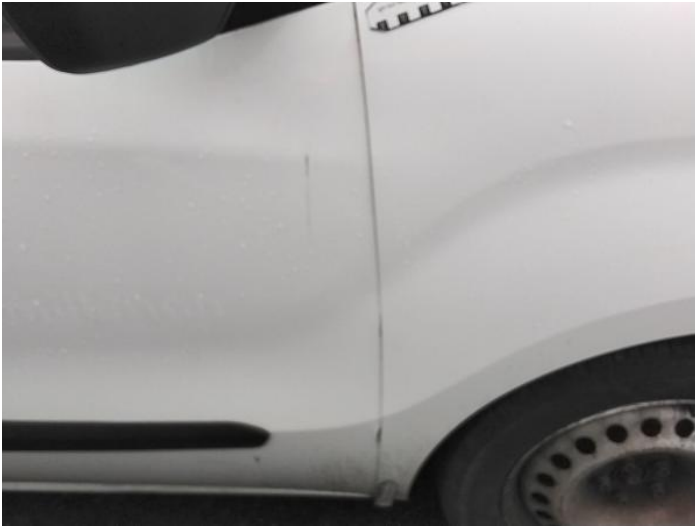
15: Door osf  
Dented  
With Paint Damage

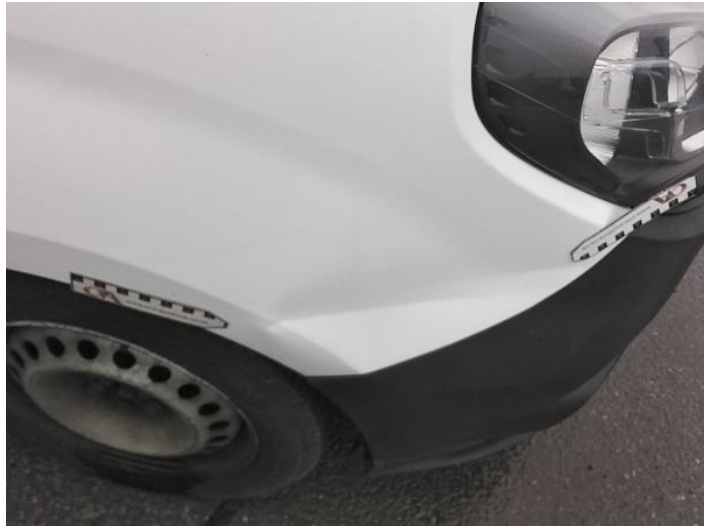
16: Wing osf  
Dented  
Over 30mm

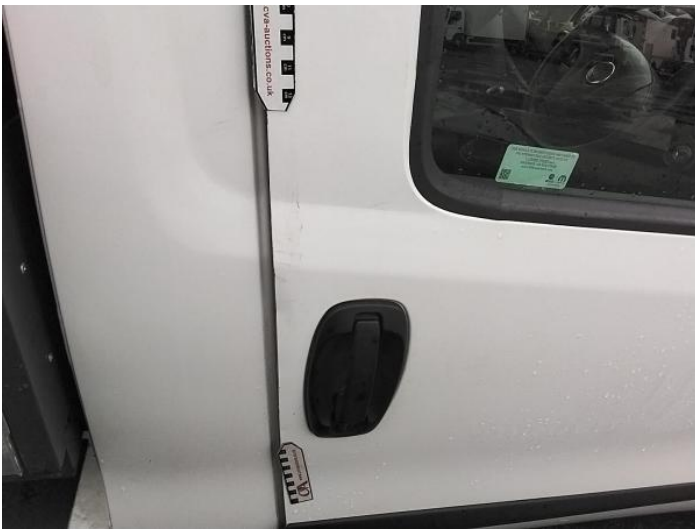
17: Door osf  
Dented  
With Paint Damage

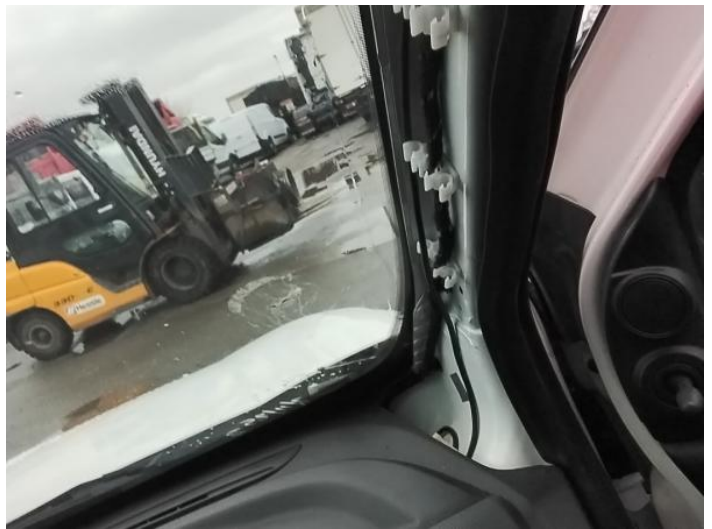
18: Fascia Panel  
Missing  
Replace

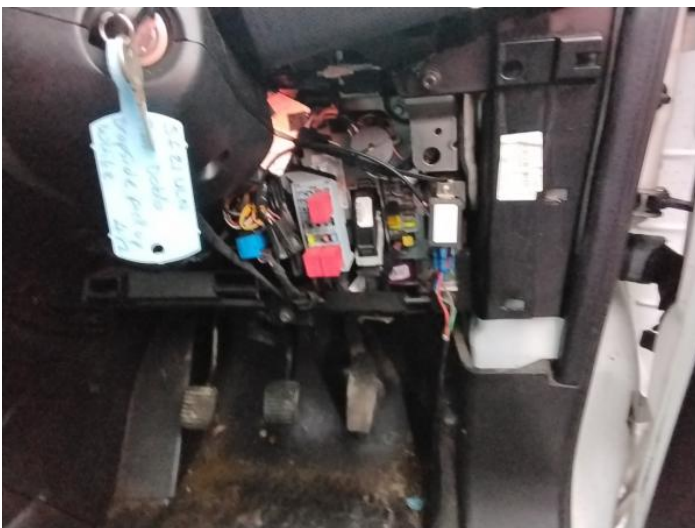
19: Fascia Panel  
Missing  
Replace

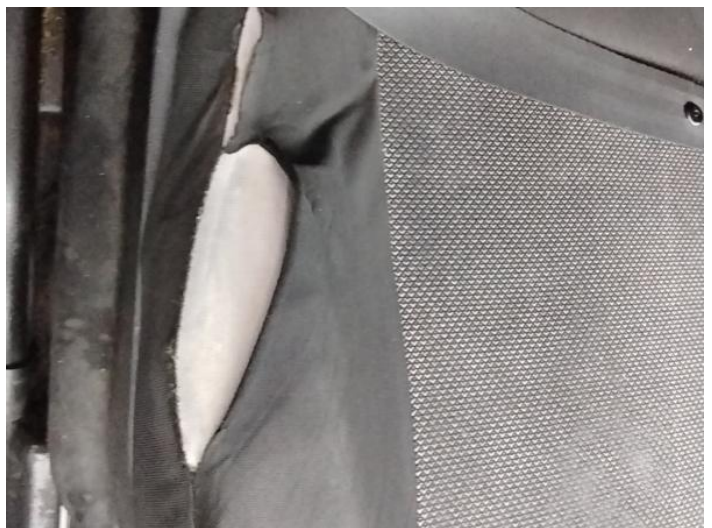
20: Seat Base Cover osf  
Torn  
Over 3mm
