## VEHICLE INSPECTION REPORT

**SJ71HSO**

### Fiat Doblo Work Up 1.6 MULTIJET 16V II

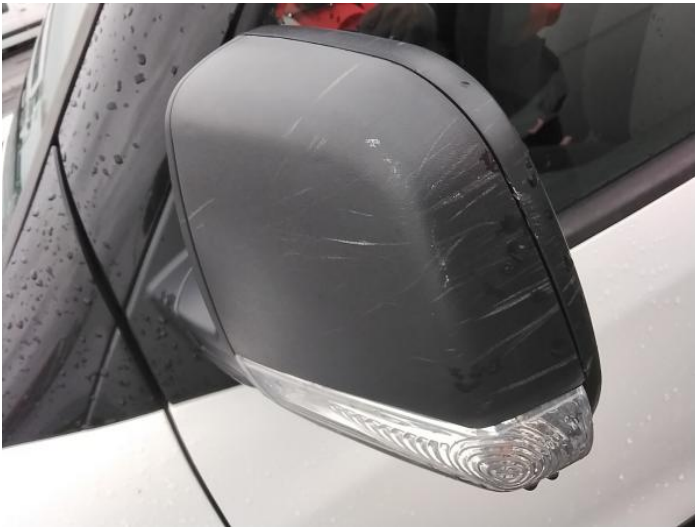
5: Door Mirror Assy nsf  
Scuffed (Unpainted)  
Over 100mm

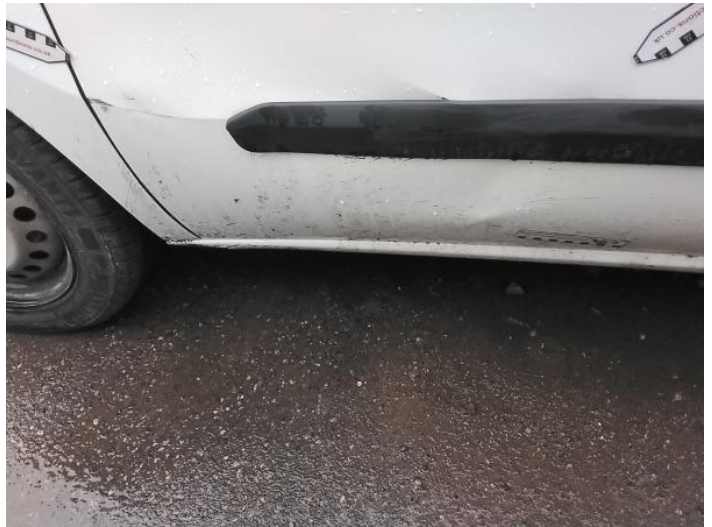
6: Door nsf  
Dented  
Over 30mm
