# VEHICLE INSPECTION REPORT

**PN71BVS**

## Fiat Doblo Work Up 1.6 Multijet II

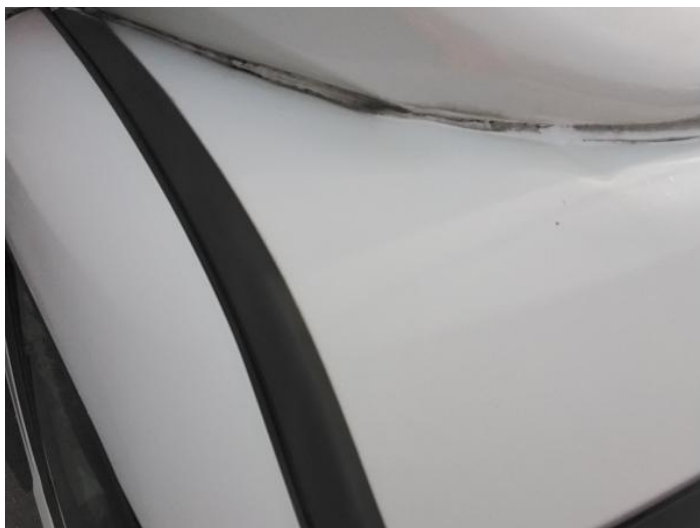
1: Roof  
Dented  
Over 30mm

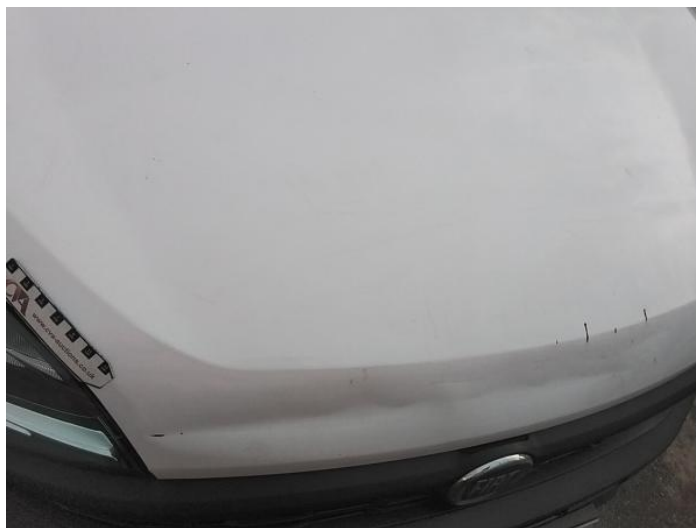
2: Bonnet  
Dented  
With Paint Damage

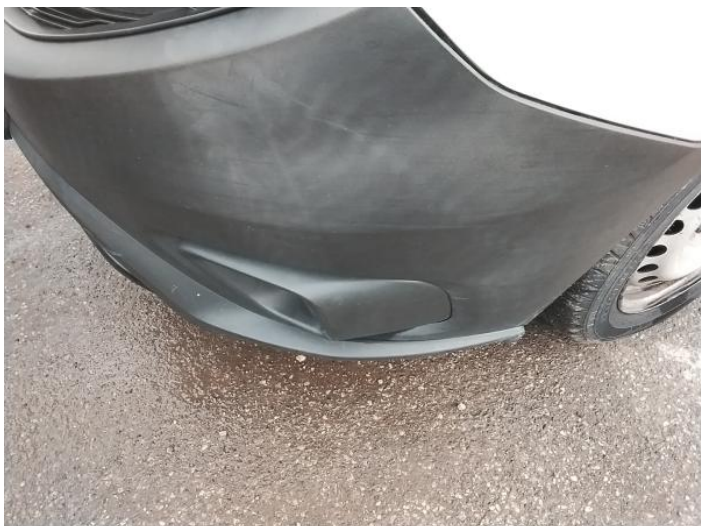
3: Bumper Front  
Scratched  
Over 100mm Thru Paint

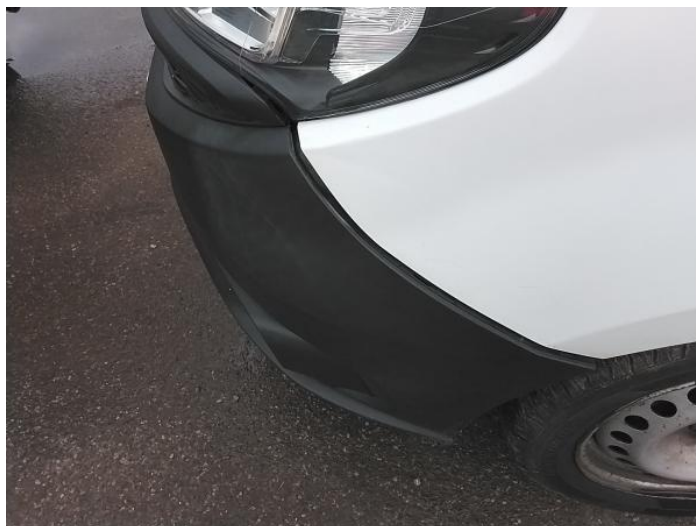
4: Bumper Front  
Insecure  
Action Required

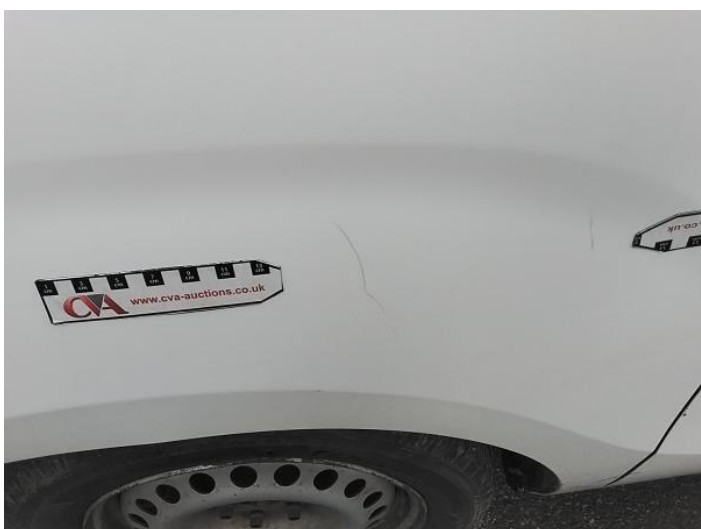
5: Wing nsf  
Scratched  
Over 25mm Thru Paint

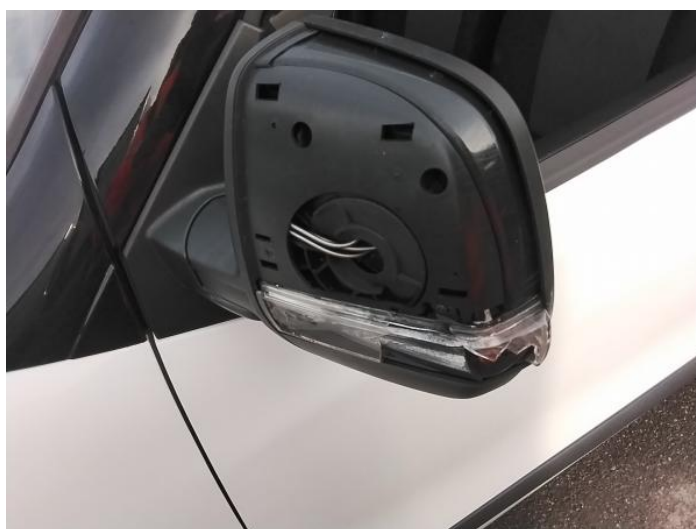
6: Door Mirror Assy nsf  
Broken  
Replace

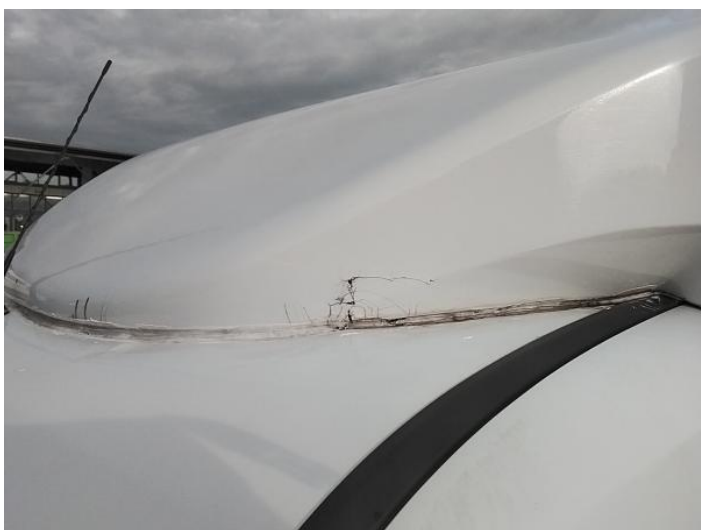
7: Qtr Panel Trim ns  
Broken  
Replace

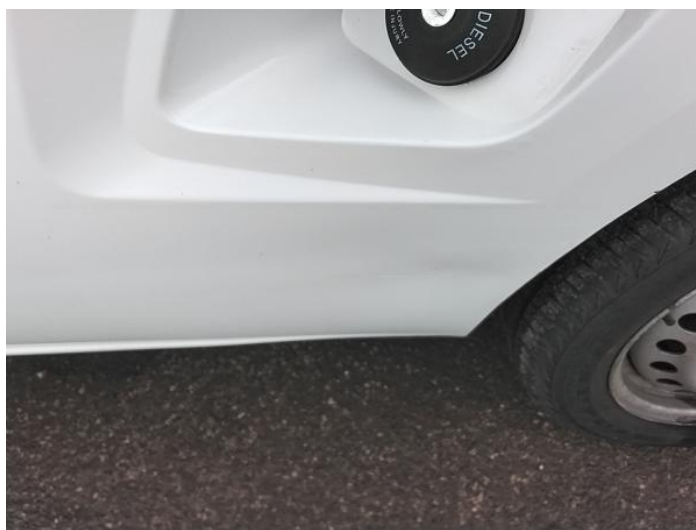
8: Qtr Panel nsr  
Dented  
Over 30mm

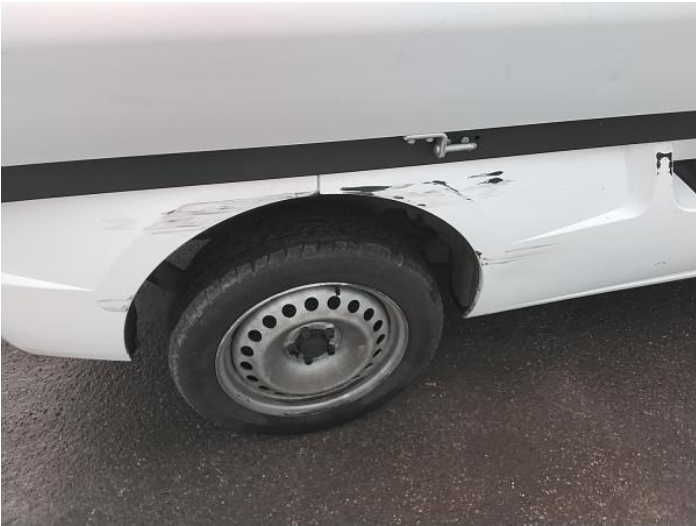
9: Qtr Panel osr  
Scratched  
Over 25mm Thru Paint

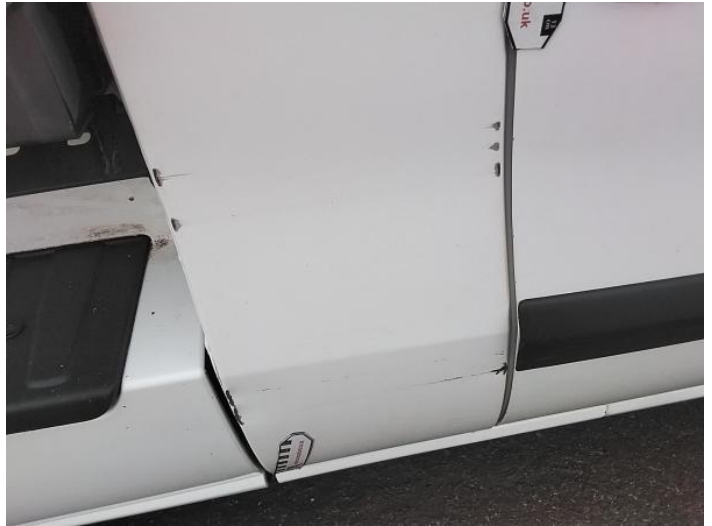
10: B Post os  
Dented  
With Paint Damage

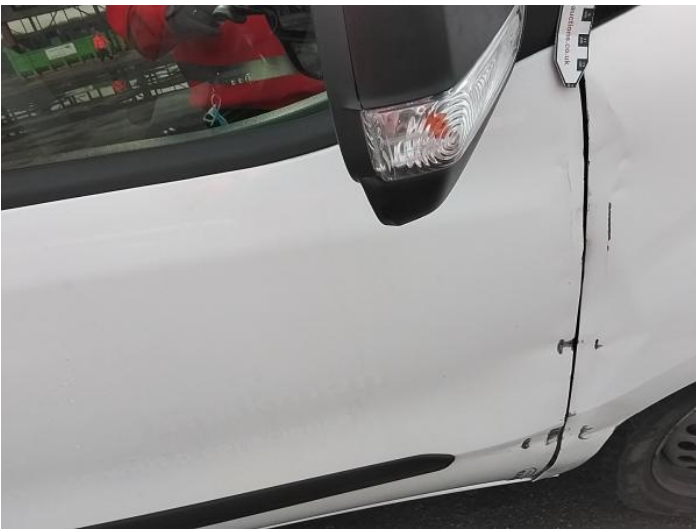
11: Door osf  
Dented  
With Paint Damage

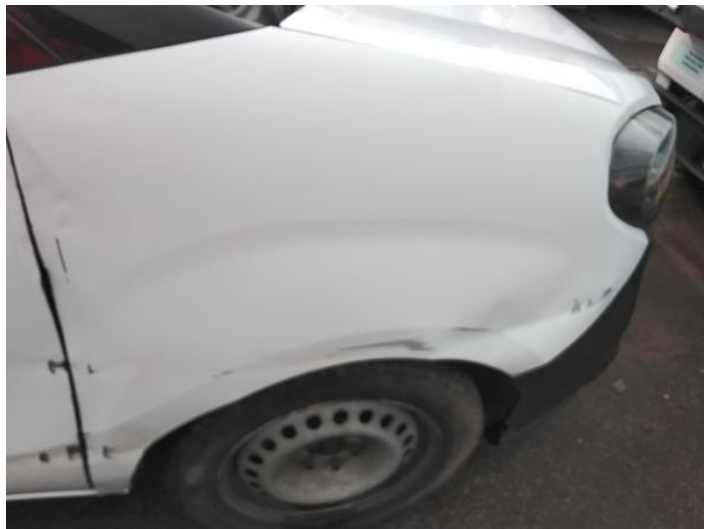
12: Wing osf  
Dented  
Over 30% Of Panel

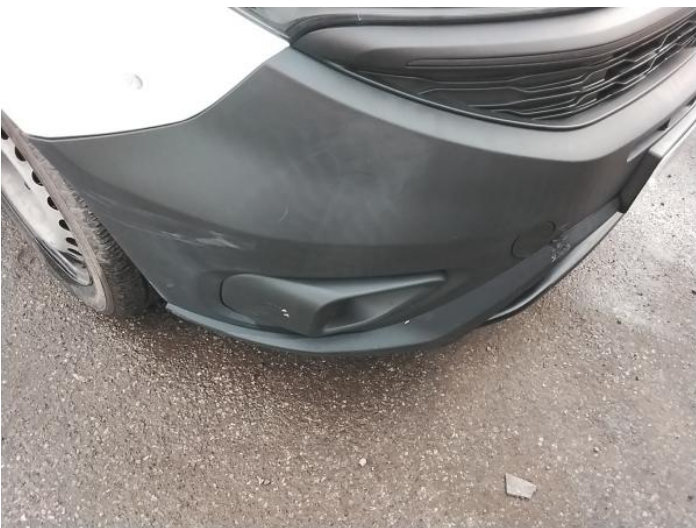
13: Bumper Front  
Scratched  
Over 100mm Thru Paint

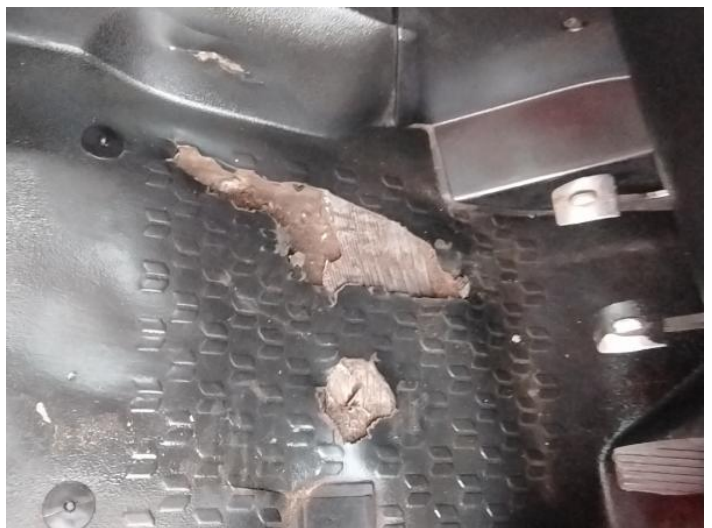
14: Carpets Front  
Holed  
Over 3mm

| <b>Carpet Condition</b> | Poor | <b>Upholstery Condition</b> | Poor |

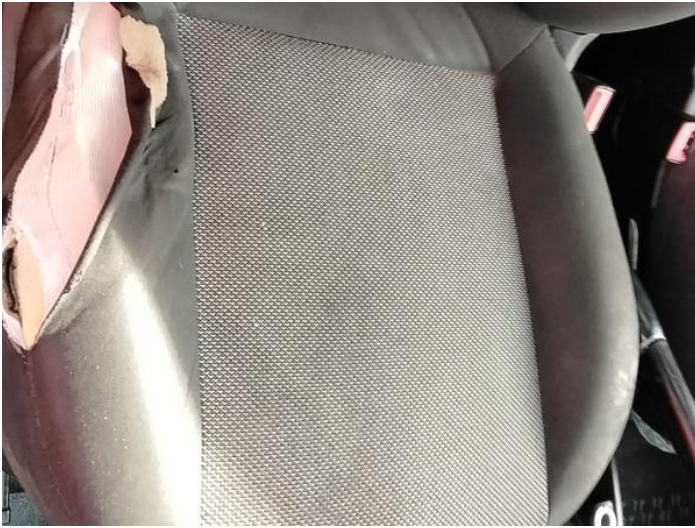
15: Seat Base Cover osf  
Holed  
Over 3mm

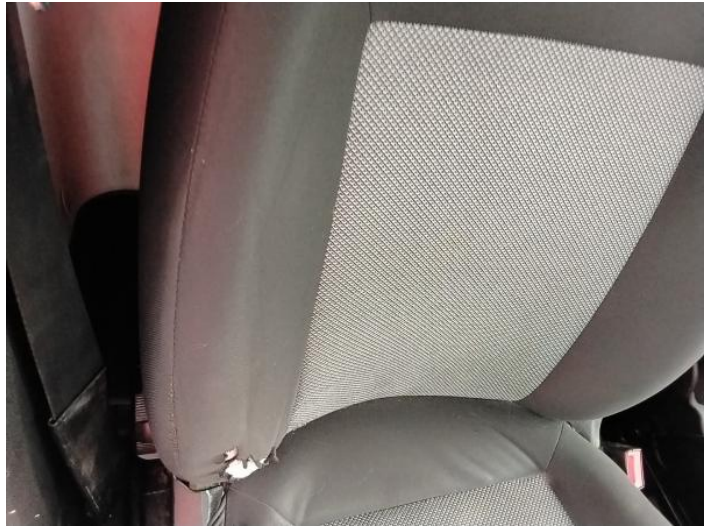
16: Seat Back Cover osf  
Holed  
Over 3mm

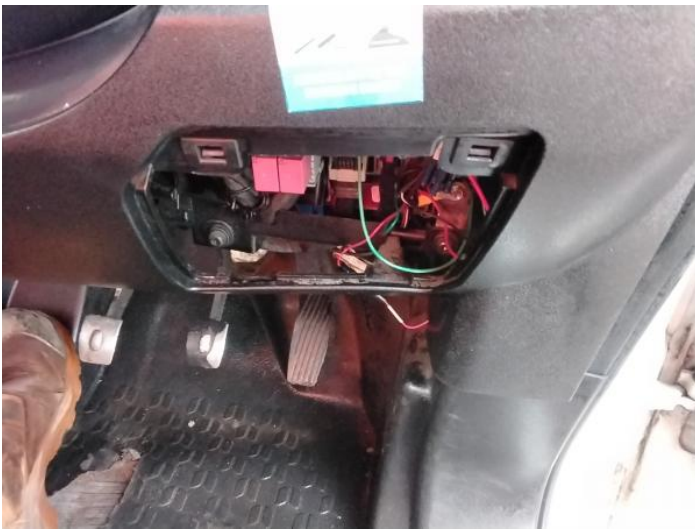
17: Fascia Panel  
Missing  
Replace

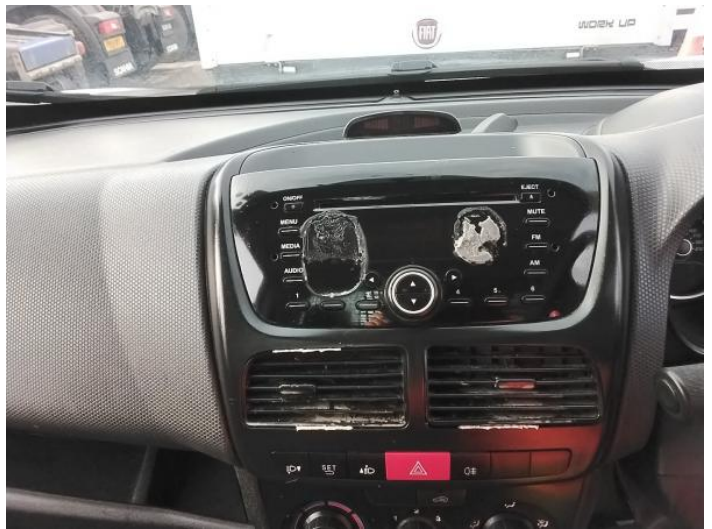
18: Fascia Panel  
Soiled  
Heavy

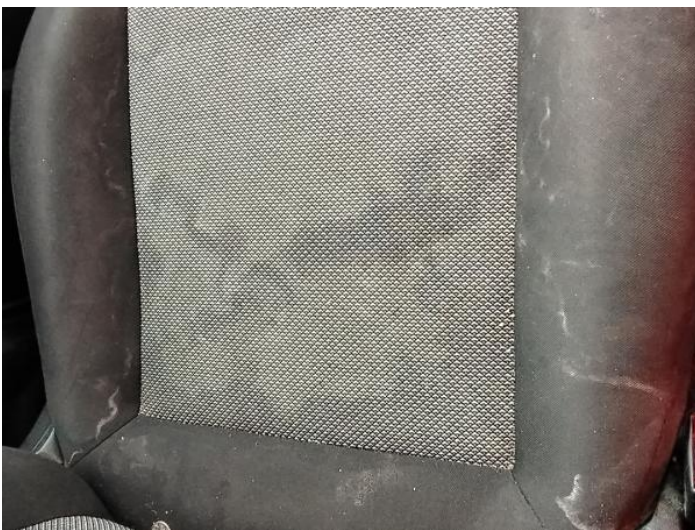
19: Seat Base Cover nsf  
Soiled  
Heavy

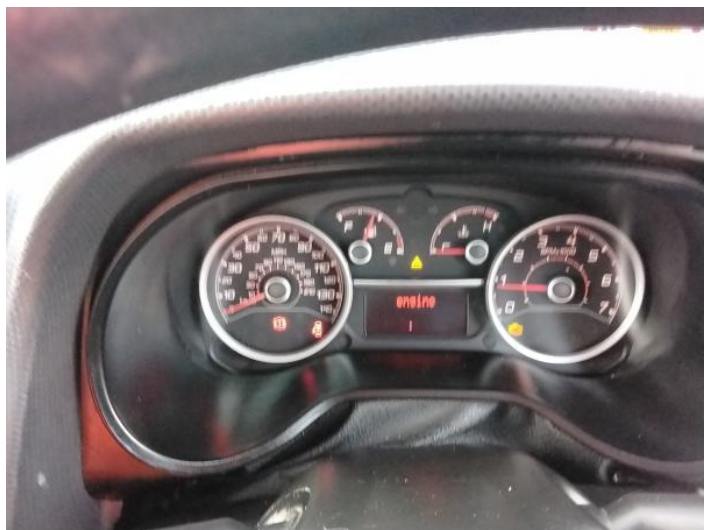
\*WARNING LIGHTS ON DASH\* AD-BLUE

20: Dash Warning Lights  
Displayed  
No Action

| EML light illuminated | Fault | DPF light illuminated | OK |
