# VEHICLE INSPECTION REPORT

**SV16KUD**

## Mercedes-Benz Actros 1824

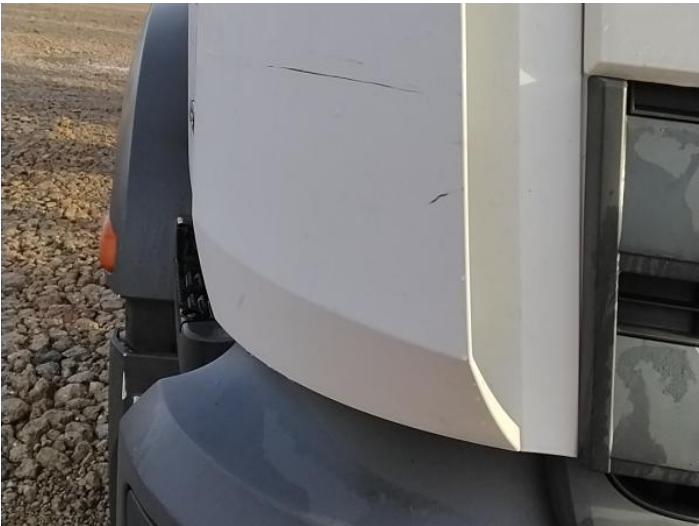
1: Bumper Front  
Scratched  
UpTo 25mm Not Thru Paint
