## VEHICLE INSPECTION REPORT

**SK12XNV**

### Volkswagen Crafter CR35 2.0 TDI 109PS

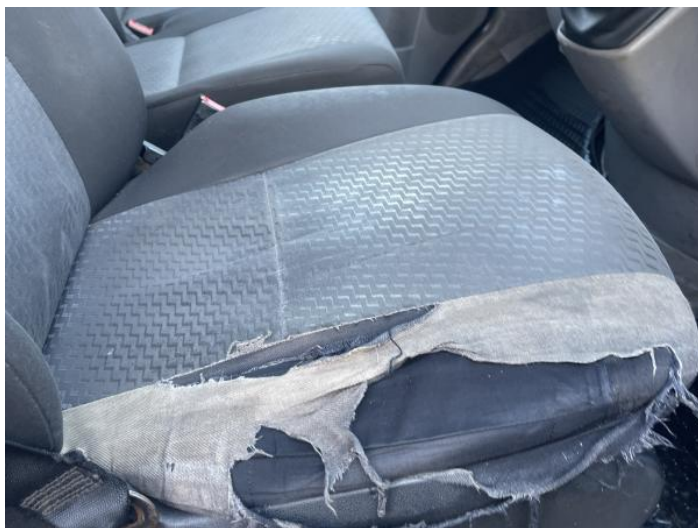
1: Seat Base Cover osf  
Torn  
Over 3mm

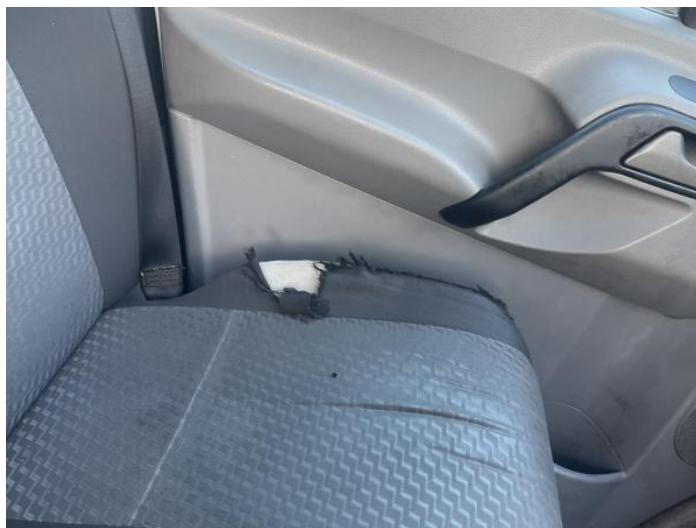
2: Seat Base Cover nsf  
Torn  
Over 3mm

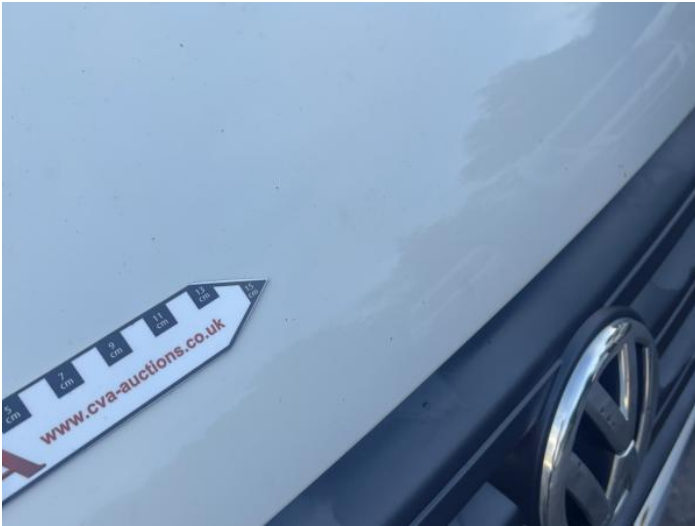
3: Bonnet  
Dented  
Over 30mm

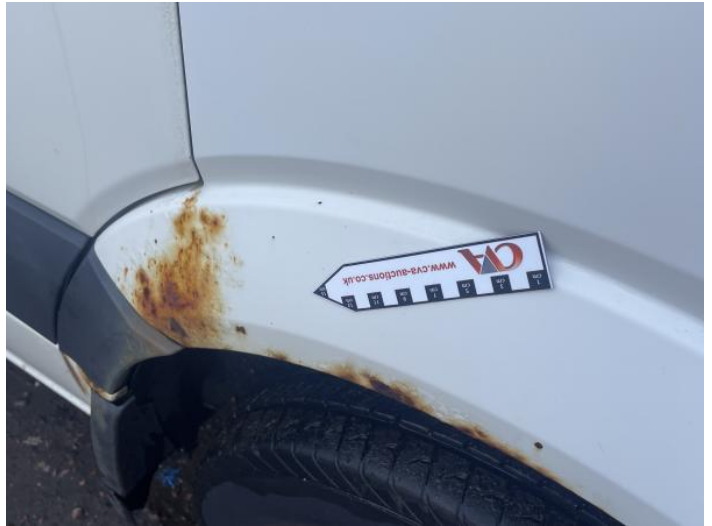
4: Wing osf  
Rusted  
Over 5mm

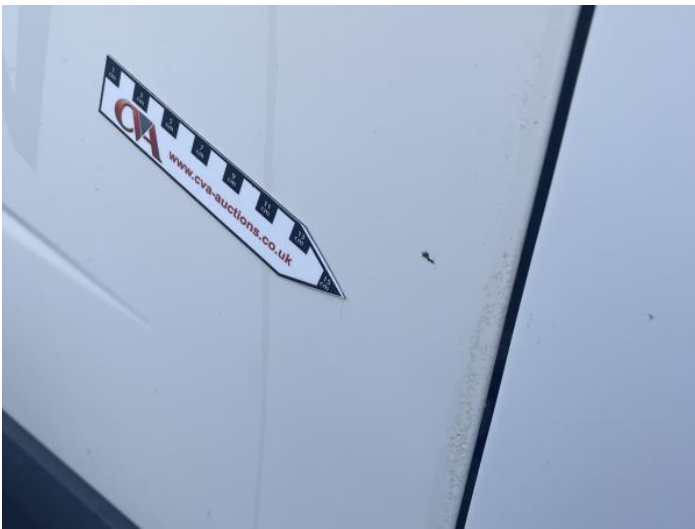
5: Door osf  
Dented  
Over 2 UpTo 10mm

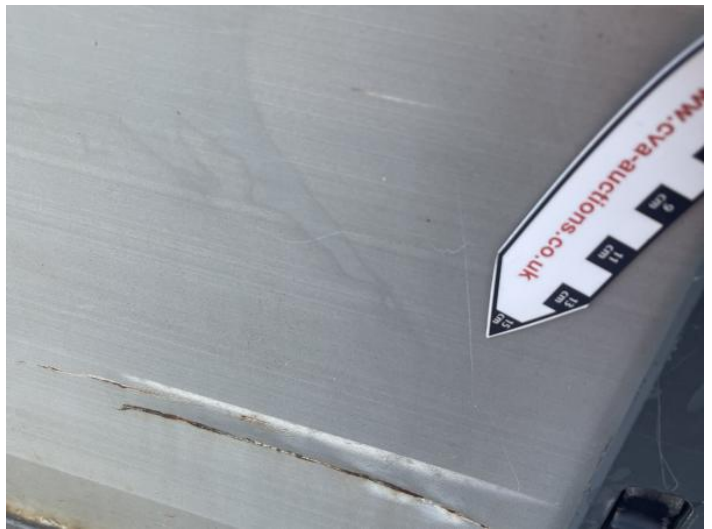
6: Qtr Panel osr  
Dented  
With Paint Damage

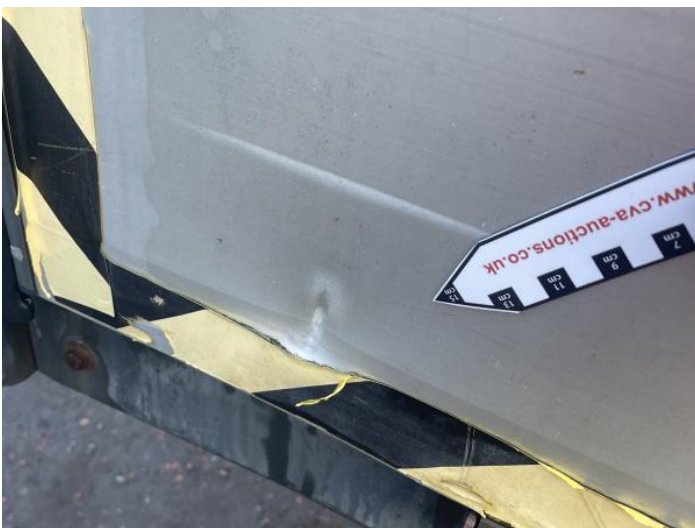
7: Tailgate  
Dented  
With Paint Damage

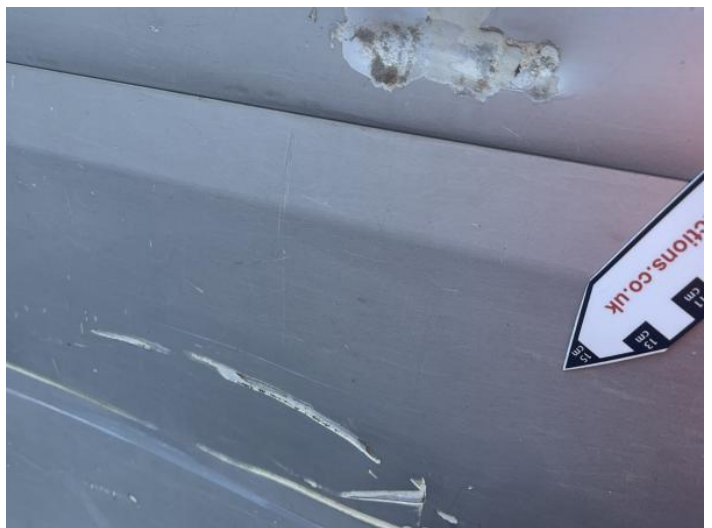
8: Qtr Panel nsr  
Dented  
Over 30mm

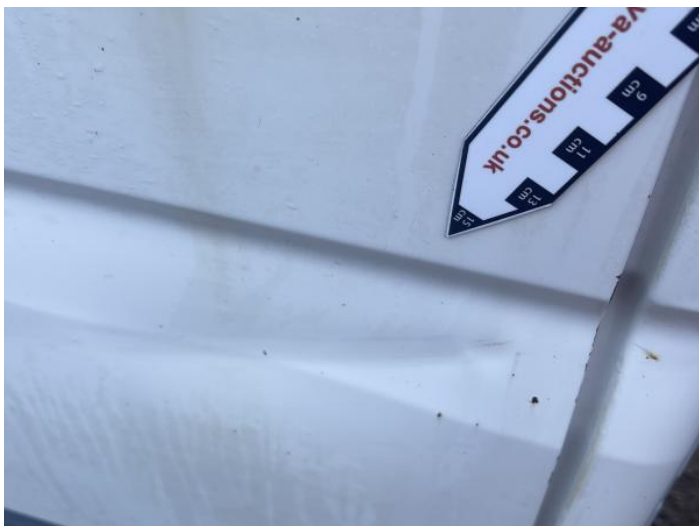
9: Door nsr  
Dented  
With Paint Damage

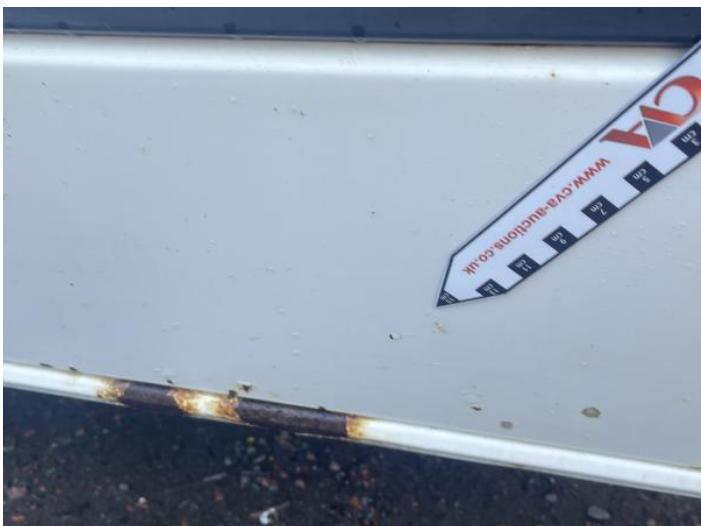
10: Sill ns  
Rusted  
Over 5mm

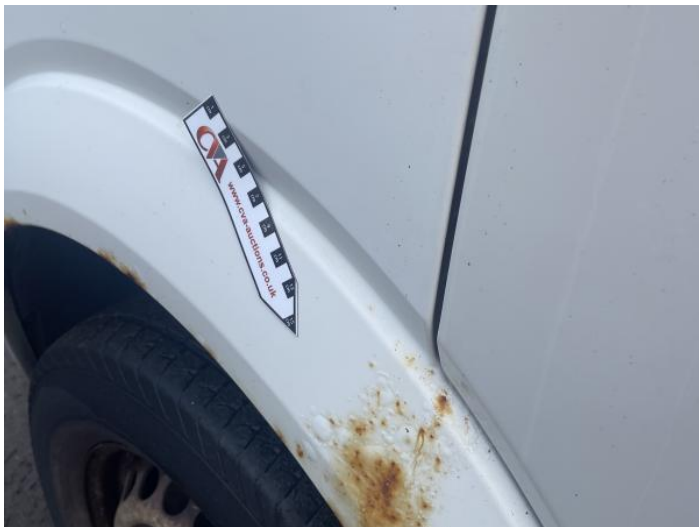
11: Wing nsf  
Rusted  
Over 5mm
