## VEHICLE INSPECTION REPORT

**BJ16UJU**

### Ford Transit 350 TREND 2.2 TDCi 125ps

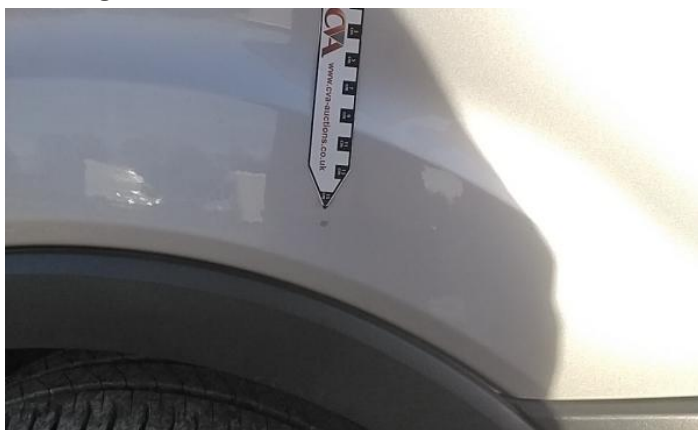
1: Wing of  
Chipped  
1 To 5

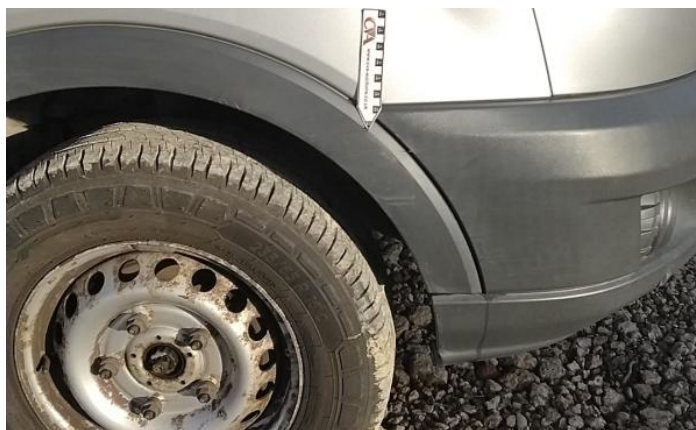
2: Moulding of Wing  
Scuffed (Unpainted)  
Over 100mm

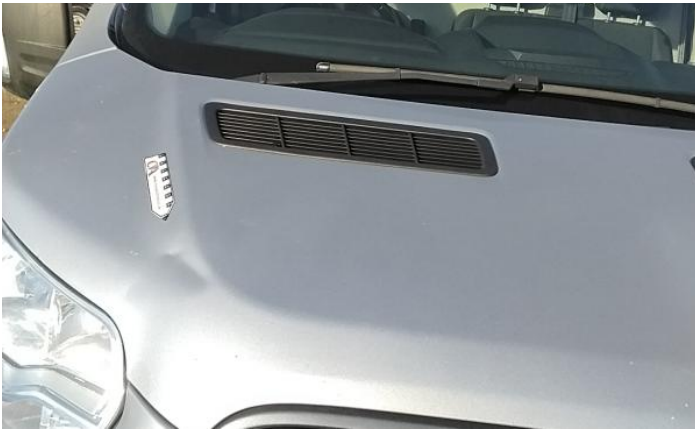
3: Bonnet  
Dented  
Over 2 UpTo 10mm

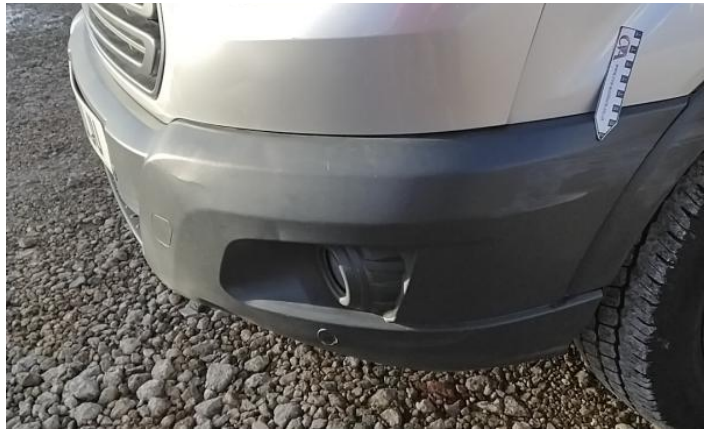
4: Bumper Front Moulding  
Scuffed (Unpainted)  
Over 100mm

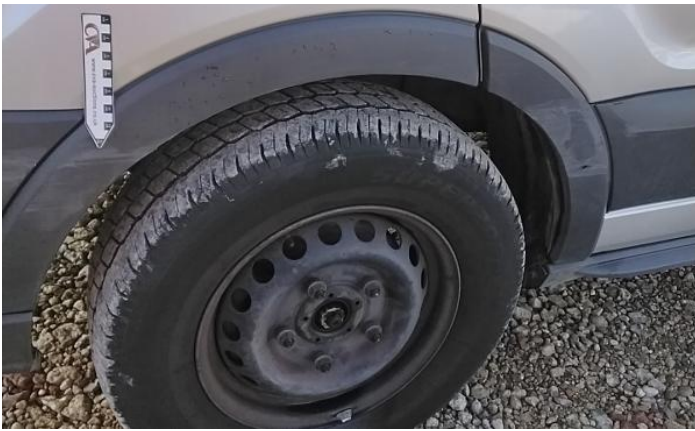
5: Moulding nsf Wing  
Scuffed (Unpainted)  
Over 100mm

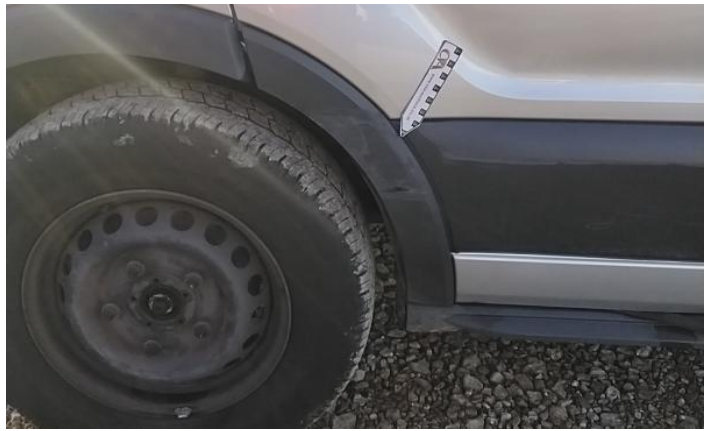
6: Door Moulding nsf  
Broken  
Replace

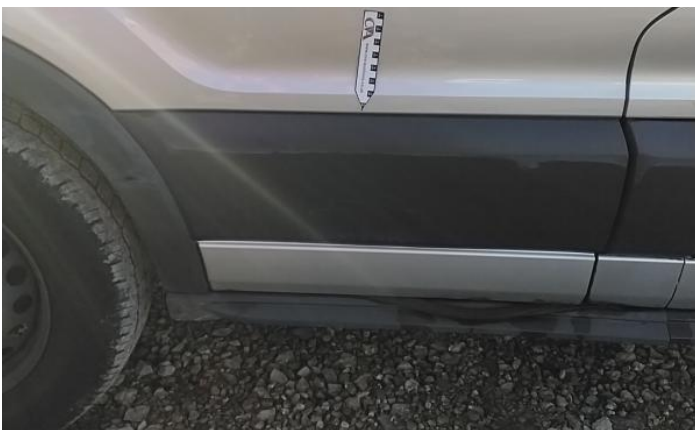
7: Door Moulding nsf  
Scuffed (Unpainted)  
Over 100mm

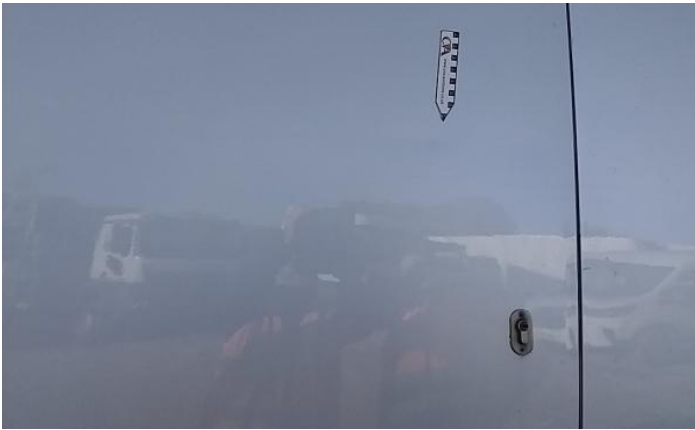
9: Door nsr  
Dented  
Over 30mm

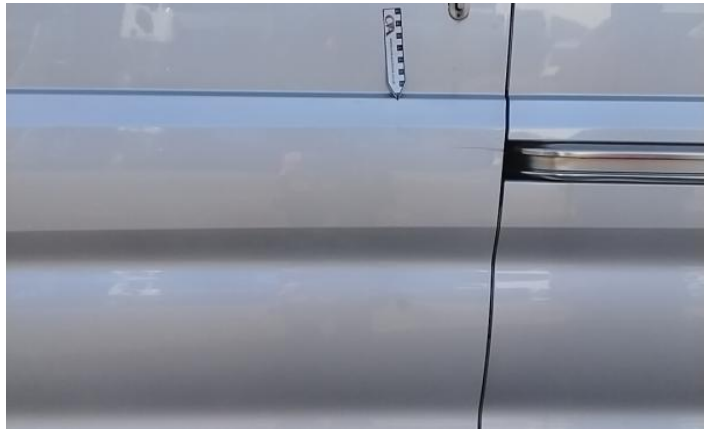
10: Door nsr  
Dented  
Between 10mm + 30mm

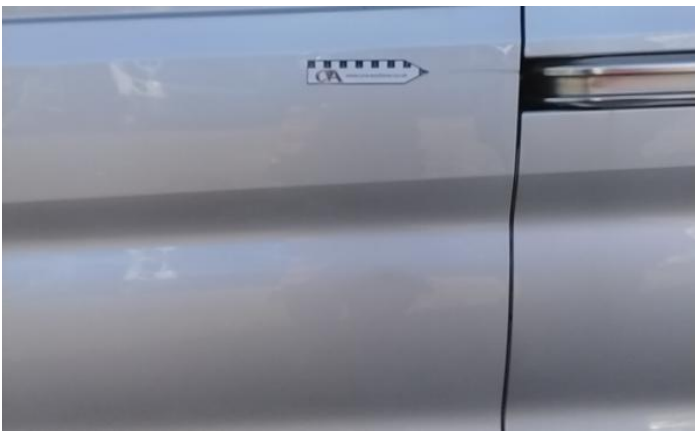
11: Door nsr  
Scratched  
Over 25mm Thru Paint

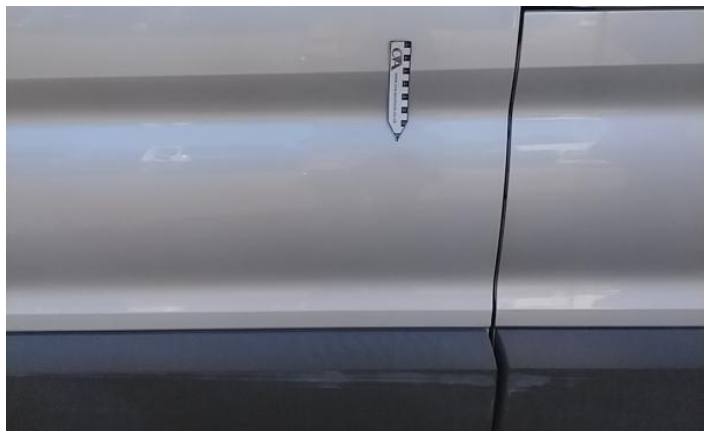
12: Door nsr  
Dented  
Between 10mm + 30mm

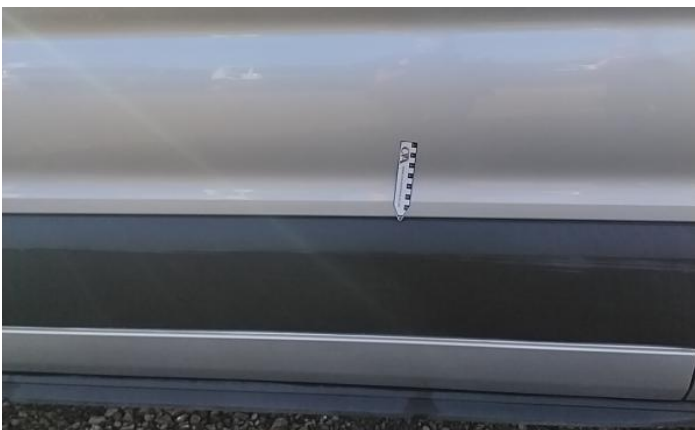
13: Door Moulding nsr  
Scuffed (Unpainted)  
Over 100mm

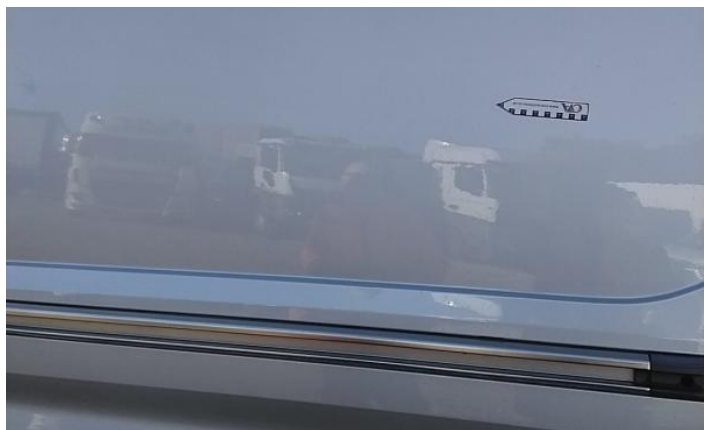
14: Qtr Panel nsr  
Scratched  
Over 25mm Not Thru Paint

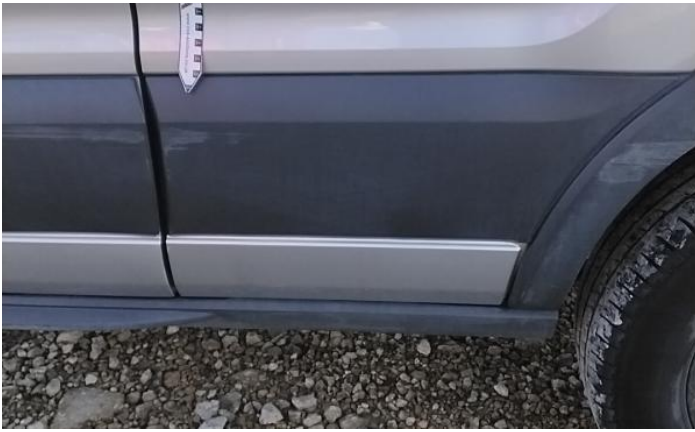
15: Qtr Panel Moulding ns  
Scuffed (Unpainted)  
Over 100mm

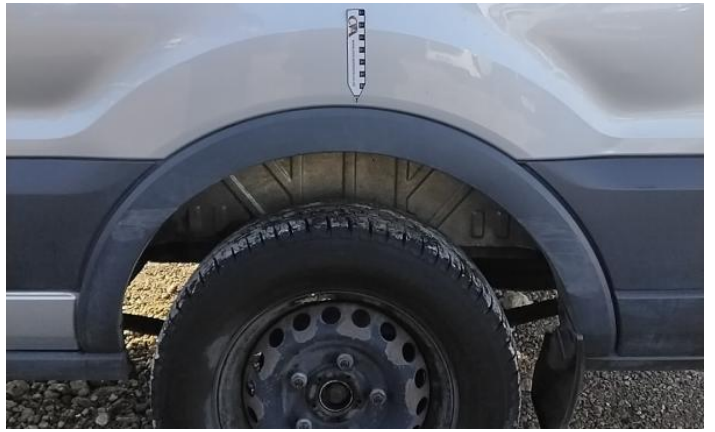
16: Qtr Panel Arch Extension ns  
Scuffed (Unpainted)  
Over 100mm

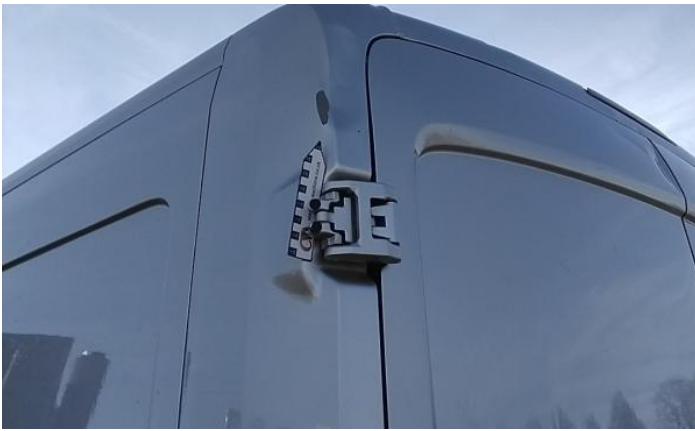
17: Qtr Panel nsr  
Dented  
With Paint Damage

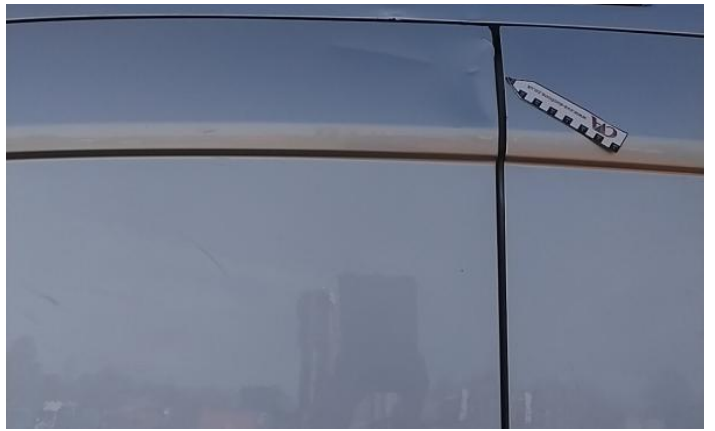
18: Door nsr  
Dented  
With Paint Damage

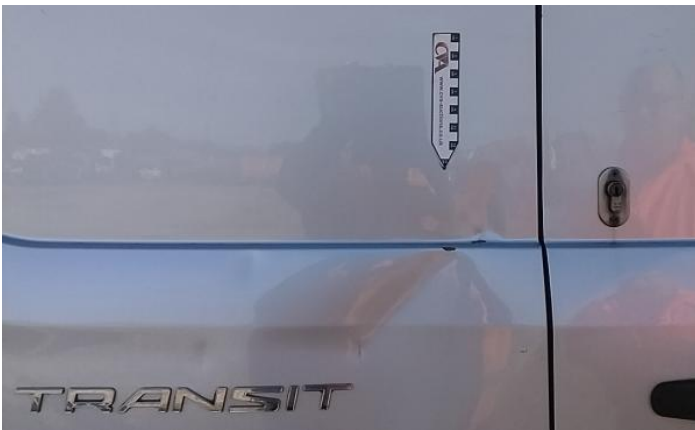
19: Door nsr  
Dented  
With Paint Damage

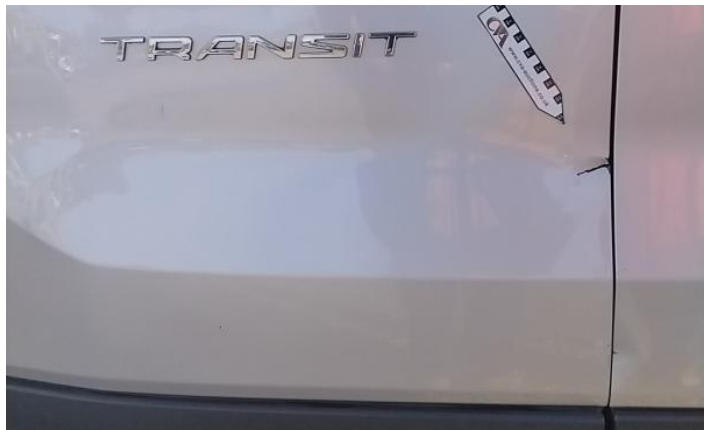
20: Door nsr  
Hole  
Over 10mm

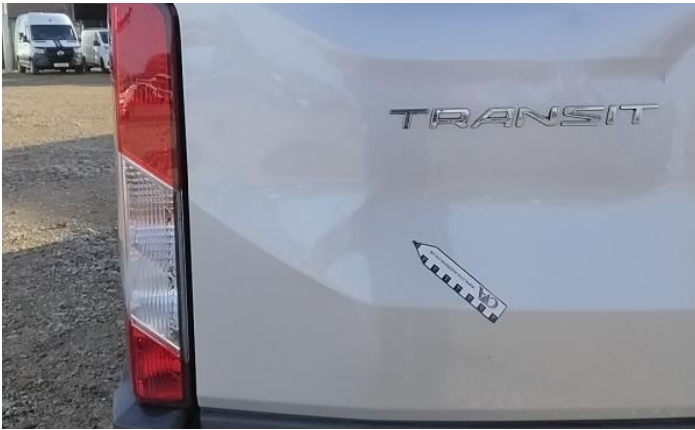
21: Door nsr  
Dented  
Over 30mm

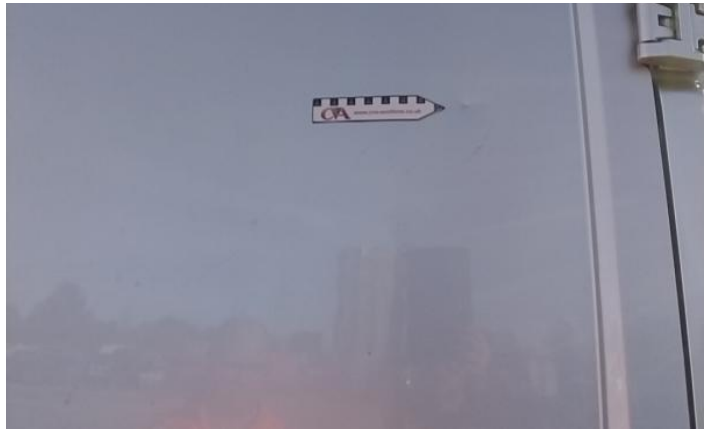
22: Door osr  
Dented  
Over 30mm

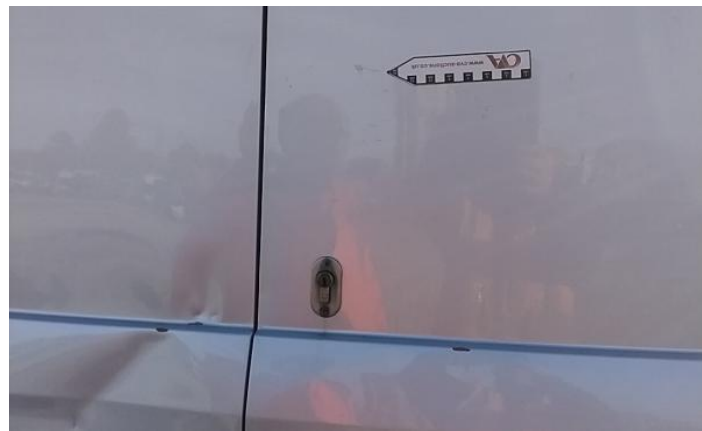
23: Door osr  
Scratched  
Over 25mm Thru Paint

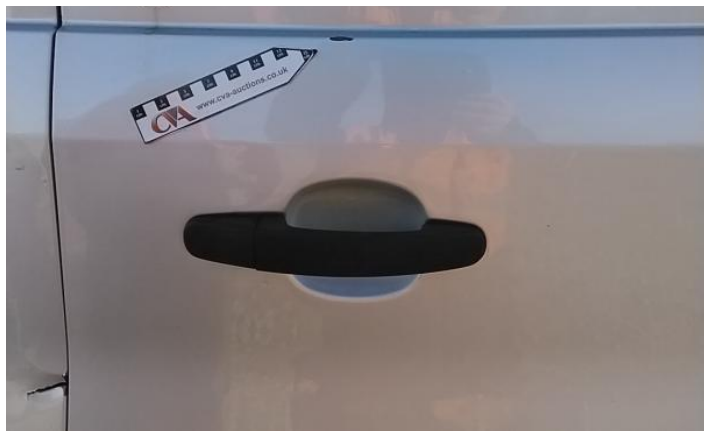
24: Door osr  
Scratched  
UpTo 25mm Thru Paint

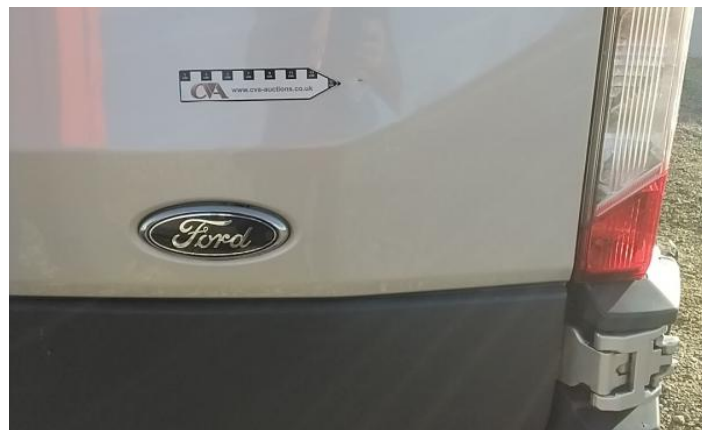
25: Door osr  
Dented  
With Paint Damage

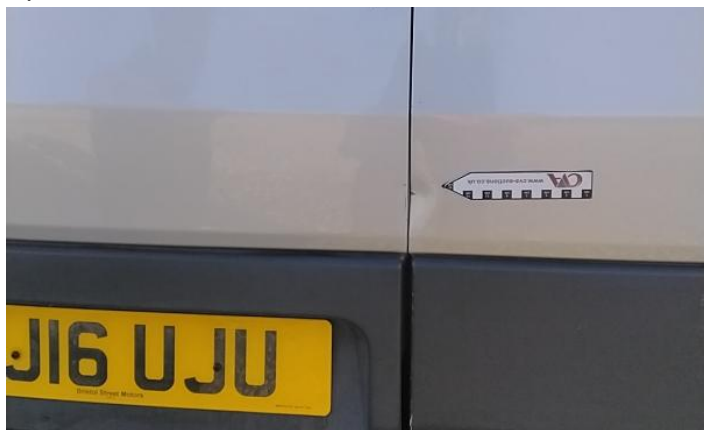
26: Door osr  
Dented  
With Paint Damage

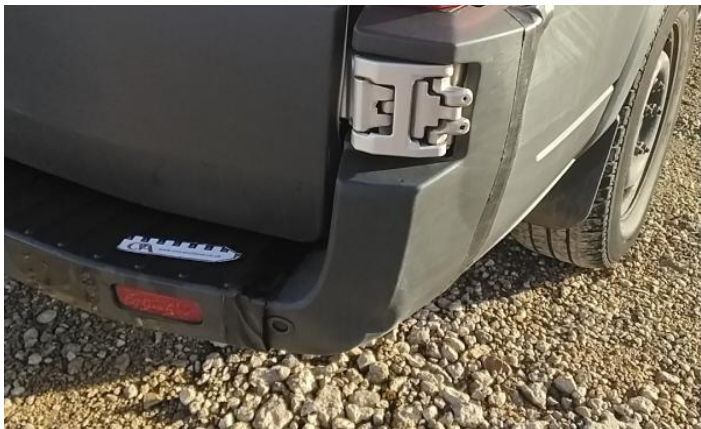
27: Bumper Rear Moulding  
Broken  
Replace

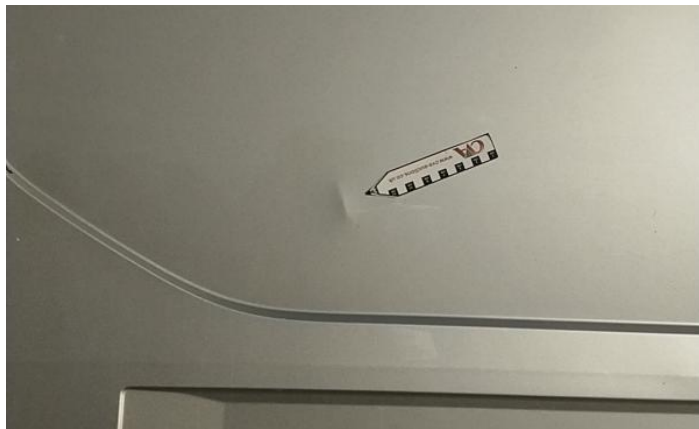
28: Qtr Panel osr  
Dented  
Over 30mm

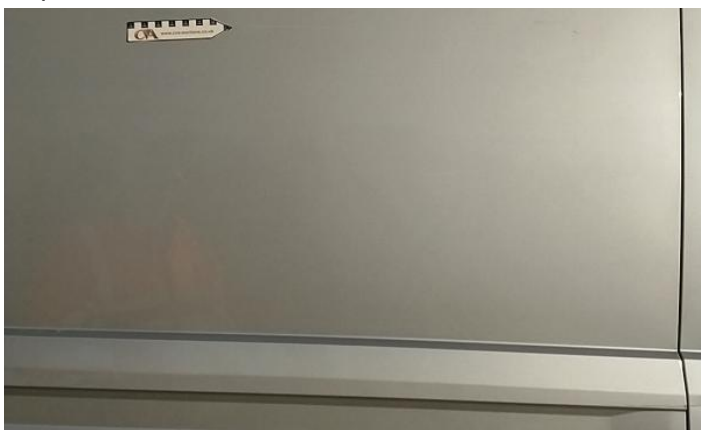
29: Qtr Panel osr  
Scratched  
Over 25mm Not Thru Paint

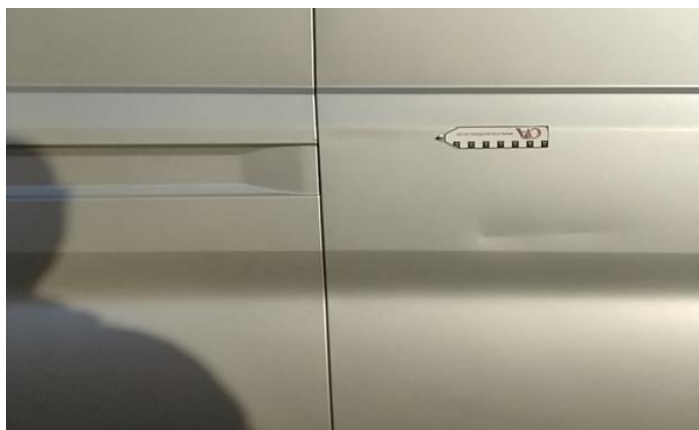
30: Qtr Panel osr  
Dented  
With Paint Damage

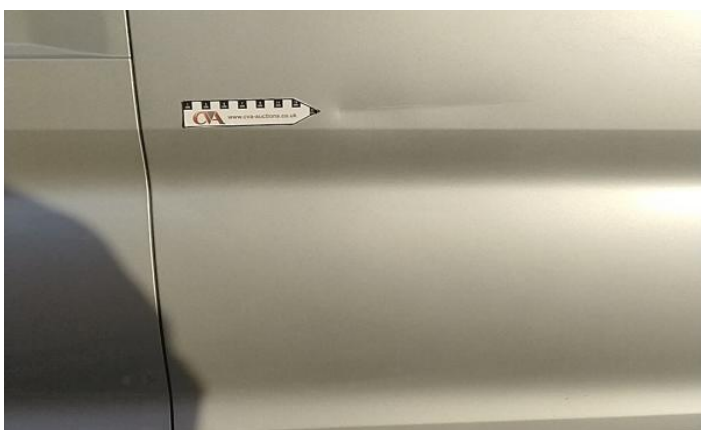
31: Qtr Panel osr  
Dented  
With Paint Damage

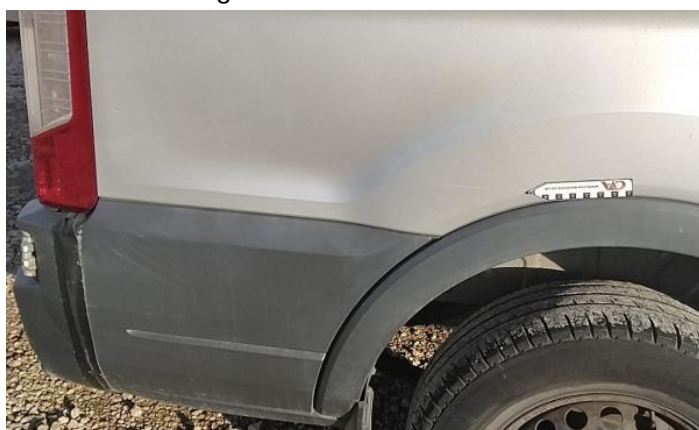
32: Qtr Panel osr  
Scratched  
Over 25mm Not Thru Paint

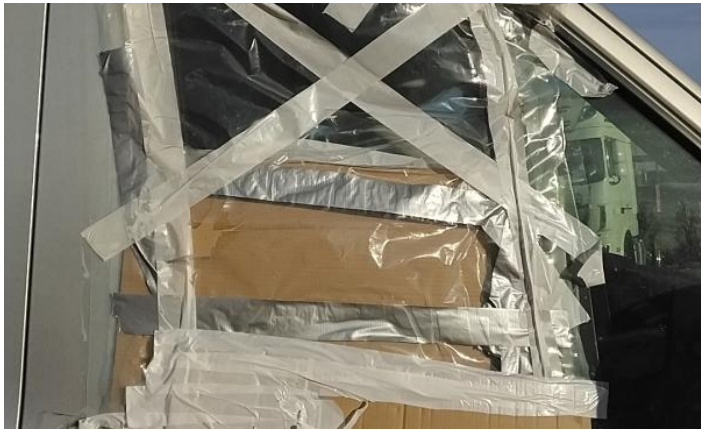
33: Door Window osf  
Missing  
Replace
