# VEHICLE INSPECTION REPORT

**BK14ANU**

## Iveco Eurocargo 75E16

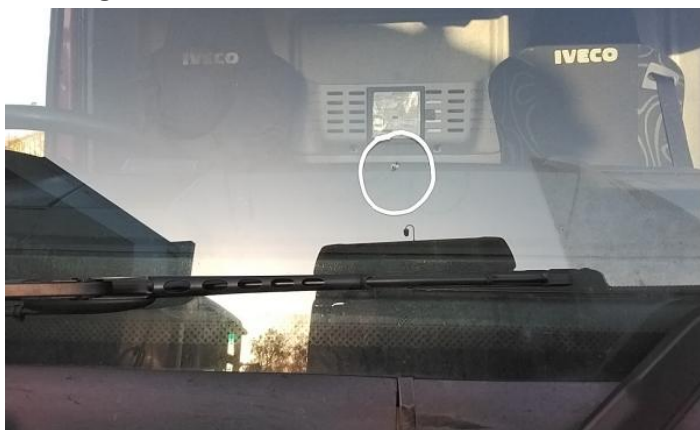
1: Screen Front  
Chipped  
Over 10mm

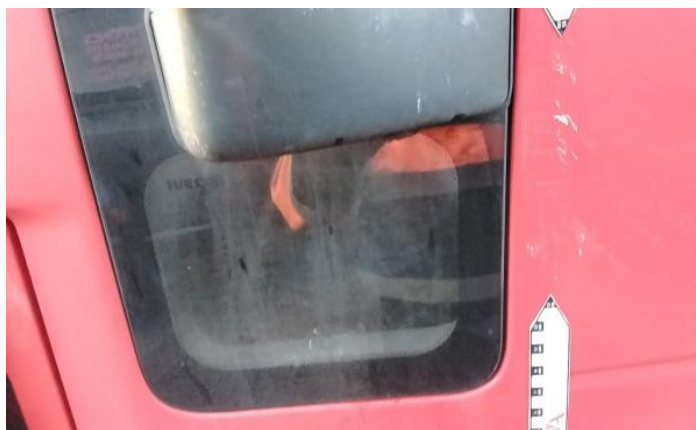
2: Door Moulding nsf  
Scratched (Painted)  
Over 25mm Thru Paint

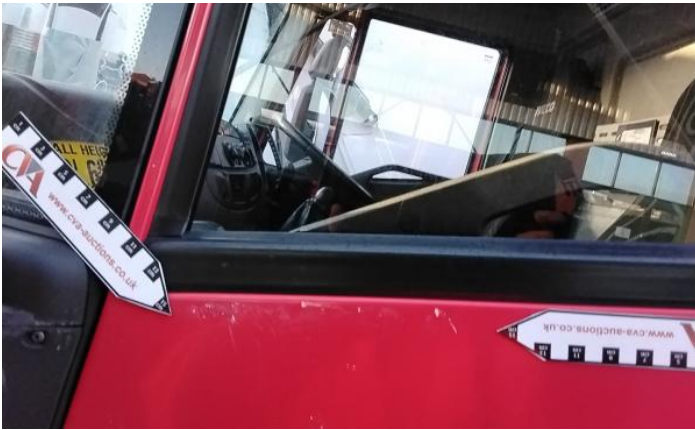
3: Door nsf  
Scratched  
Over 25mm Thru Paint

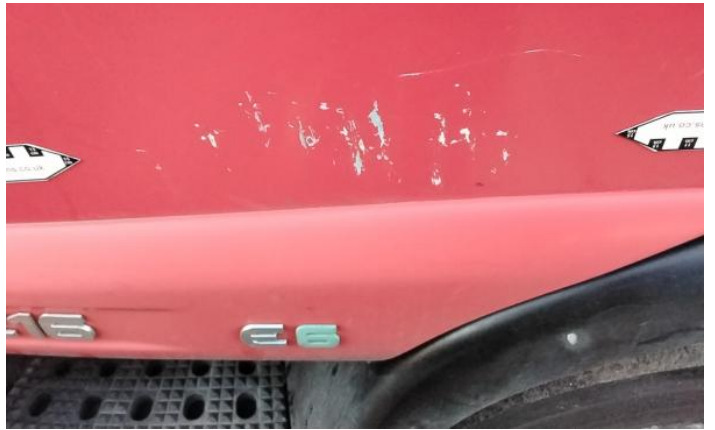
4: Door nsf  
Scratched  
Over 25mm Thru Paint

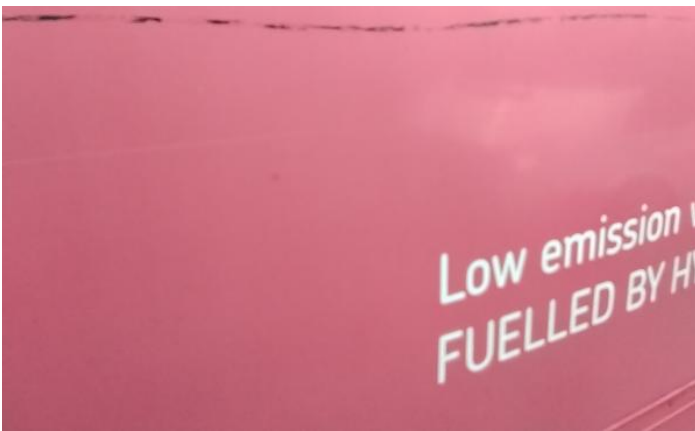
5: Qtr Panel nsr  
Scratched  
Over 25mm Not Thru Paint

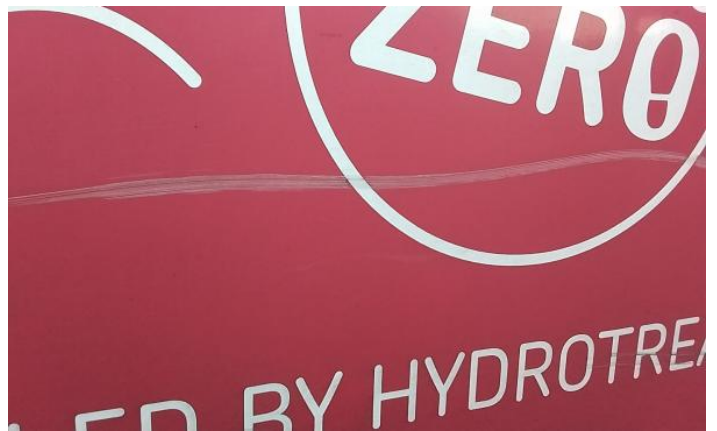
6: Qtr Panel osr  
Scratched  
Over 25mm Thru Paint

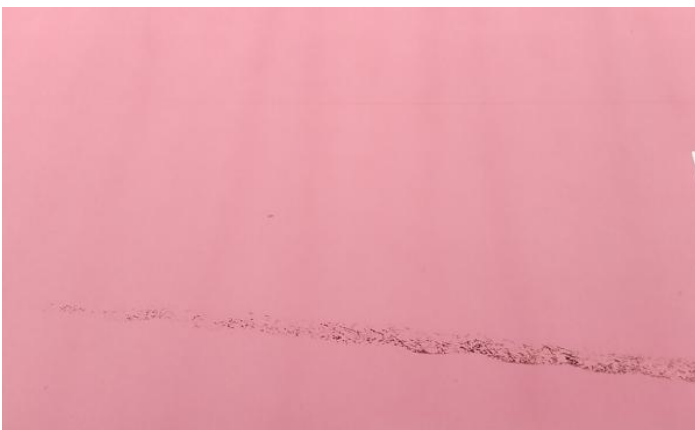
7: Qtr Panel osr  
Scratched  
Over 25mm Not Thru Paint

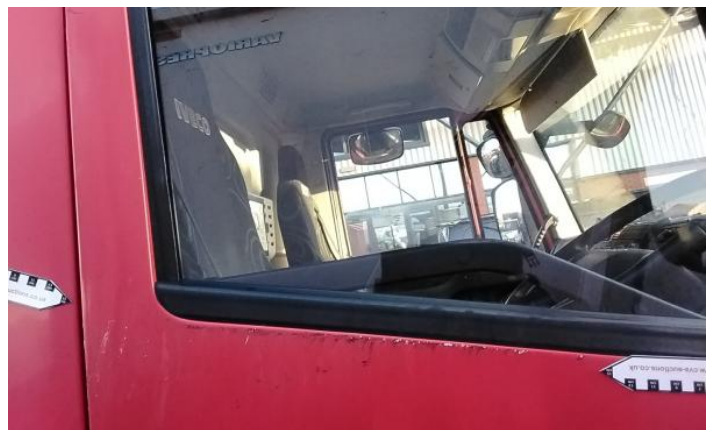
8: Door osf  
Scratched  
Over 25mm Thru Paint

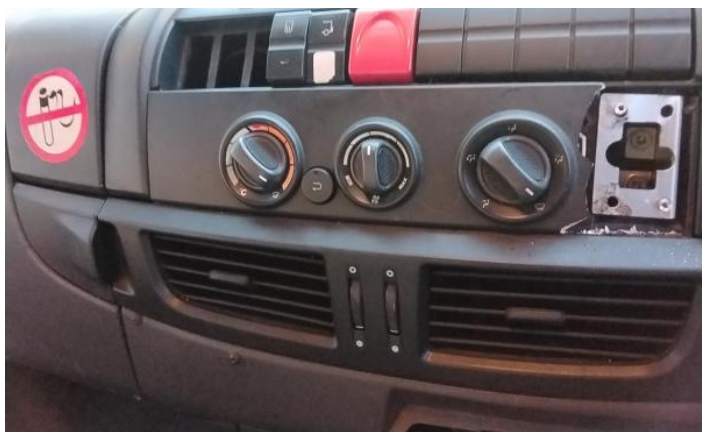
9: Fascia Panel  
Broken  
Replace
