# VEHICLE INSPECTION REPORT

**PE63NLT**

## Daf LF 45.140

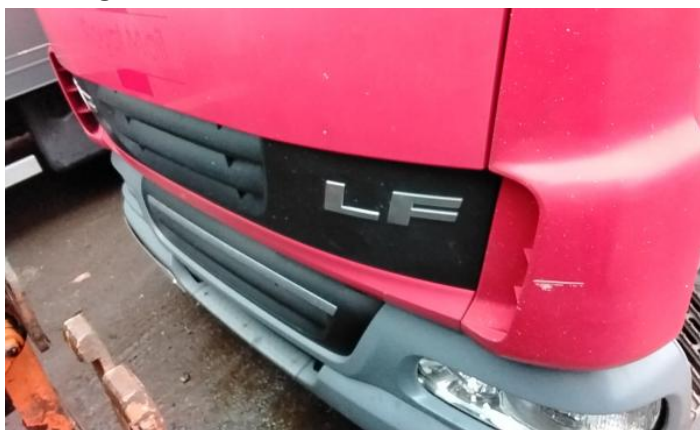
1: Bonnet  
Chipped  
Multiple Chips

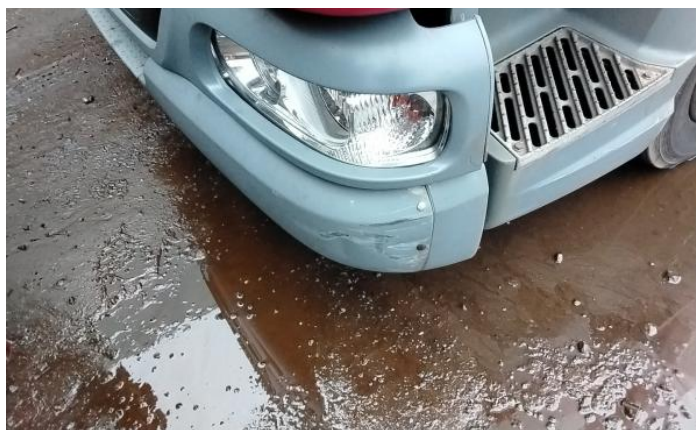
2: Bumper Front  
Dented  
With Paint Damage

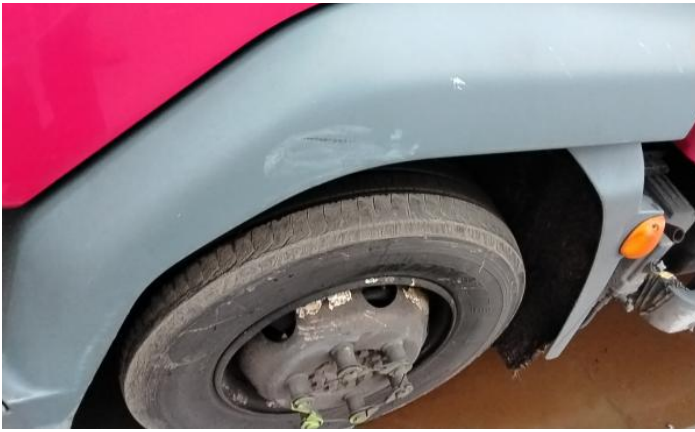
3: Wing nsf  
Scratched  
Over 25mm Thru Paint

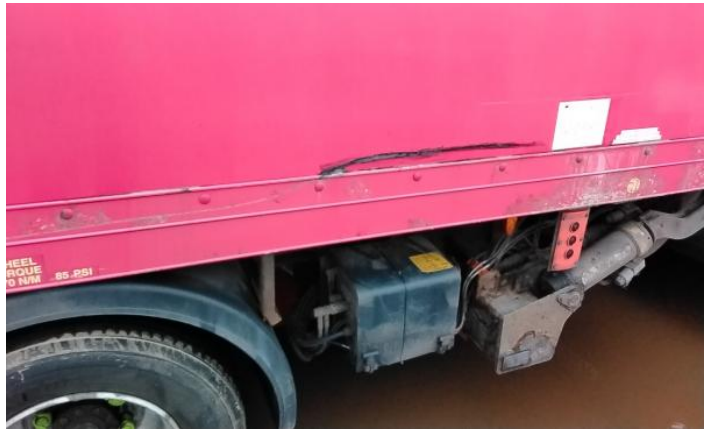
4: Qtr Panel nsr  
Scratched  
Over 25mm Thru Paint

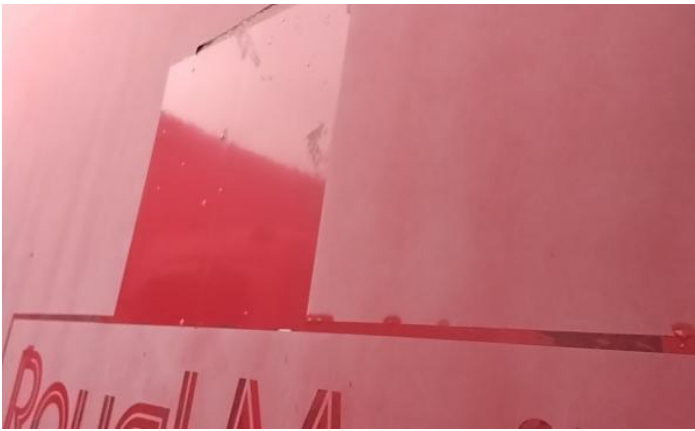
5: Qtr Panel osr  
Scratched  
Over 25mm Thru Paint

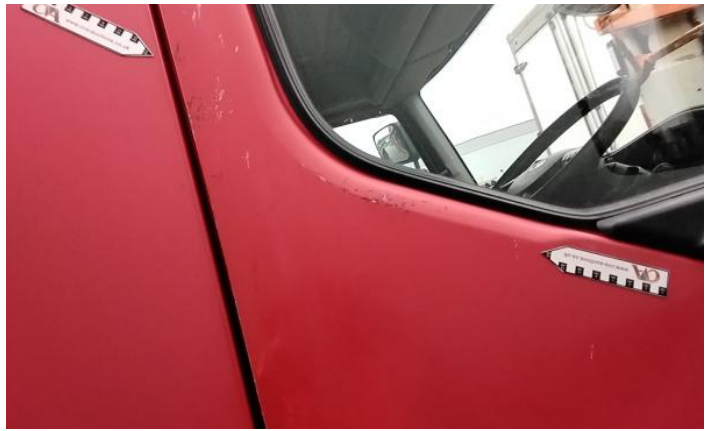
6: Door osf  
Scratched  
Over 25mm Thru Paint

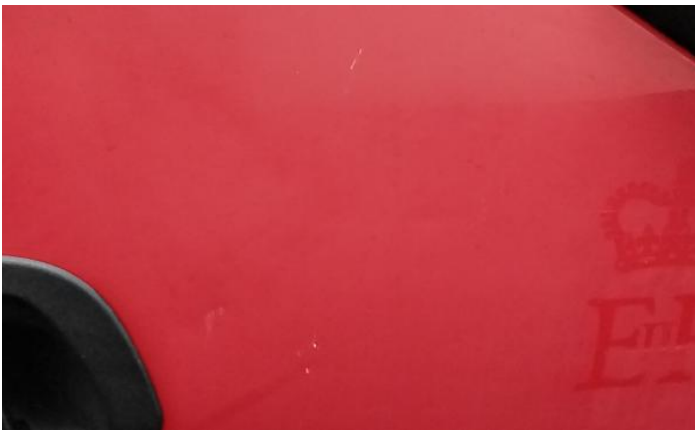
7: Door osf  
Scratched  
Over 25mm Thru Paint

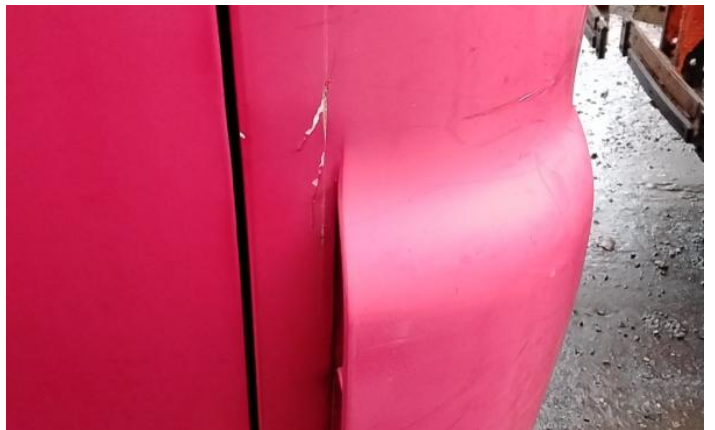
8: Panel Front  
Cracked  
Replace
