# VEHICLE INSPECTION REPORT

**PF67KDN**

## Fiat Ducato 2.3 MULTI JET 130PS

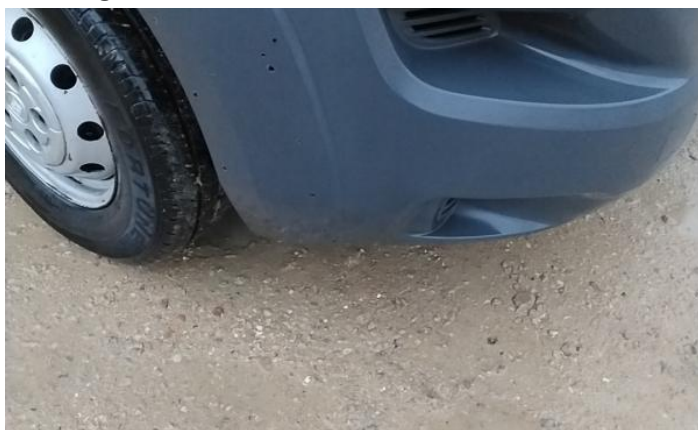
1: Bumper Front Moulding  
Missing  
Replace

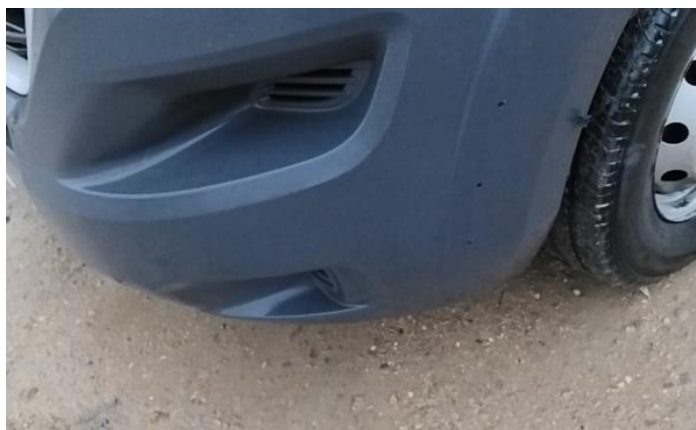
2: Bumper Front Moulding  
Missing  
Replace

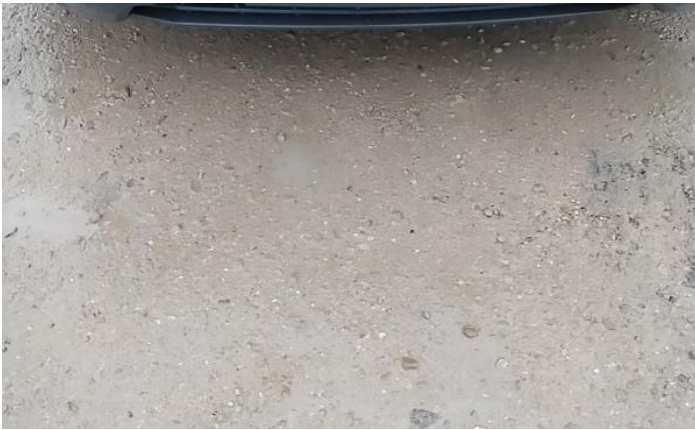
3: Bumper Front  
Scratched  
Over 25mm Not Thru Paint

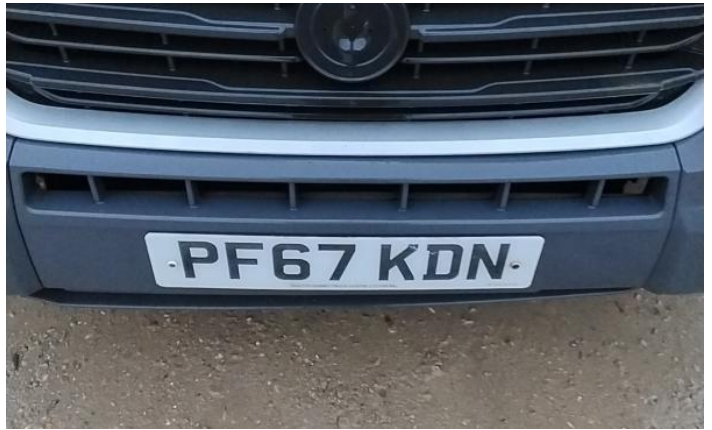
4: Badgedecal Front  
Missing  
Replace

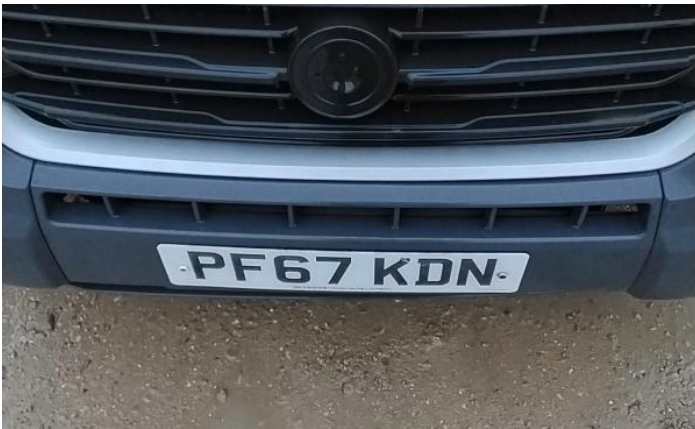
5: Grille Front  
Scratched (Painted)  
Over 25mm Not Thru Paint

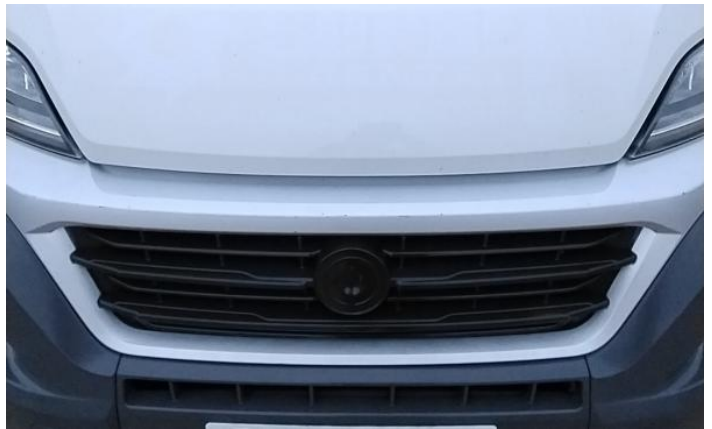
6: Bonnet  
Chipped  
Multiple Chips

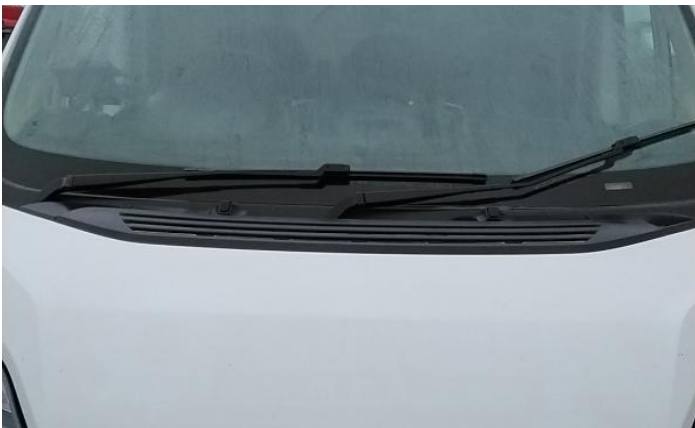
7: Screen Front  
Chipped  
UpTo 10mm

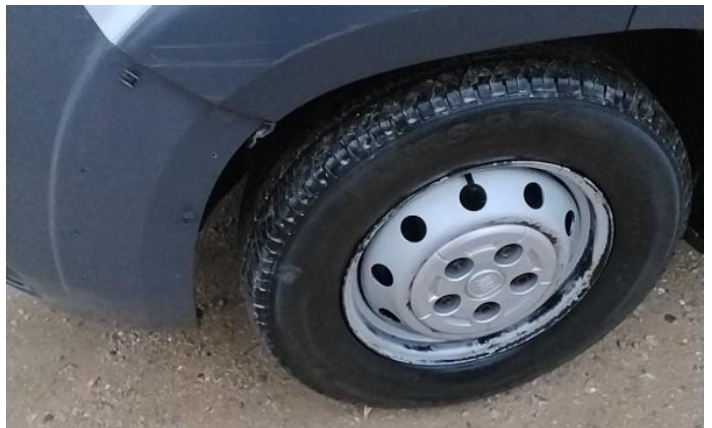
8: Wing Front Arch Extension ns  
Scuffed (Unpainted)  
Over 100mm

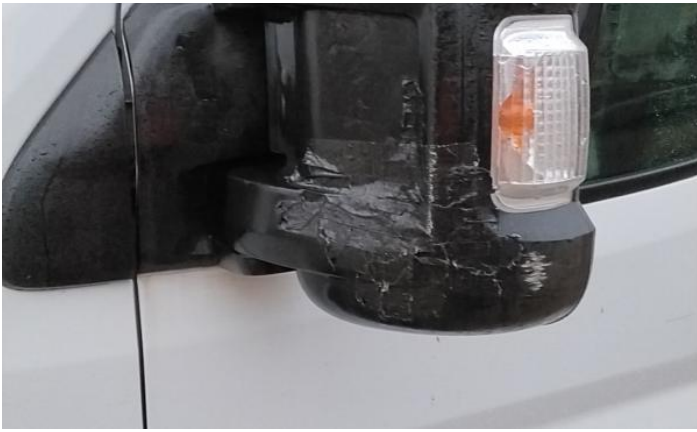
9: Door Mirror Assy nsf  
Broken  
Replace

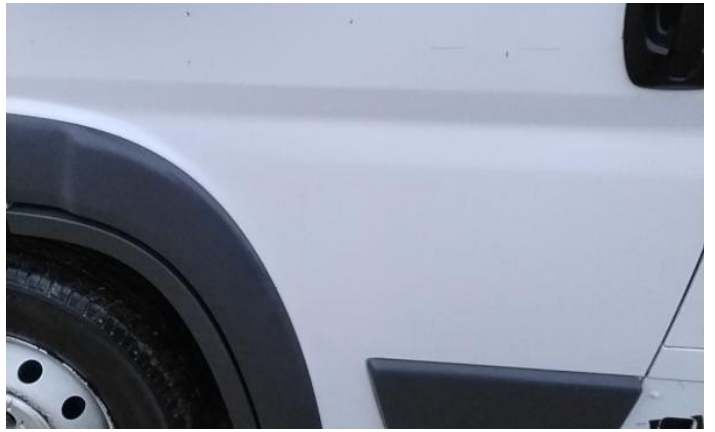
10: Door nsf  
Scratched  
Over 25mm Thru Paint

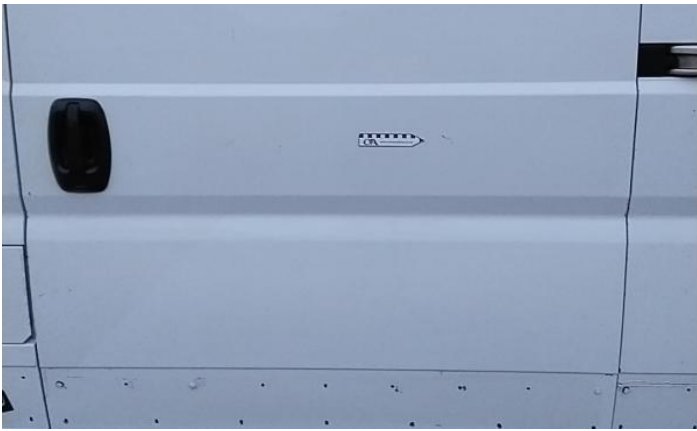
11: Door nsr  
Scratched  
Over 25mm Thru Paint

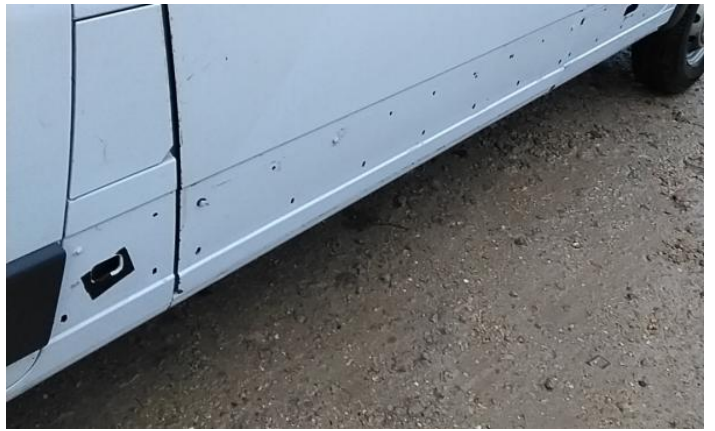
12: Door Moulding nsr  
Missing  
Replace

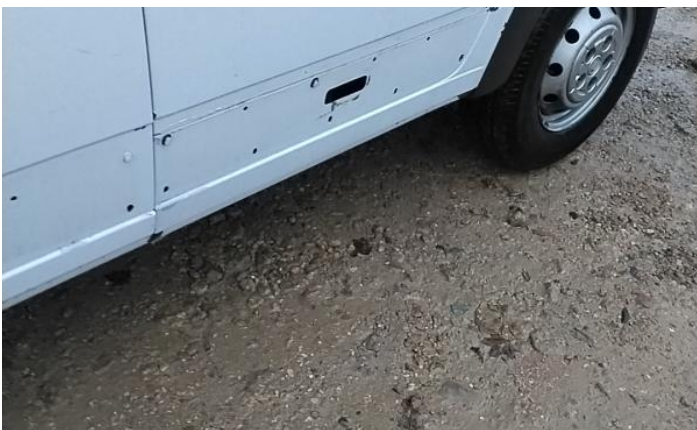
13: Qtr Panel Moulding ns  
Missing  
Replace

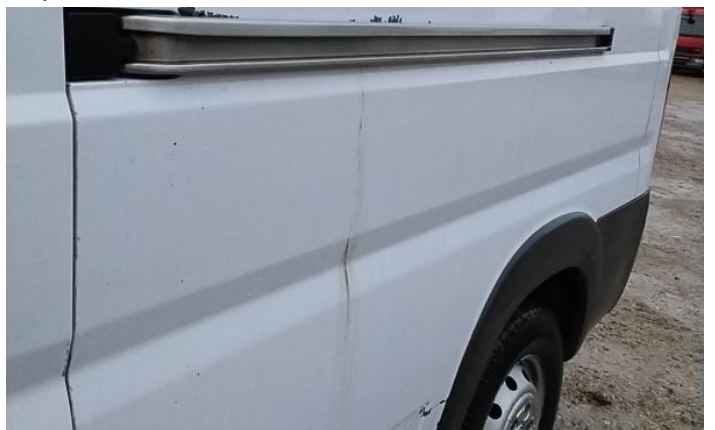
14: Qtr Panel nsr  
Scratched  
Rusted

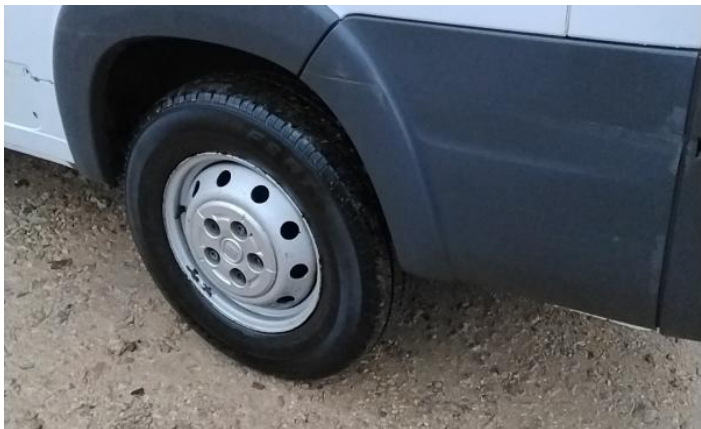
15: Qtr Panel Moulding ns  
Scuffed (Unpainted)  
Over 100mm

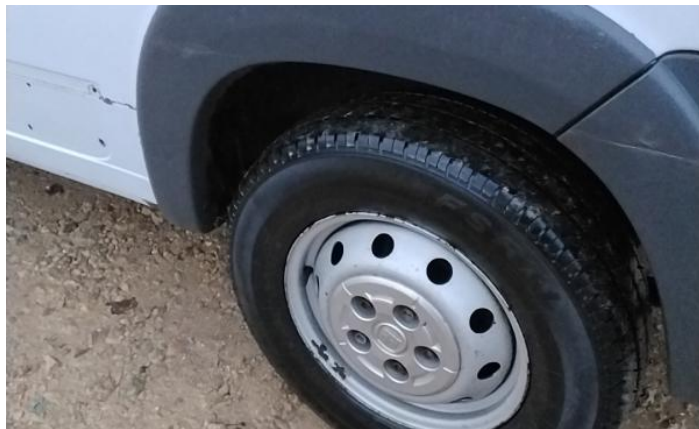
16: Qtr Panel Arch Extension ns  
Scuffed (Unpainted)  
Over 100mm

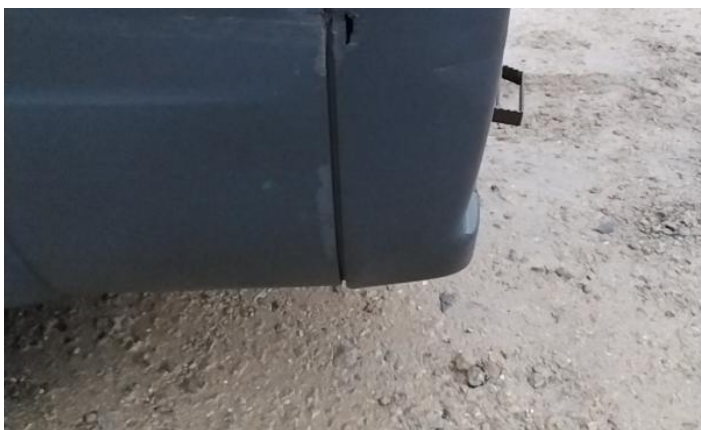
17: Bumper Rear Moulding  
Broken  
Replace

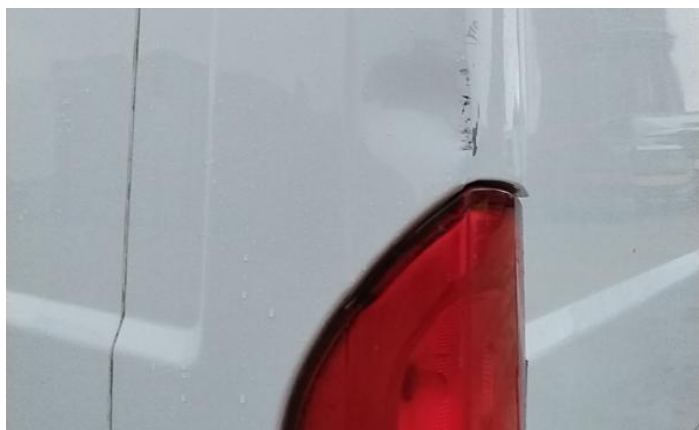
18: Qtr Panel nsr  
Dented  
With Paint Damage

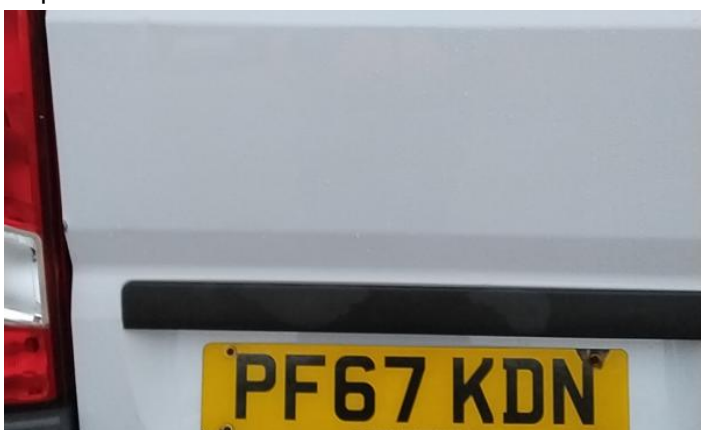
19: Door nsr  
Chipped  
1 To 5

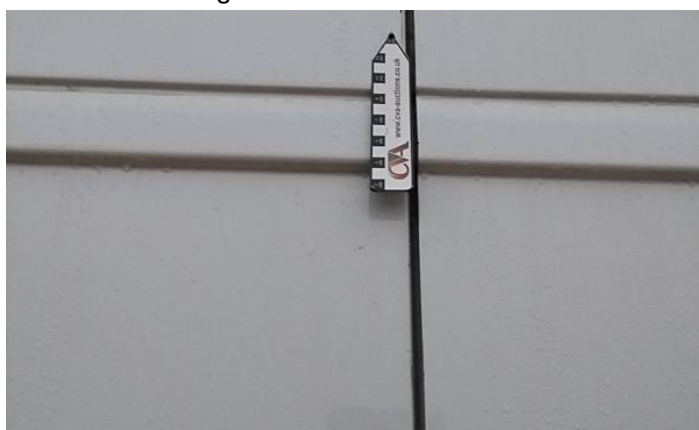
20: Door nsr  
Chipped  
Multiple Chips

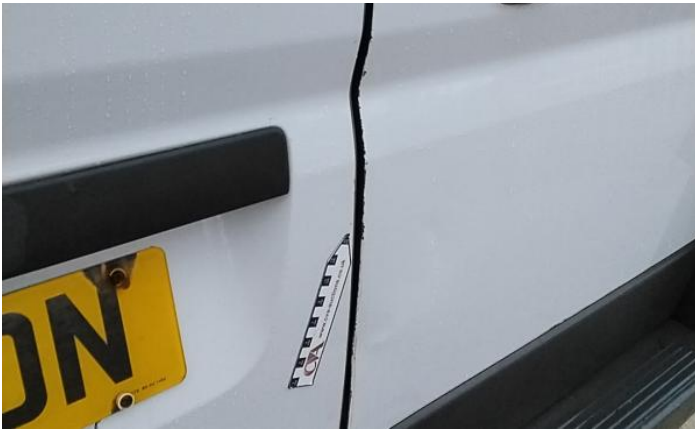
21: Door osr  
Chipped  
Edge Chip

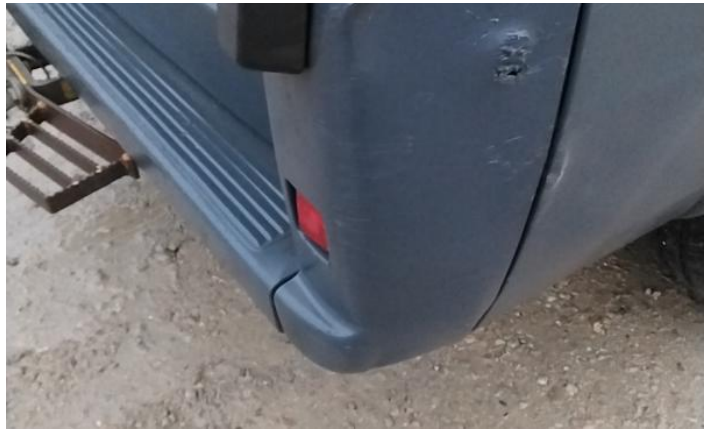
22: Bumper Rear Moulding  
Broken  
Replace

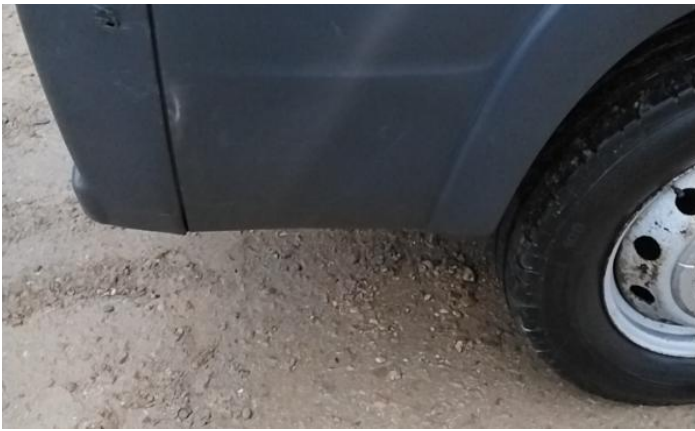
23: Qtr Panel Moulding os  
Broken  
Replace

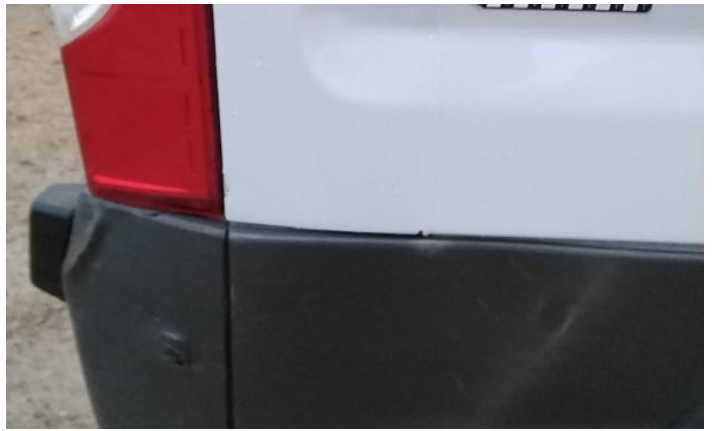
24: Qtr Panel osr  
Scratched  
Over 25mm Thru Paint

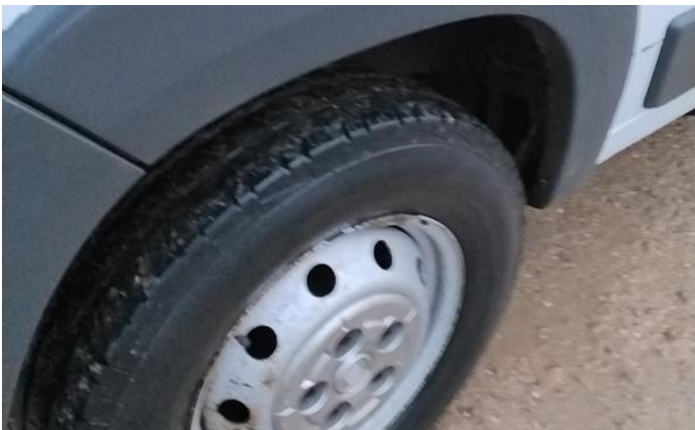
25: Qtr Panel Arch Extension os  
Scuffed (Unpainted)  
Over 100mm

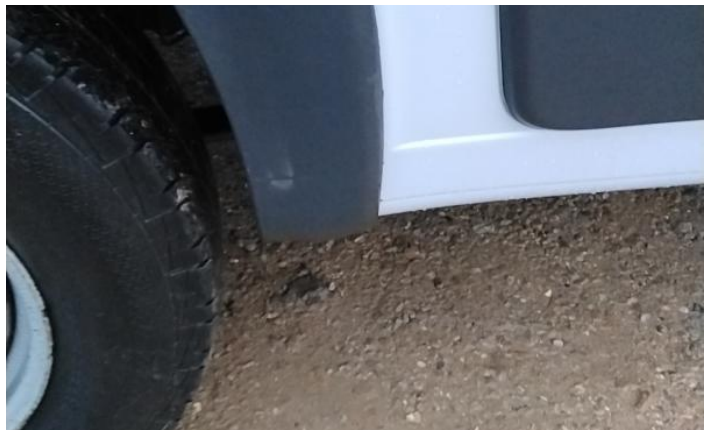
26: Qtr Panel osr  
Cracked  
Replace

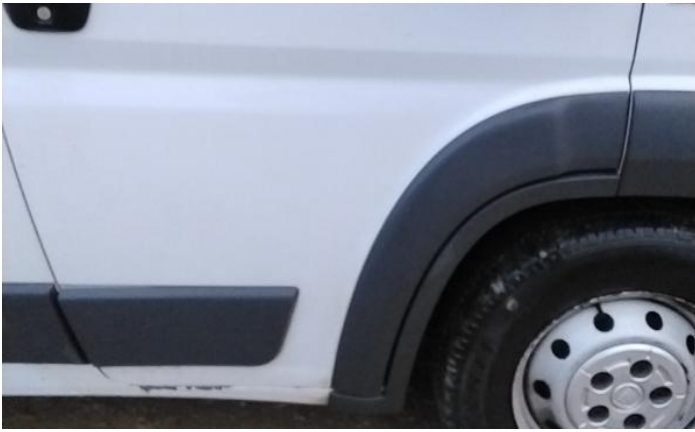
27: Door osf  
Chipped  
Multiple Chips

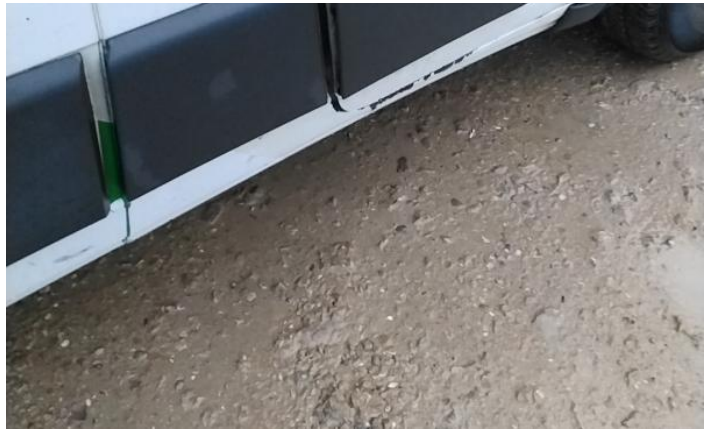
28: Door Moulding osf  
Scuffed (Unpainted)  
Over 100mm

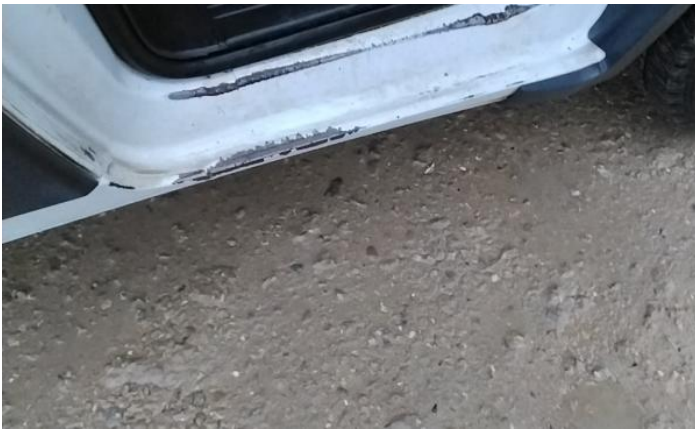
29: Sill os  
Rusted  
Over 5mm

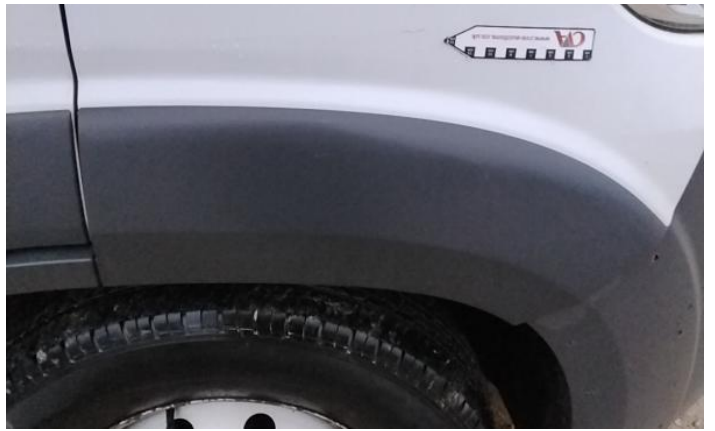
30: Wing osf  
Scratched  
Over 25mm Thru Paint

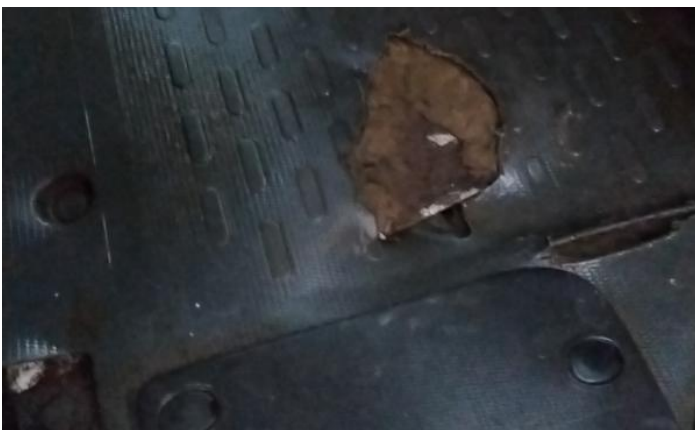
31: Carpets Front  
Holed  
Over 3mm
