# VEHICLE INSPECTION REPORT

**MV19UAH**

## Scania P 320

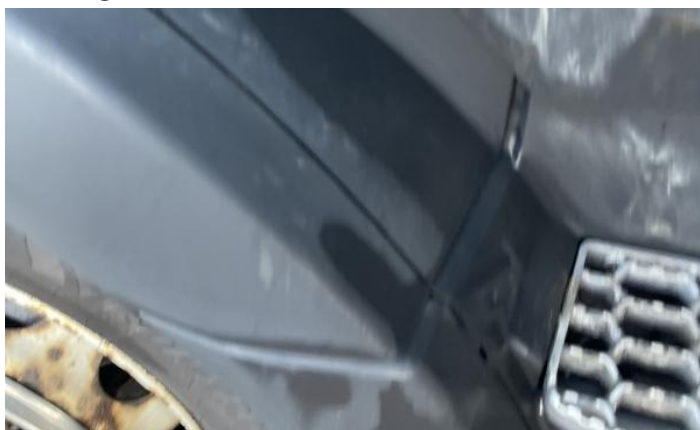
1: Door Moulding of  
Scuffed (Unpainted)  
Over 100mm

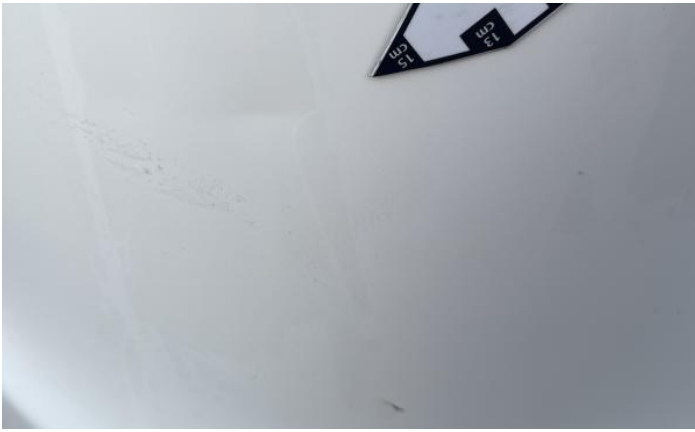
3: Wing osf  
Dented  
Over 30mm

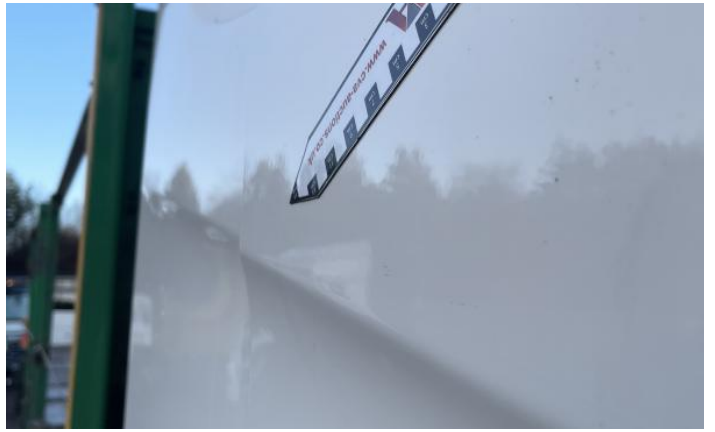
4: Door osf  
Dented  
Over 30mm

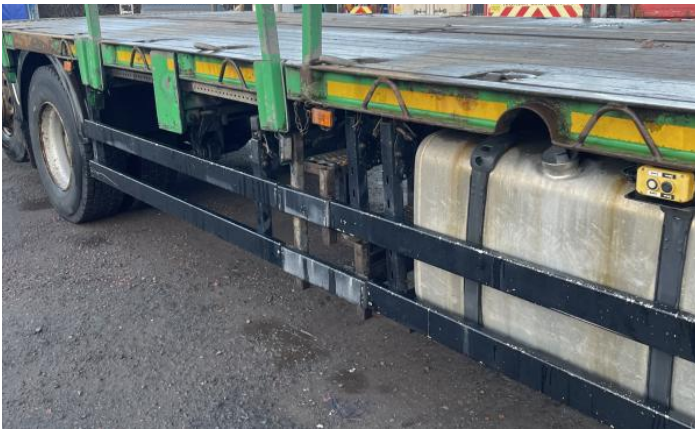
5: Qtr Panel osr  
Rusted  
Over 5mm

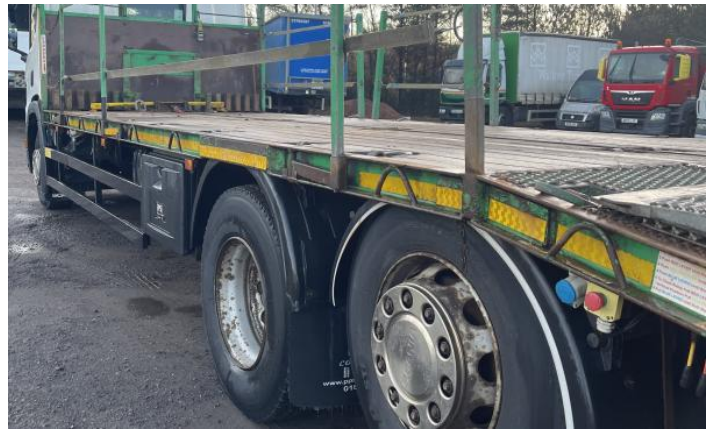
6: Qtr Panel nsr  
Rusted  
Over 5mm

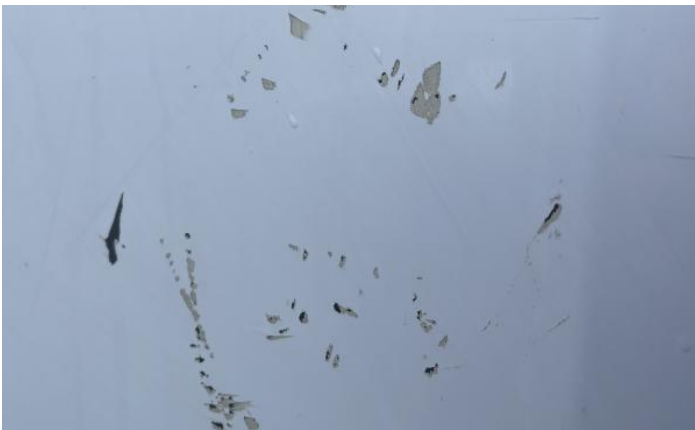
7: Qtr Panel nsr  
Scratched  
Over 25mm Thru Paint

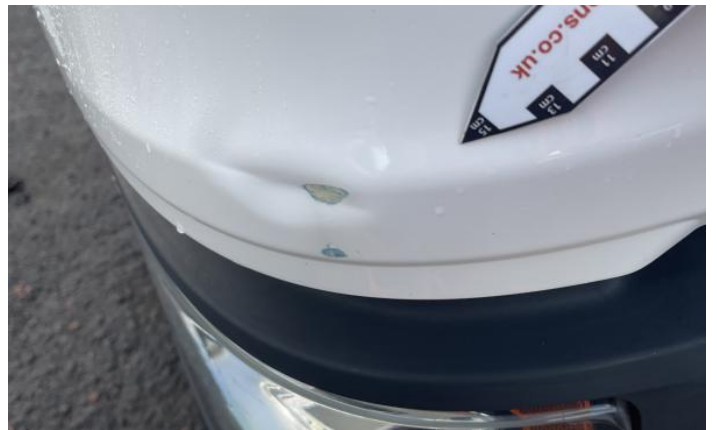
8: Wing nsf  
Dented  
With Paint Damage

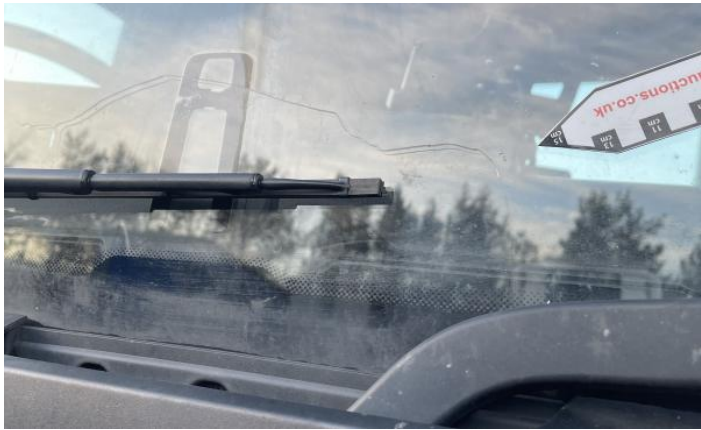
9: Screen Front  
Cracked  
Replace
