# VEHICLE INSPECTION REPORT

**BK14AOF**

## Iveco Eurocargo 75E16

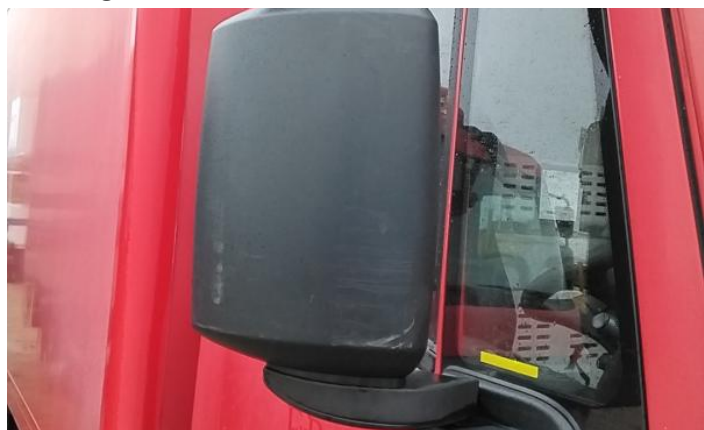
1: Door Mirror Assy osf  
Scuffed (Unpainted)  
Over 100mm

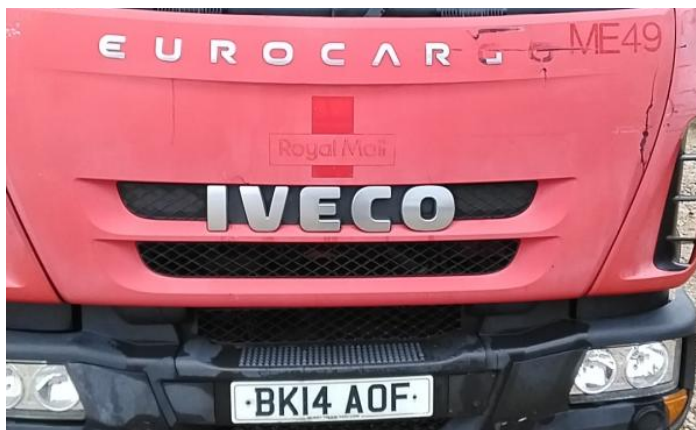
2: Bonnet  
Cracked  
Replace

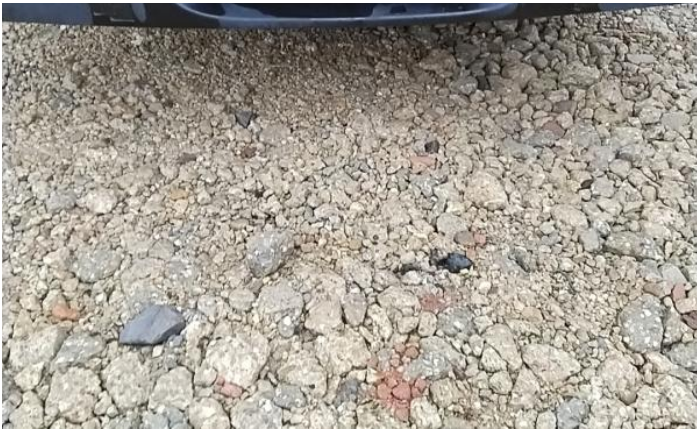
3: Bumper Front  
Hole  
Over 25mm

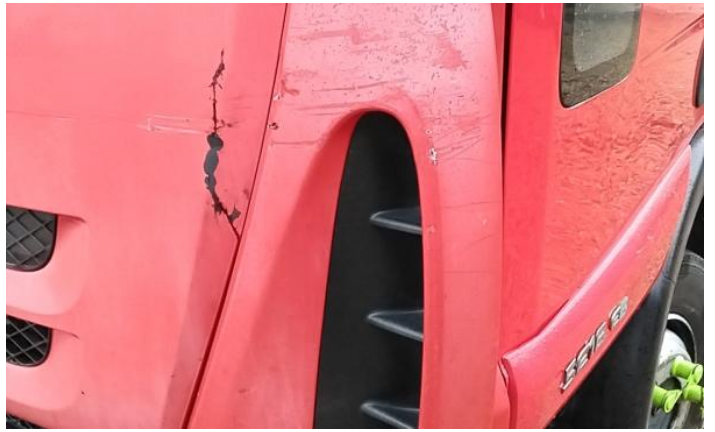
4: Wing nsf  
Scratched  
Over 25mm Thru Paint

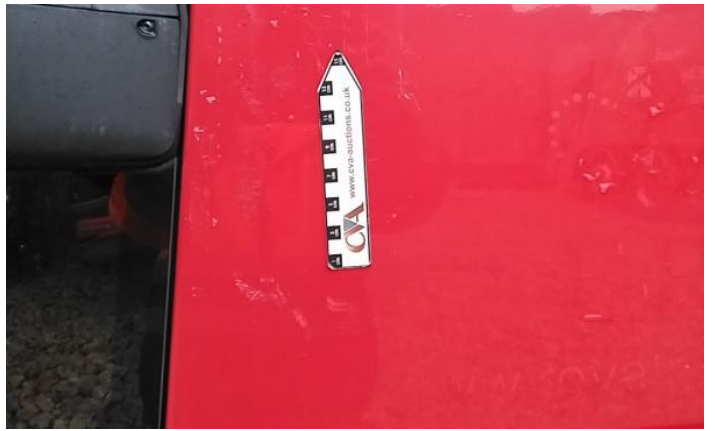
6: Door nsf  
Rusted  
Over 5mm

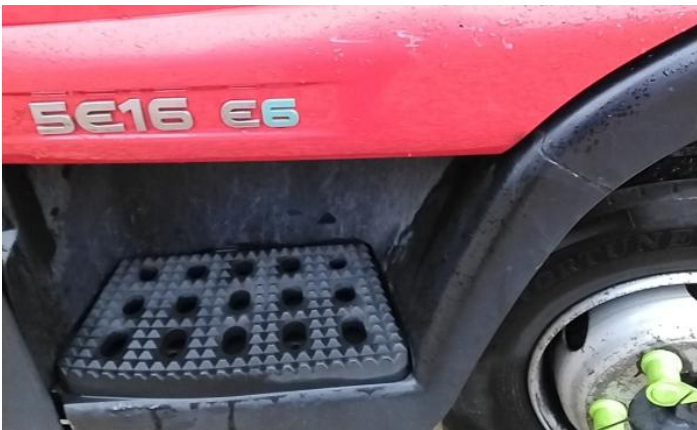
7: Door Moulding nsf  
Scratched (Painted)  
Over 25mm Not Thru Paint

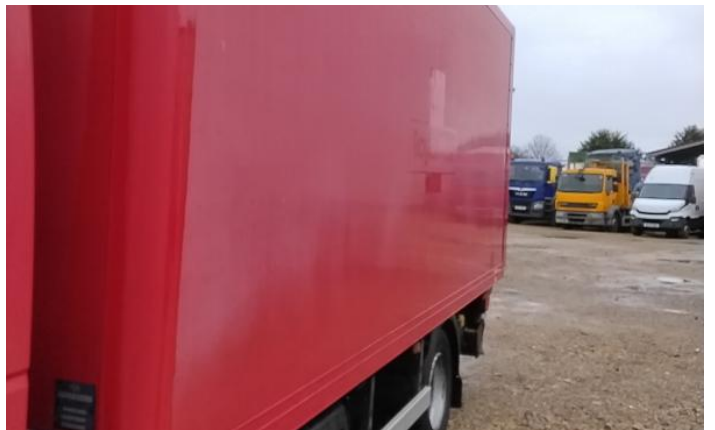
8: Panel Rear  
Scratched  
Over 25mm Thru Paint

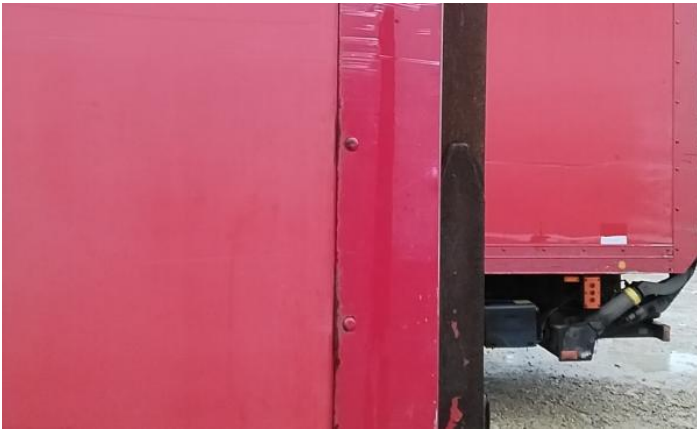
9: Qtr Panel nsr  
Scratched  
Over 25mm Thru Paint

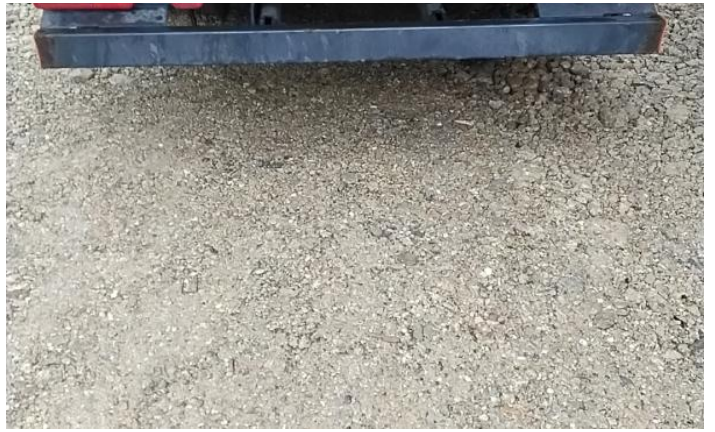
10: Bumper Rear  
Rusted  
Over 5mm

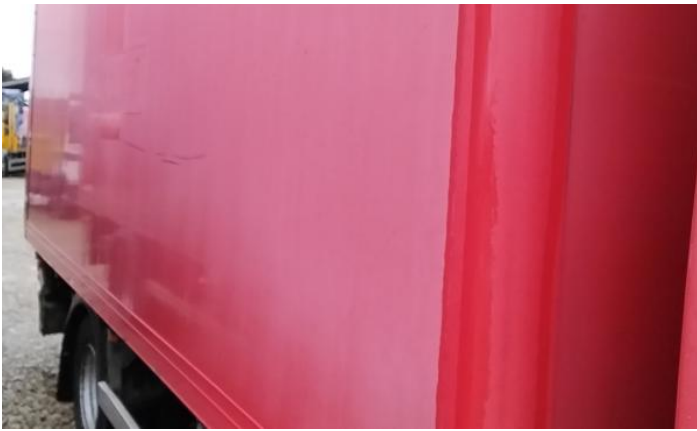
11: Panel Rear  
Scratched  
Over 25mm Thru Paint

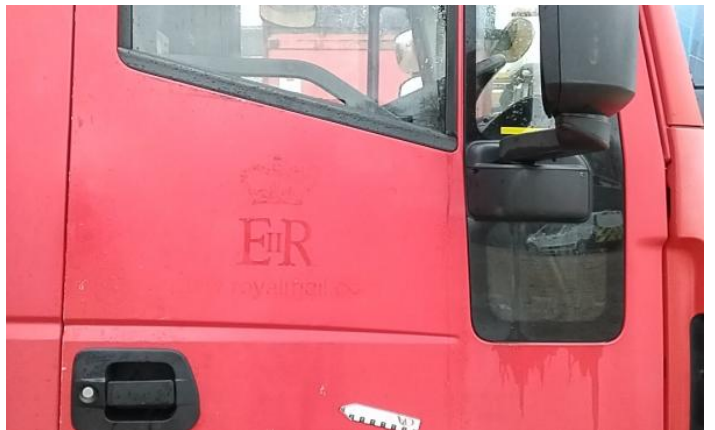
14: Door osf  
Scratched  
Over 25mm Thru Paint

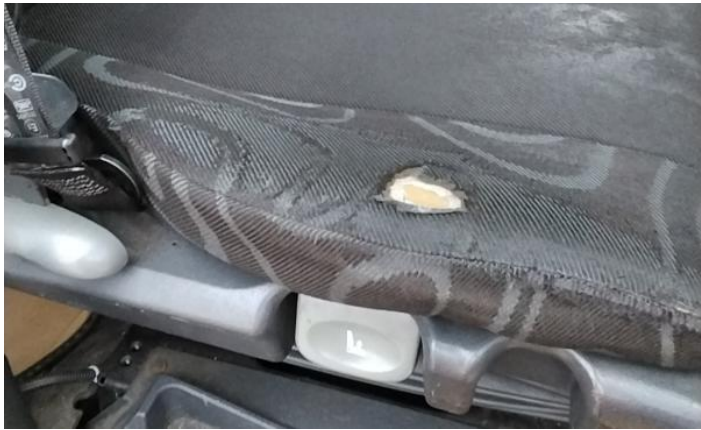
15: Seat Base Cover osf  
 Holed  
 Over 3mm
