# VEHICLE INSPECTION REPORT

**PE63NFN**

## Daf LF 45.140

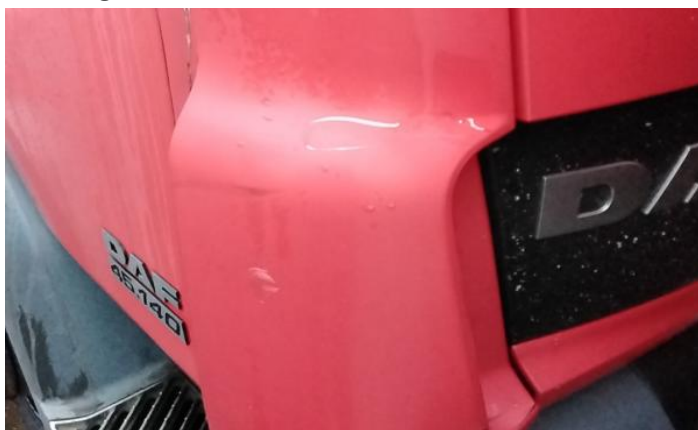
1: Panel Front  
Cracked  
Replace

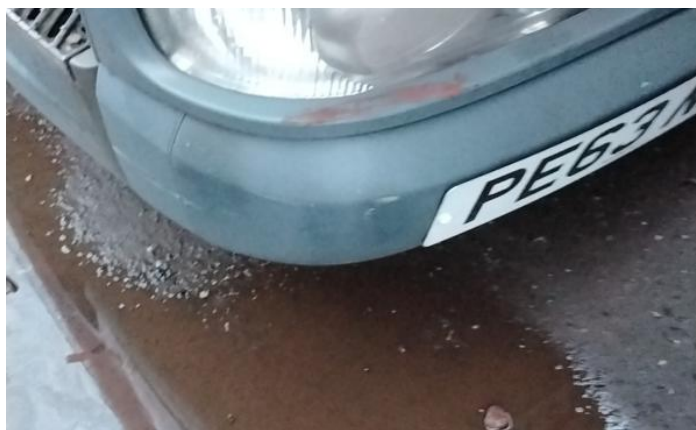
2: Bumper Front  
Scratched  
Over 100mm Thru Paint

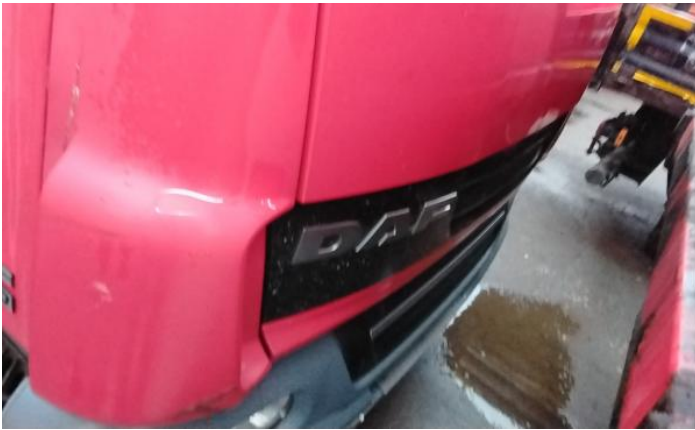
3: Bonnet  
Chipped  
Multiple Chips

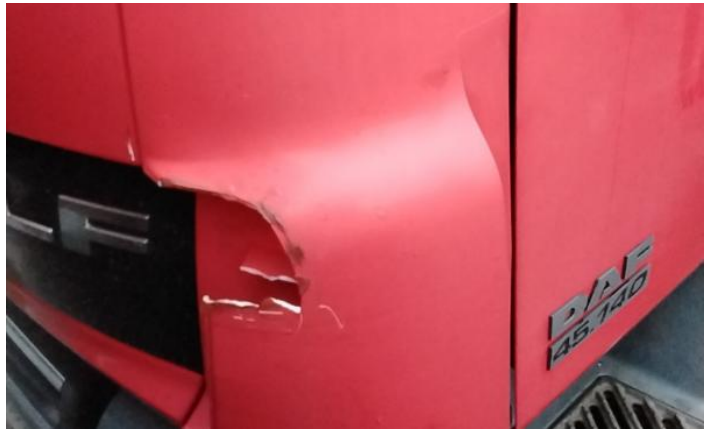
4: Panel Front  
Cracked  
Replace

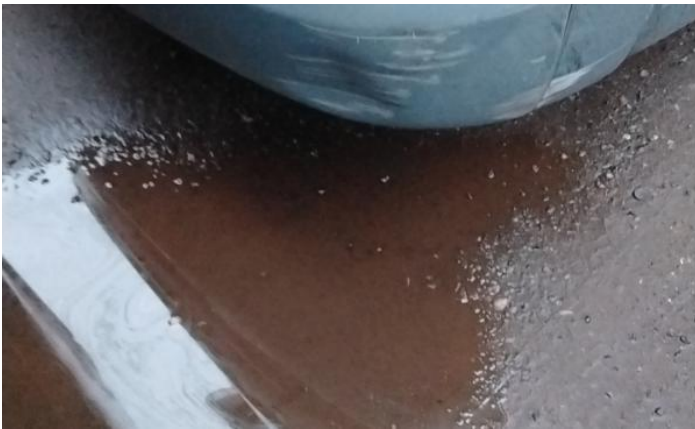
5: Bumper Front  
Dented  
With Paint Damage

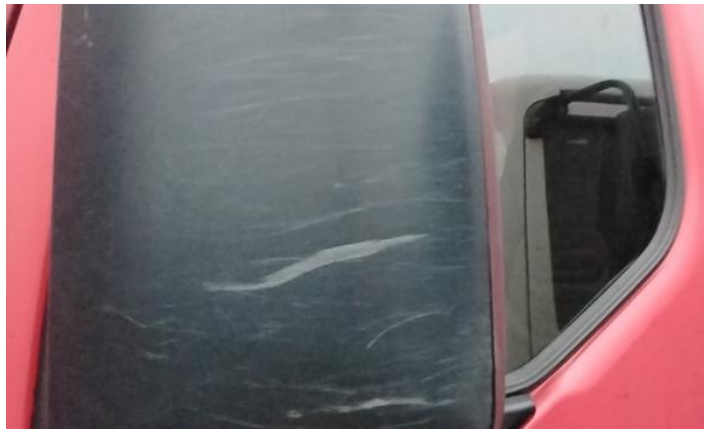
6: Door Mirror Assy nsf  
Scuffed (Unpainted)  
Over 100mm

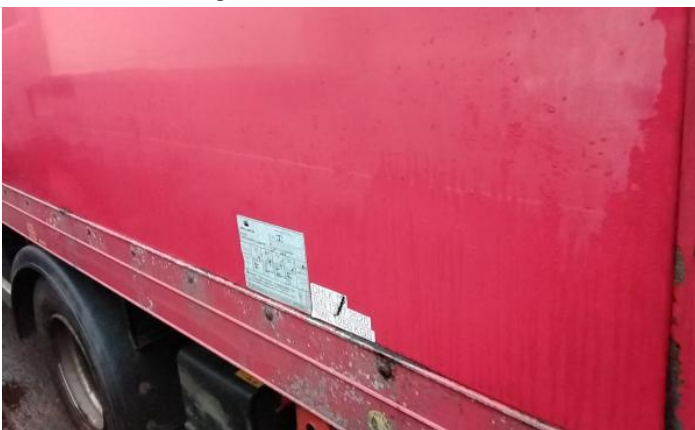
7: Qtr Panel nsr  
Scratched  
Over 25mm Thru Paint

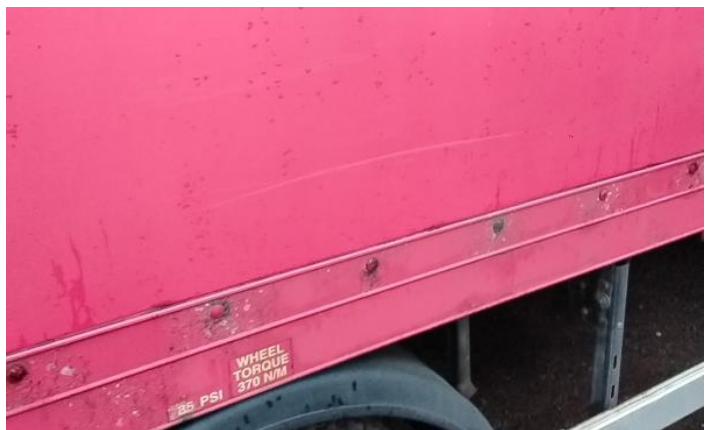
8: Qtr Panel osr  
Scratched  
Over 25mm Thru Paint

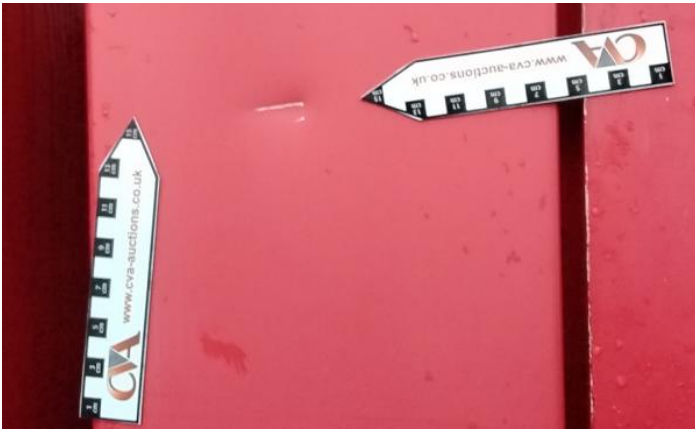
9: Qtr Panel osr  
Dented  
With Paint Damage

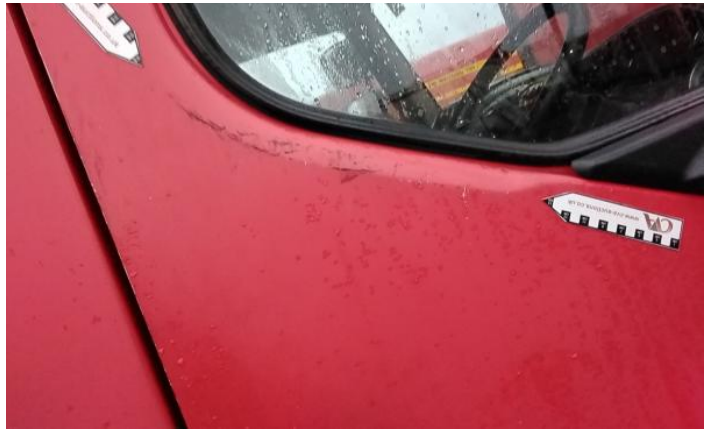
10: Door osf  
Scratched  
Over 25mm Thru Paint

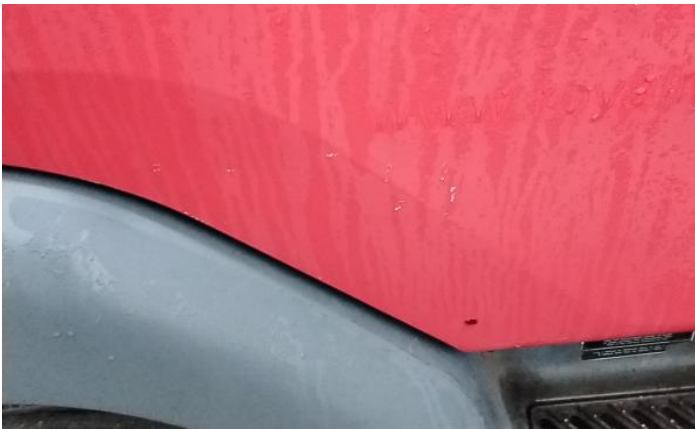
11: Door osf  
Chipped  
Multiple Chips

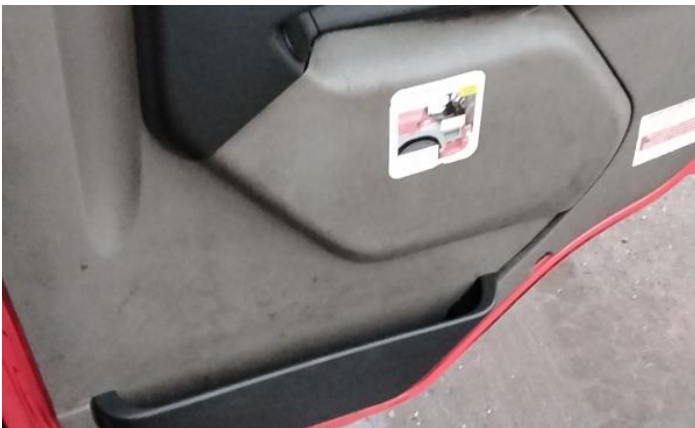
13: Door Pad osf  
Soiled  
Heavy

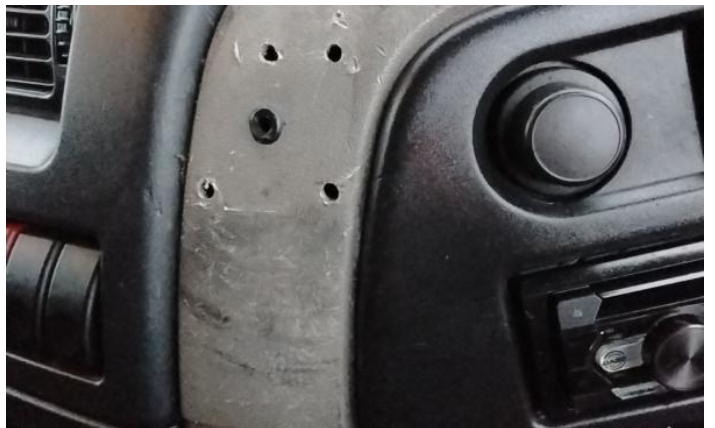
14: Fascia Panel  
Holed  
Over 3mm
