# VEHICLE INSPECTION REPORT

**PJ13XEW**

## Daf LF 45.160

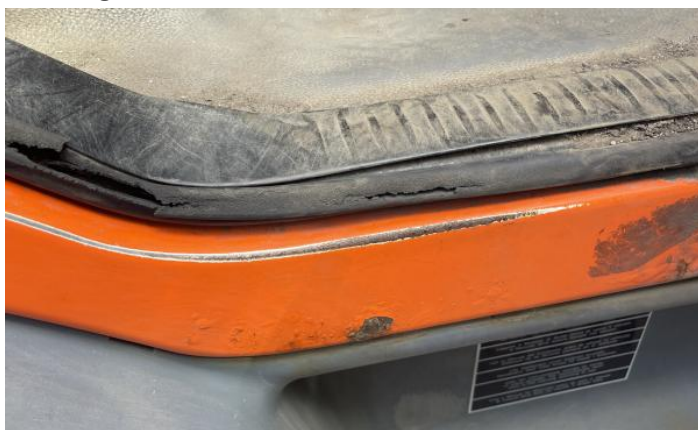
1: Sill os  
Scratched  
Over 25mm Thru Paint

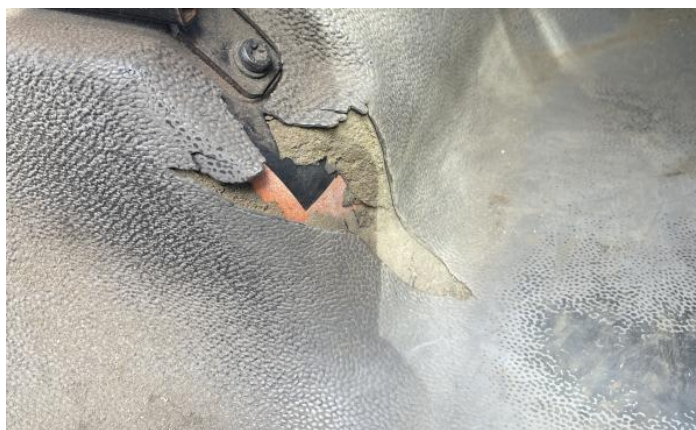
2: Carpets Front  
Holed  
Over 3mm

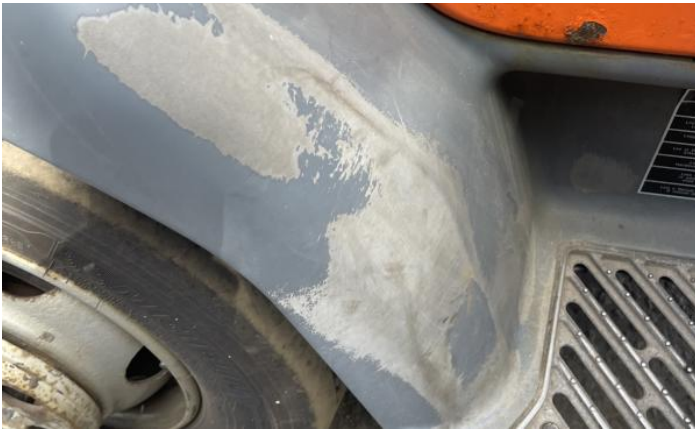
3: Door Moulding osf  
Scuffed (Unpainted)  
Over 100mm

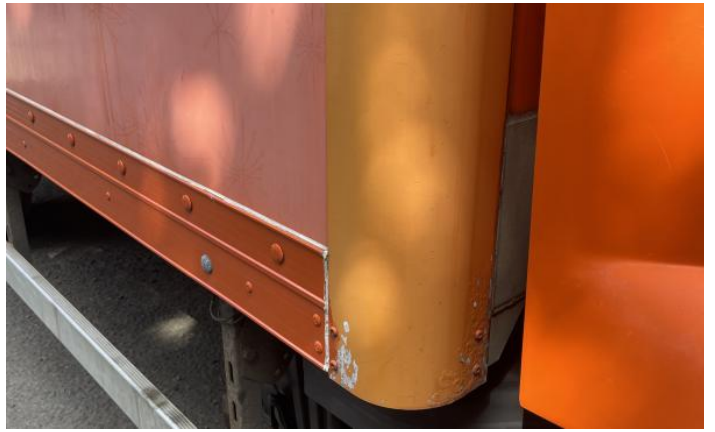
4: Qtr Panel osr  
Rusted  
Over 5mm

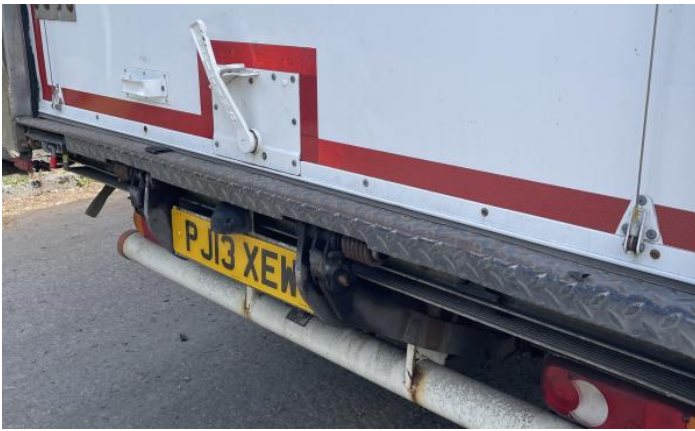
5: Tailgate  
Rusted  
Over 5mm

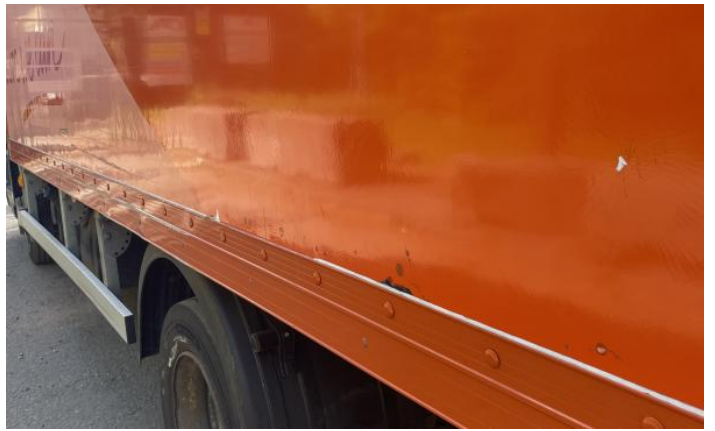
6: Qtr Panel nsr  
Dented  
Over 30mm

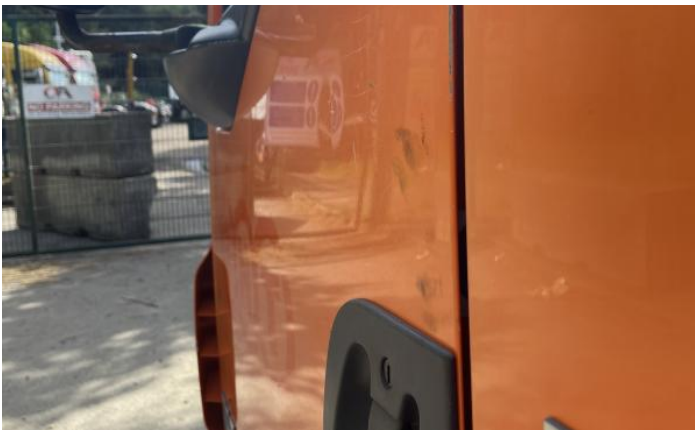
7: Door nsf  
Dented  
With Paint Damage

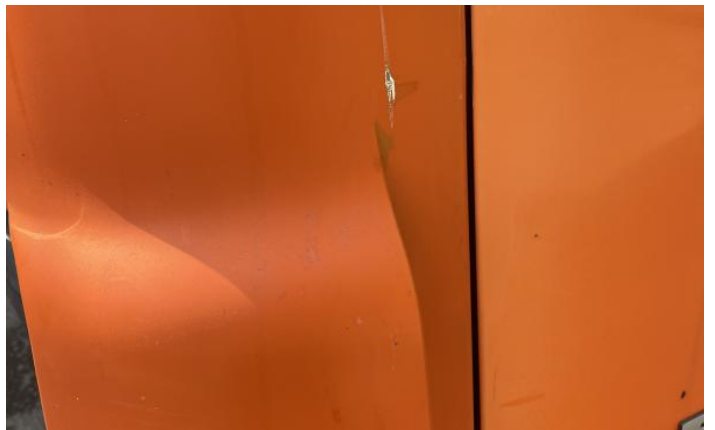
8: Wing nsf  
Scratched  
Over 25mm Thru Paint

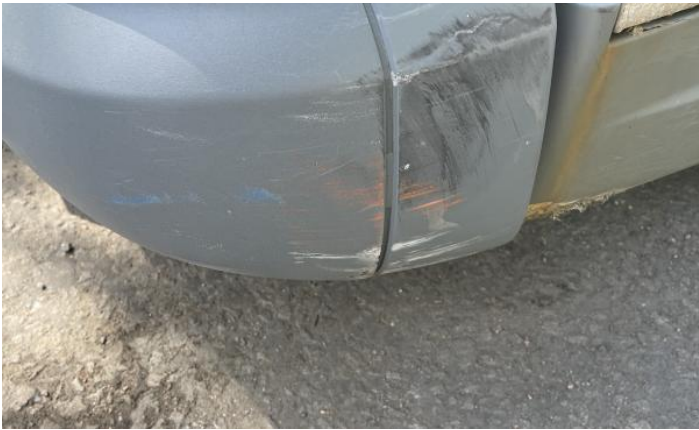
9: Bumper Front Moulding  
Scuffed (Unpainted)  
Over 100mm

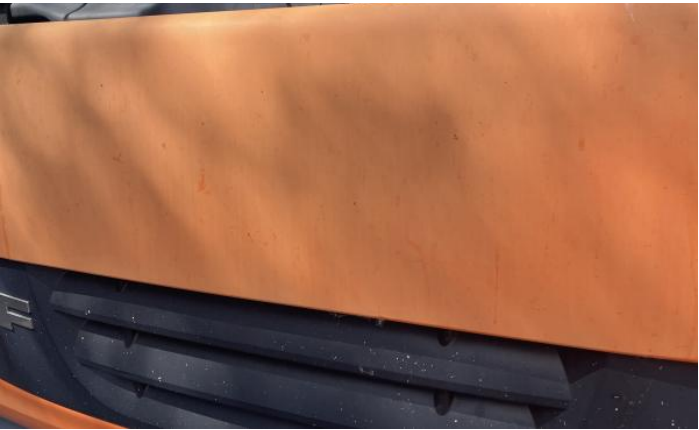
10: Bonnet  
Chipped  
Multiple Chips
