VEHICLE INSPECTION REPORT

PN63DME

Daf LF 45.160

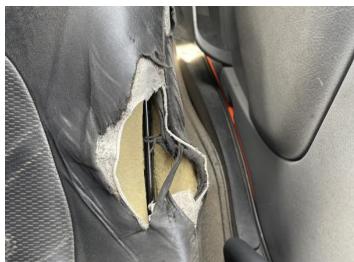
1: Seat Base Cover osf Torn Over 3mm

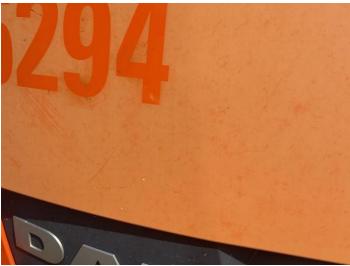
2: Bonnet Chipped Multiple Chips

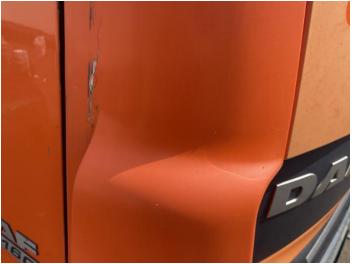
3: Wing osf Cracked Replace

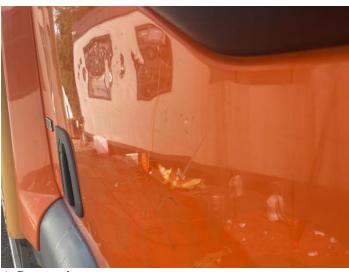
4: Door osf Dented Over 30mm

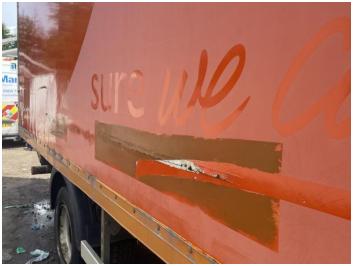
5: Qtr Panel osr Hole Over 10mm

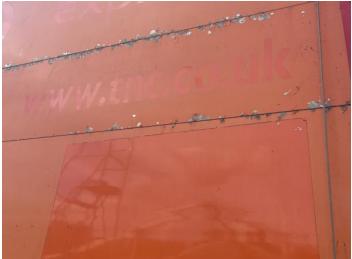
6: Tailgate Rusted Over 5mm

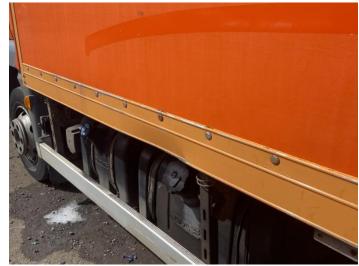
7: Qtr Panel nsr Dented Over 30mm

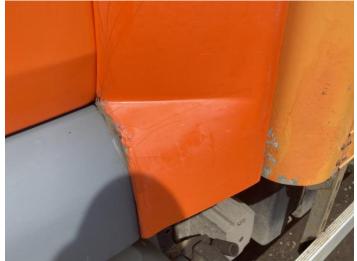
8: B Post ns Cracked Replace

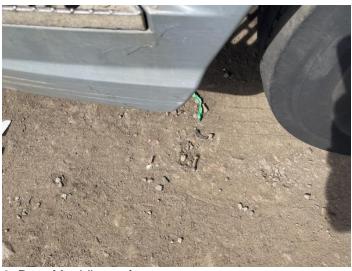
9: Door Moulding nsf Scuffed (Unpainted) Over 100mm
